MAP OF SURVEY
 LOCATED IN
 NW 1/4 OF SEC. 8, T. 39S., R. 1W.W.M.
 JACKSON COUNTY OREGON
 FOR

GRANT RICHEY

EVERETT L. SWAIN, R.L.S. ASHLAND, OREGON
 SCALE: 1"=100' SEPTEMBER 17, 1974
 BASIS OF BEARING: SOLAR OBSERVATION

SURVEY NARRATIVE TO COMPLY WITH PARAGRAPH 209.250
OREGON REVISED STATUTES

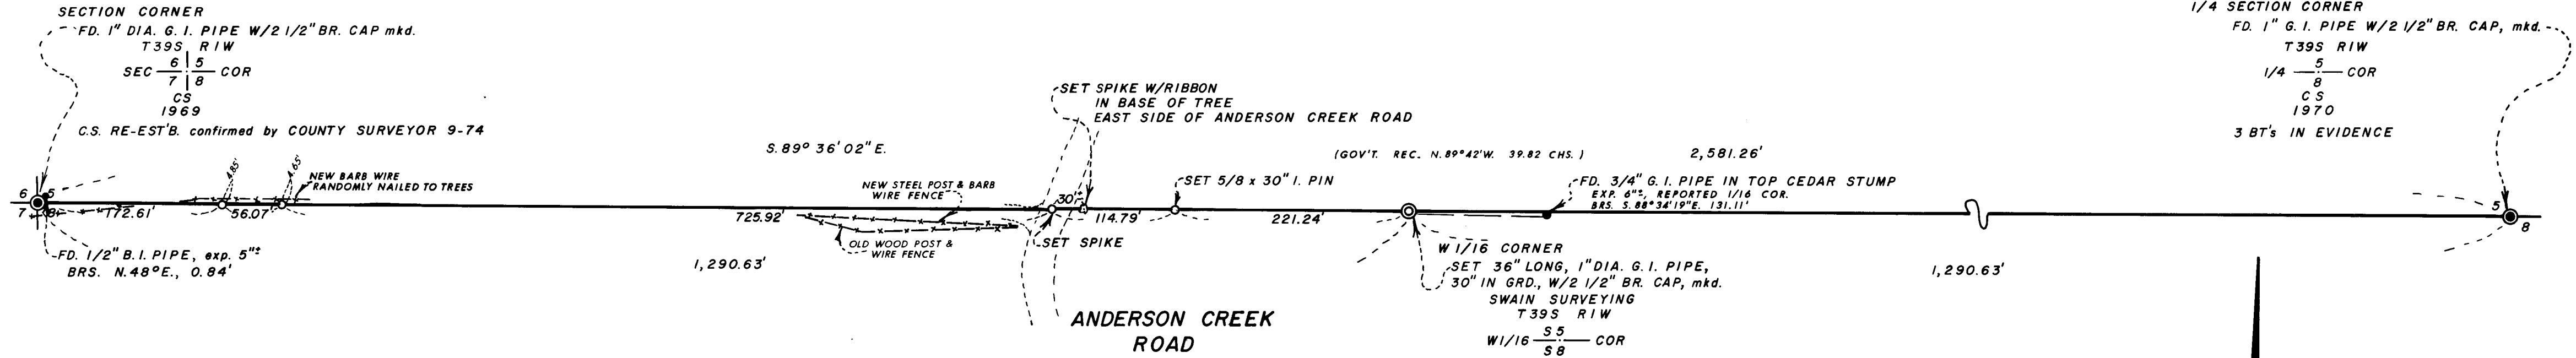
- FOUND MONUMENTS AS SHOWN
- SET 5/8 x 24 INCH IRON PIN TAGGED RLS 759 UNLESS OTHERWISE SHOWN

- from which
- A RED FIR, 7" DIA., BRS. S. 82° 38' E., 25.6' SCRIBED W 1/16 S 8 BT
 - A RED FIR, 10 1/2" DIA., BRS. S. 52° 13' W., 19.55' SCRIBED W 1/16 S 8 BT

PROCEDURE: A Wild T-2 theodolite, Hewlett-Packard 3800A distance meter and a 200 foot chrome clad 1/4 inch wide steel tape with tension handles and tape theometer were used to conduct this survey. A random closed traverse was established with side ties to the section corner and quarter corner. All angles and measurements which were not included in the closed traverse were observed twice (2). The average of the 2 observed values was used in establishing the final section line location.

The existing fence bearing Westerly from Anderson Creek Road does not appear to have been established upon any survey line. The new barb wire is strung from tree to tree, sometimes running in an arc and some very distant angle points also appear.

A well blazed and brushed line is in evidence East of Anderson Creek Road. A 3/4 inch iron pipe was found driven in the top of a cedar stump. Beyond this point there ceased to be any evidence of a brushed survey line or blazed trees. This pipe may have been stubbed in from the section corner. However, there is no proof positive as to how this pipe was set or who set it.
