PLAT
of
Subdivision of Section 4
T. 39 S., R. 3 W., of W.M.
Jackson County, Oregon

AMMENDED
 Survey Narrative
 No. 6469

Survey of Subdivision of Sec. 4, Township 39 South, Range 3 West of the Willamette Meridian, Jackson County, Oregon.

SURVEY NARRATIVE

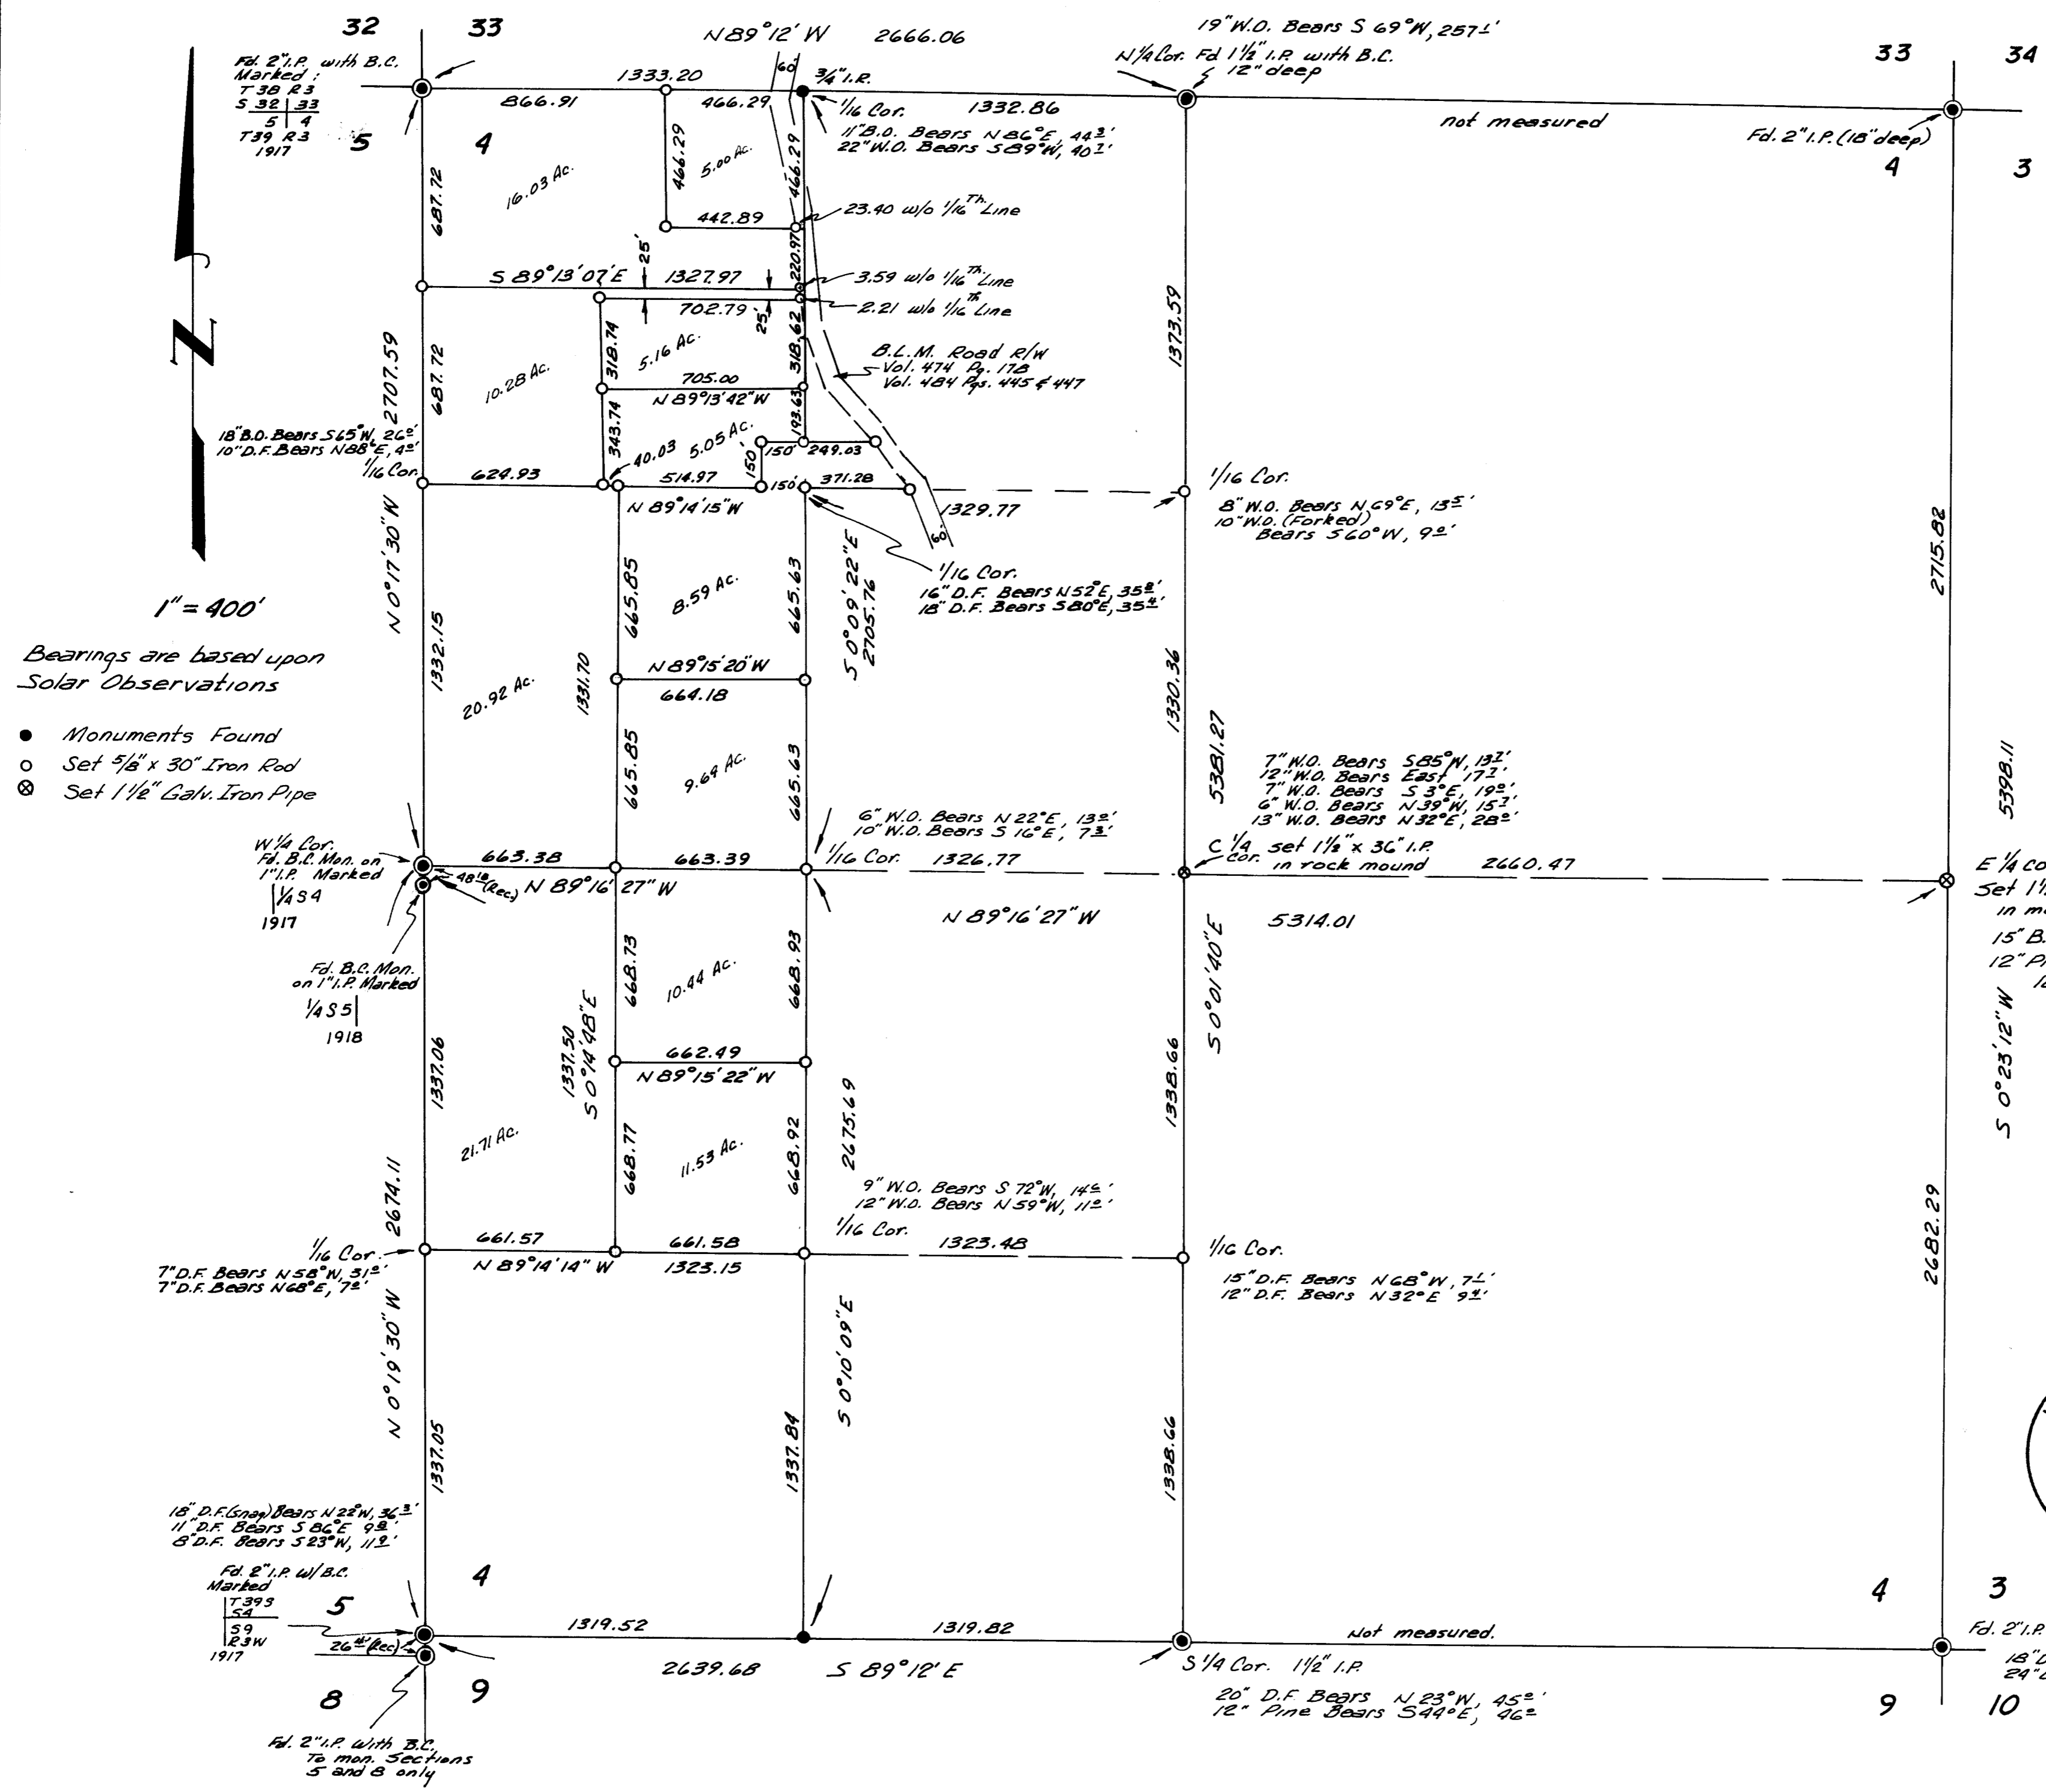
Note: Acreage shown for those tracts in the
SW 1/4 of NW 1/4 and in NW 1/4 of SW 1/4 reflect
consideration for a 25' wide strip which
joins each individual parcel to Lomas Rd.

1" = 400'

Bearings are based upon
Solar Observations

- Monuments Found
- Set 5/8" x 30" Iron Rod
- ⊗ Set 1 1/2" Galv. Iron Pipe

The accompanying plat shows the location of all monuments found, and set and the description of all bearing trees relative to those monuments established by this survey.

After determining the location of said east quarter corner, I measured between the east and the west quarter corners, then between the north and the south quarter corners to determine the location of the center of the section. I then complete my traverse of the west half of Section 4 by measuring the west half of the south line, the west line and the west half of the north line. After balancing and adjusting the survey of the west half of Section 4, I then subdivide the west half and place monuments as shown on the accompanying plat.
