MAP OF SURVEY  
LOCATED IN  
S 1/2 OF SEC. 9, TWP. 38S., R. 4 E.W.M.  
JACKSON COUNTY OREGON  
FOR

**LUMBER MILLS CORPORATION OF CALIFORNIA**

EVERETT L. SWAIN, R.L.S. ASHLAND, OREGON  
SCALE 1" = 500' JULY 10, 1976 Revised 9/23/76  
BASIS OF BEARING: SOLAR OBSERVATION

SURVEY NO. **6505**

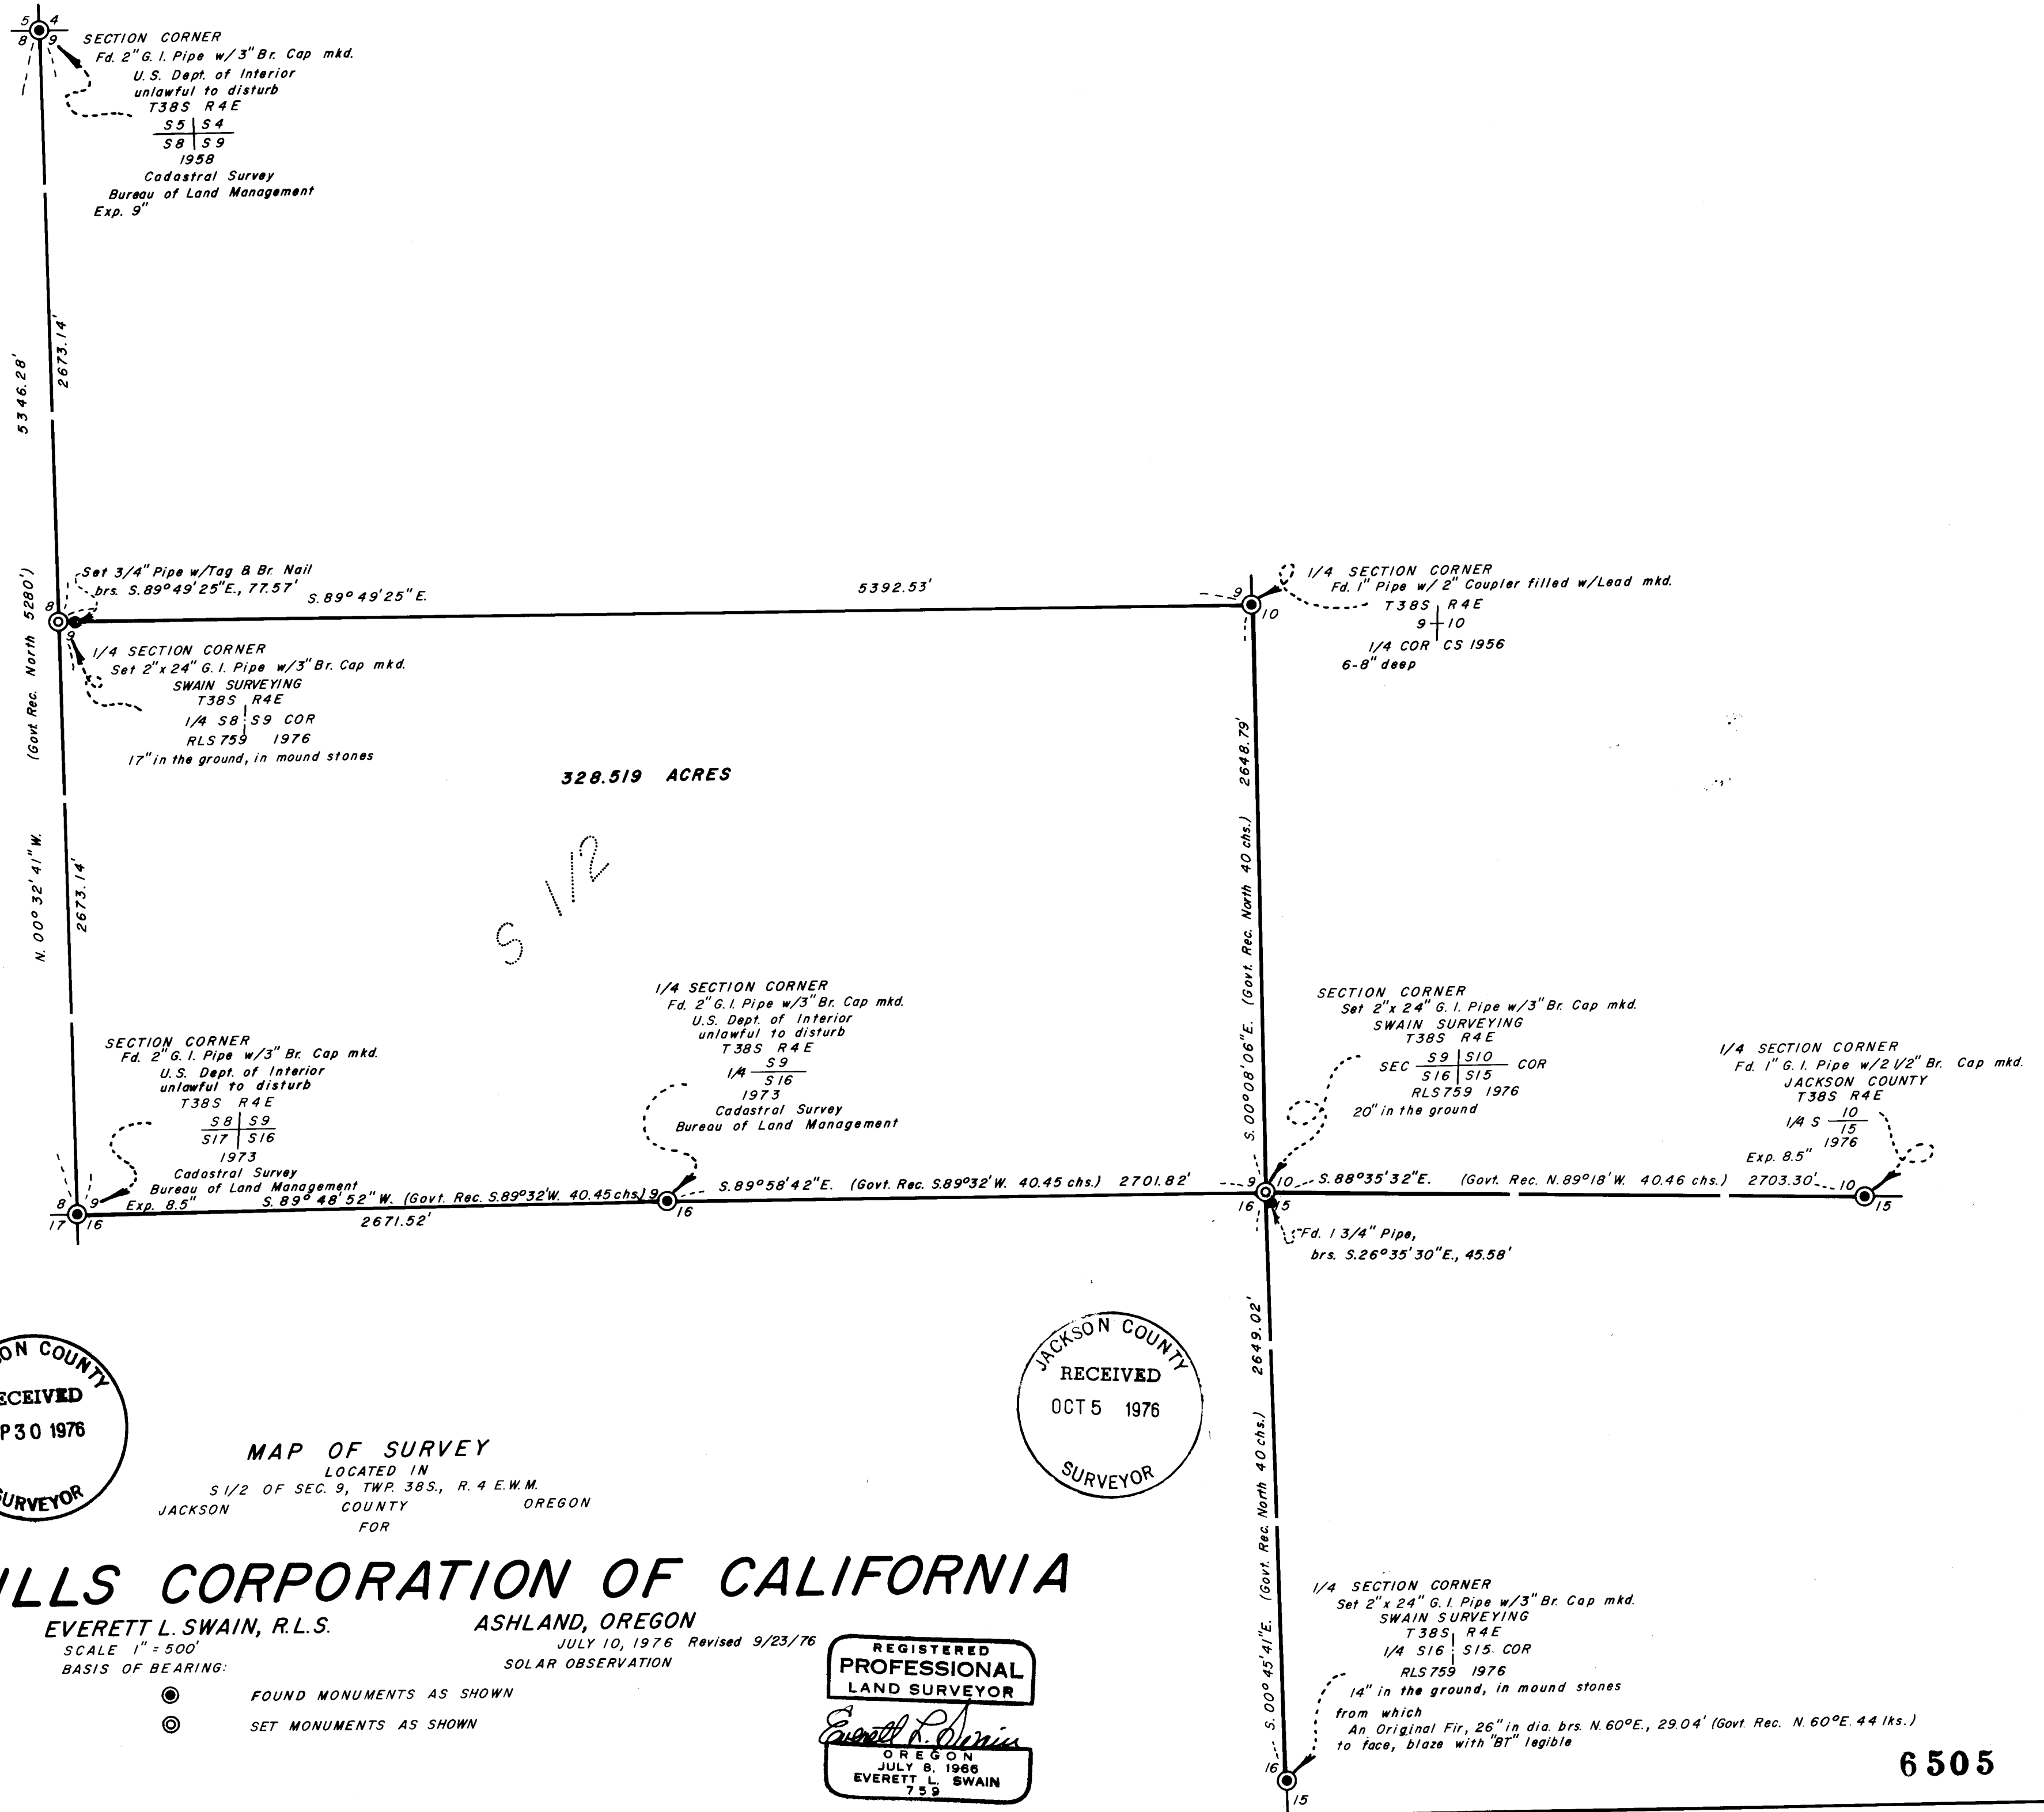
- FOUND MONUMENTS AS SHOWN
- SET MONUMENTS AS SHOWN

Before the filing of this map of survey occurred, an additional request by my client to run and mark the true boundary line on the south side of Section 9, said Township and Range, was received. Therefore, additional data has been added to the map pertaining to said south boundary.
