DEPENDENT SURVEY OF SEC. LINE
SEC'S 29 & 32, T. 38 S., R. 2 W., W. M.
FOR: MALCOLM BROWN

BY EDWARD A. MCGINTY
MEDFORD, OREGON
MAY 1977

SURVEY NO. 6863

SURVEY NARRATIVE TO COMPLY WITH O.R.S. 209-250

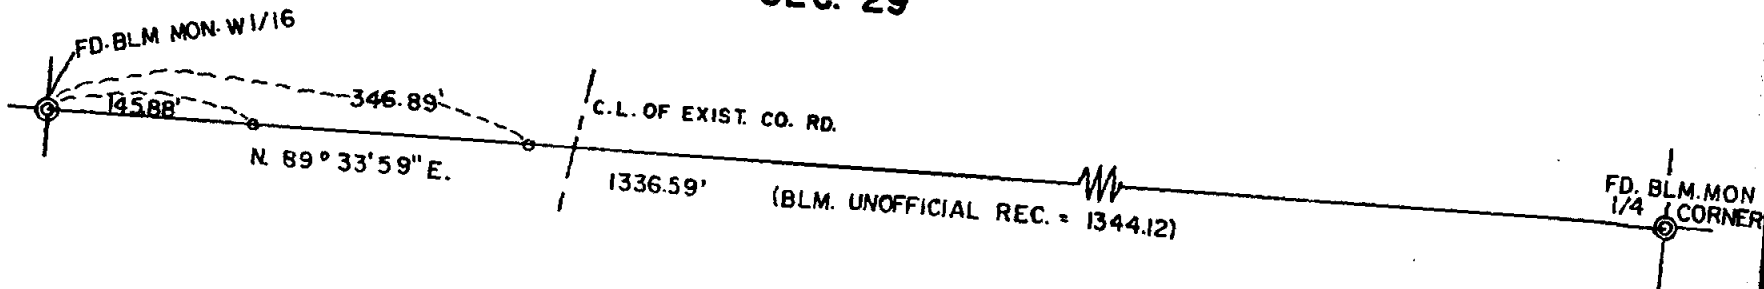
SCALE 1" = 100'
● = FD. BLM. MOUN.
○ = SET 5/8 I. PIN

This survey is dependent on monuments set by the BLM on a correction survey in 1975. This correction survey has not been officially approved as of this time.

Section 32 was sub-divided by the BLM in about 1965 and later found to be in error. The original NW cor. of Sec. 32 was recovered by the County Survey Dept.

BLM computed the off-sets from the difference between the orig. corner and the proportional corner set at the NW. corner of Sec. 32, then reset the effected corners in Sec. 32 in 1975.

On this survey found discrepancy in remeasurement, which exceeds BLM's standard of error, which would indicate they may have other errors in the first survey. This was discussed with BLM Cadastral Engr. L. Rosebury.
