MAP OF SURVEY

Located in the NE and the NW 1/4's of section 14,
T 38 S, R 3 W, W.M., JACKSON COUNTY, OREGON.
for

DAVE JOHNSON

SURVEY NARRATIVE TO COMPLY WITH O.R.S. 209.250.

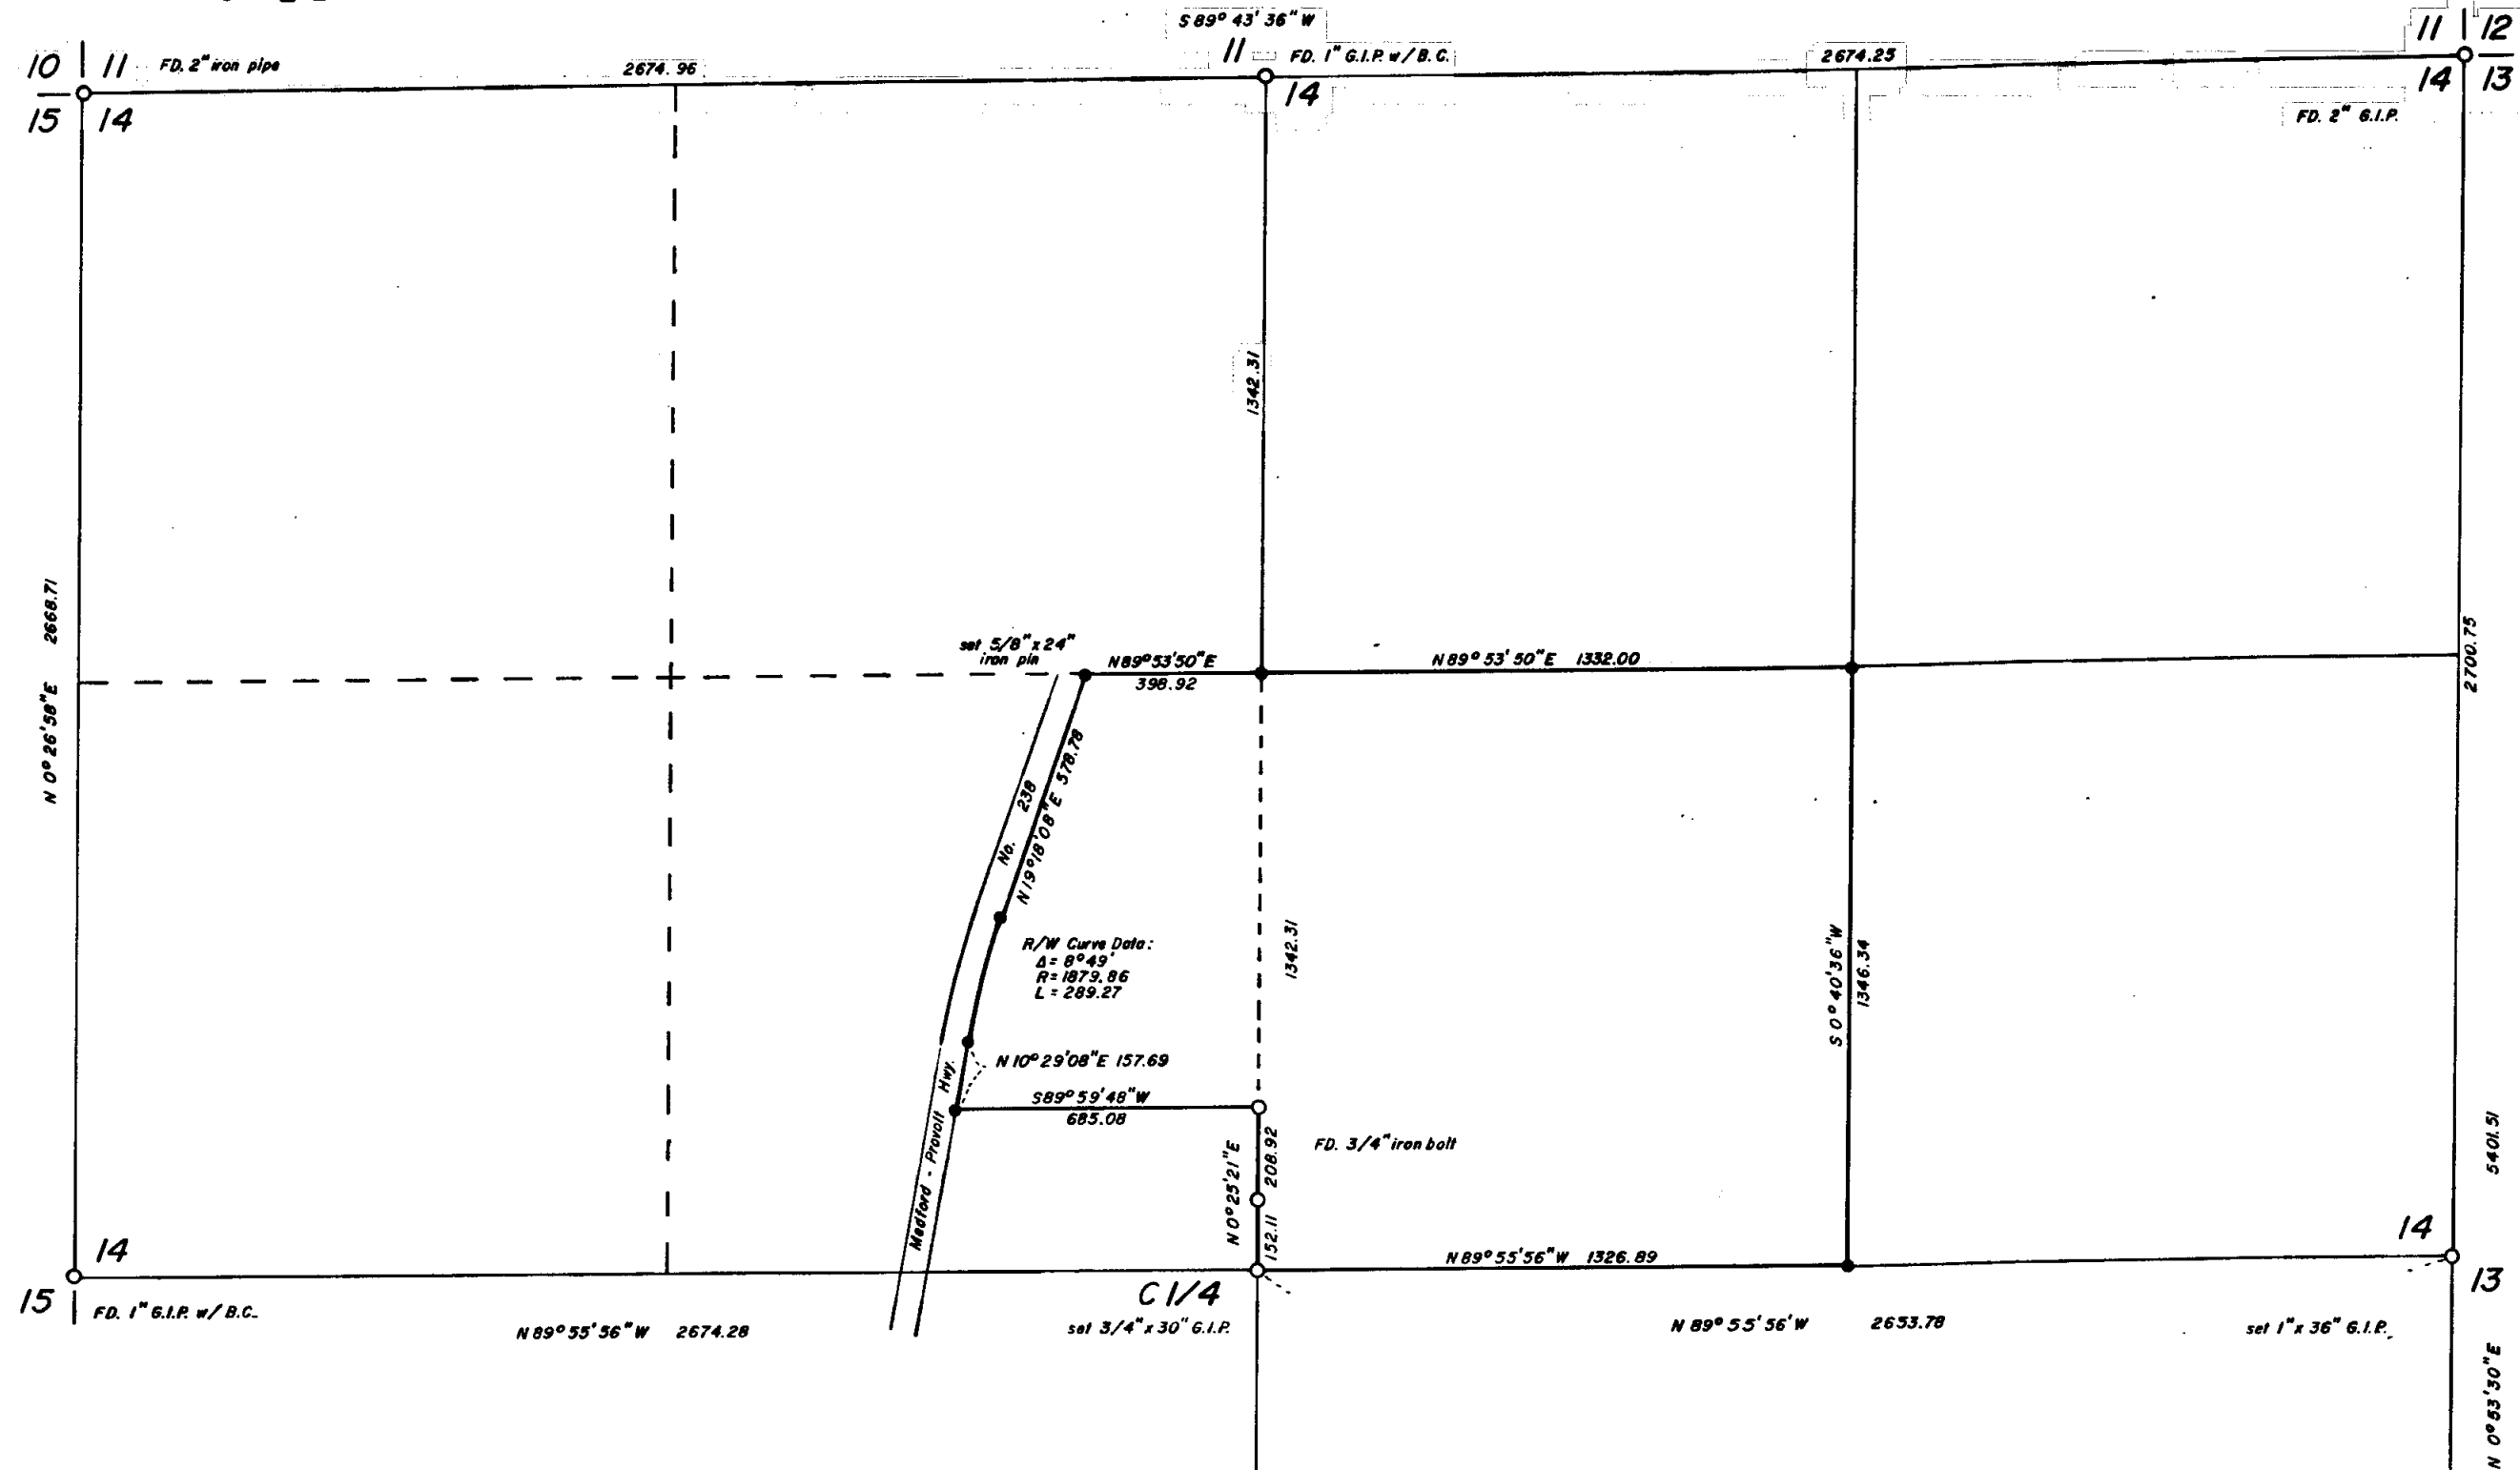
BASIS OF BEARING: SOLAR OBSERVATION
MONUMENTS FOUND AS SHOWN

● SET 5/8" x 30" iron pin
SCALE: 1" = 300'
DATE: AUGUST 26, 1977

An intensive search was made for the $\frac{1}{4}$ corner common to sections 14 and 13, yielding no evidence. The corner was set on a proportion basis between adjacent section corners. The proportionate position fit the topog call to the north within a half chain.

The subdivision of section 14 followed and the SW $\frac{1}{4}$ of the NE $\frac{1}{4}$ was monumented as shown.

The Highway right of way was determined from monuments found per surveys no.s 862 and 815, as well as the State Hwy. Map.

Procedure: At the section corner common to sections
13,14,23 and 24 a black iron pipe, 1 5/8"
outside diameter was found and 3 witness
trees. The pipe is not of record and its
origin is unknown. The 3 witness trees
evident at the corner are all White Oak,
which aroused considerable concern as the
original notes of David P. Thompson called
for Black Oak. Two trees have opened
faces, while the third, the NE tree, was
opened upon arrival at the position. In
the partially opened face the tree is
scribed "T38S" with the style of scribing
commonly identified as Thompson's. This
tree is now a snag 10" in diameter, having
been dead for a number of years. The mis-
called species was quite disconcerting,
however Thompson's notes stated that the
survey was done in February, and it is pos-
sible that the trees without foliage were
erroneously identified. The corner falls
on a steep South slope, making it doubtful
that Black Oak would have ever existed in

Due to the lack of record original evidence
at the corner the $\frac{1}{4}$ corners to the south
and the west were tied, as well as the sec-
tion corner to the North. This information
indicated that the pipe appeared to be in
the most practical location to fit the ap-
purtenances in existance at the corner.

In attempting to position the corner from
record information from the witness trees
several possible locations arose. Holding
a distance intersection solely would have
been impractical as it didn't fit bearings
by excessive amounts, while conversely the
bearing intersection of all three trees
was an impossible condition.
