SURVEY FOR PARTITION OF PROPERTY FOR  
 THE HALLMARK FAMILY

IN THE SE 1/4 SE 1/4 OF SECTION 32 T.37S. R.4W., W. M.  
 JACKSON COUNTY, OREGON.

Survey For Partition of Property for the Hallmark Family,  
In the SE1/4 SE1/4 of Section 32, T36S R4W, W.M.

Narrative description to comply with Par. 209.250, O.R.S.

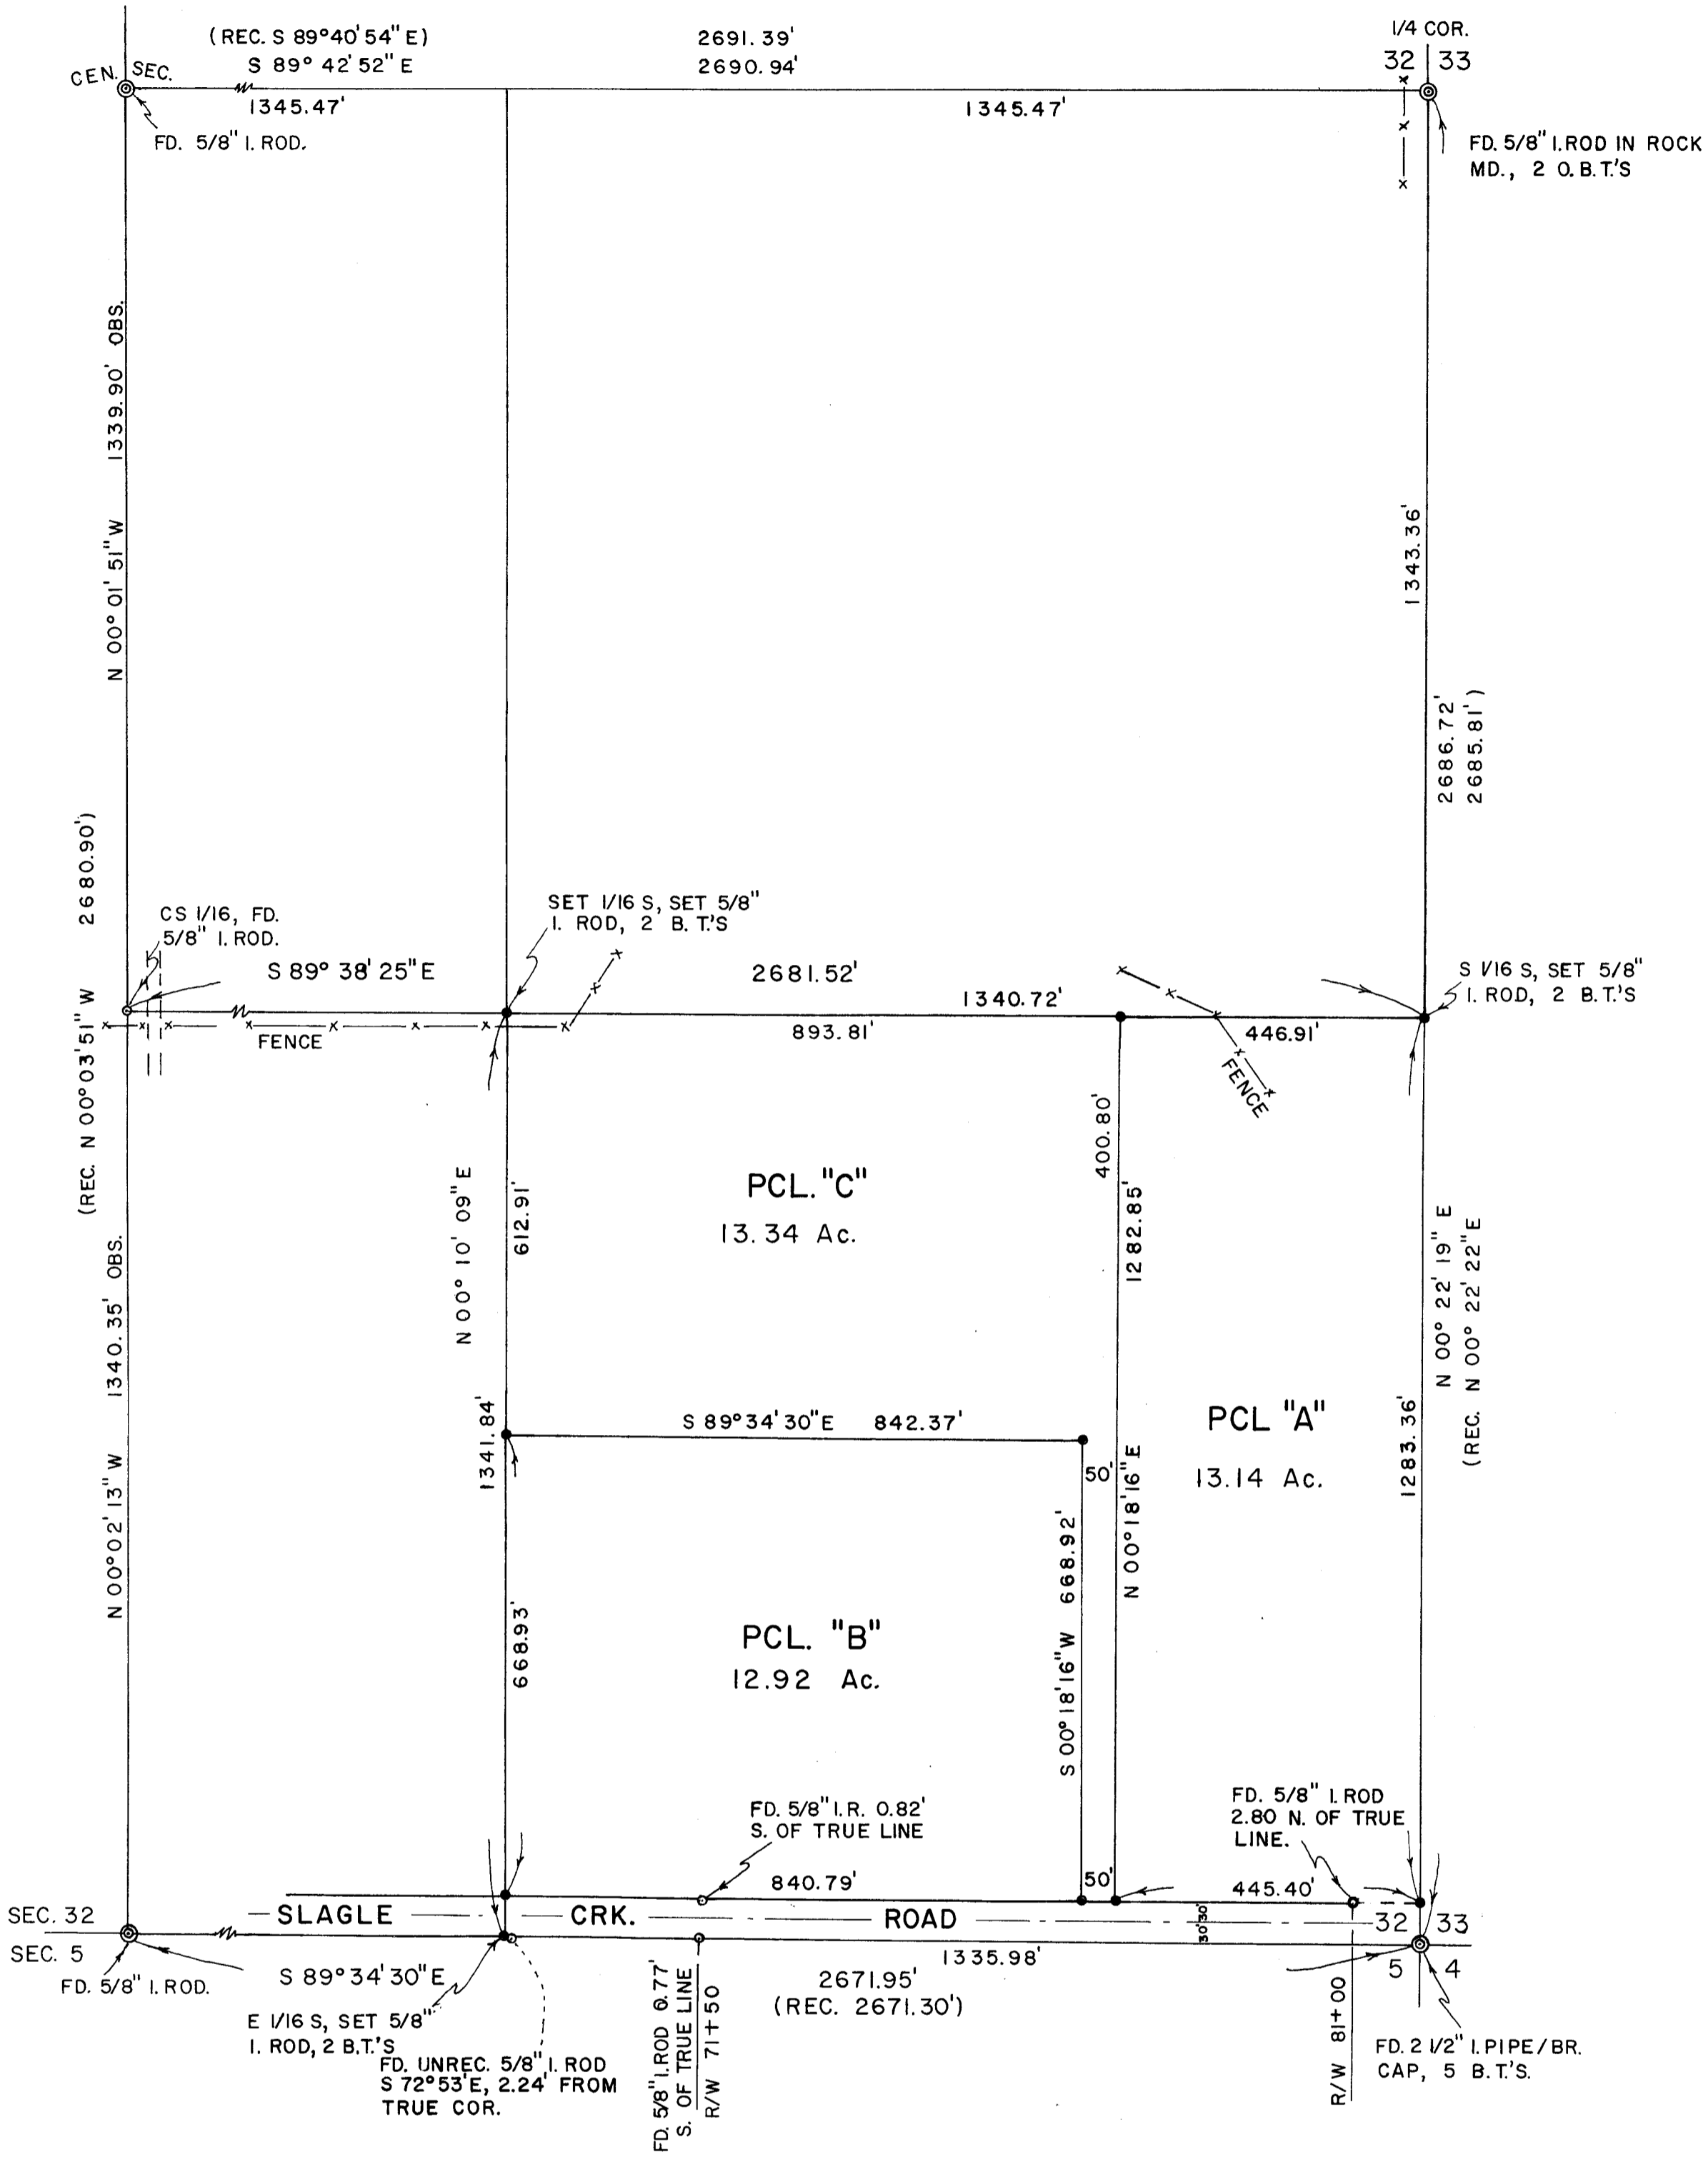
BEARING BASIS = SOUTH LINE OF SECTION 34, AS SHOWN IN SURVEY NO. 5876.

- INDICATES MONUMENT FOUND.
- INDICATES 5/8" I. ROD/YEL. CAP "RE 3683", SET IN THIS SURVEY.

SCALE: 1 INCH = 200 FEET

Purpose: To partition the SE1/4 SE1/4 into 3 parcels, as requested.

Procedure: It was necessary to subdivide the SE1/4 in order to determine the necessary "forty" corners and boundaries. Survey No. 5876 had previously subdivided Section 32, setting the center 1/4 corner and CSI/16 corner. My survey began, using Tellurometer CA-1000 and Kern I-second theodolite equipment, by tying in all of the corners required for said subdivision. The true southwest, northwest, and northeast corners of the SE1/4 SE1/4, as well as other monument positions needed, were then computed, and set. A cross traverse was also run on the ground between certain of my electronic survey points, as a double check. As indicated by the comparative dimensions shown on my map, there were some small discrepancies found in the data shown in Survey No. 5876. These were small enough so that the established corners were acceptable.
