SURVEY IN THE ORIGINAL TOWN OF TALENT
 LOCATED IN THE S.E. 1/4 SEC. 23 T 38 S R 1 W WM.
 JACKSON COUNTY, OREGON
 FOR
 GRANVIL BRITTSAN
 78-9

SURVEY NARRATIVE TO COMPLY WITH O.R.S. 209-250

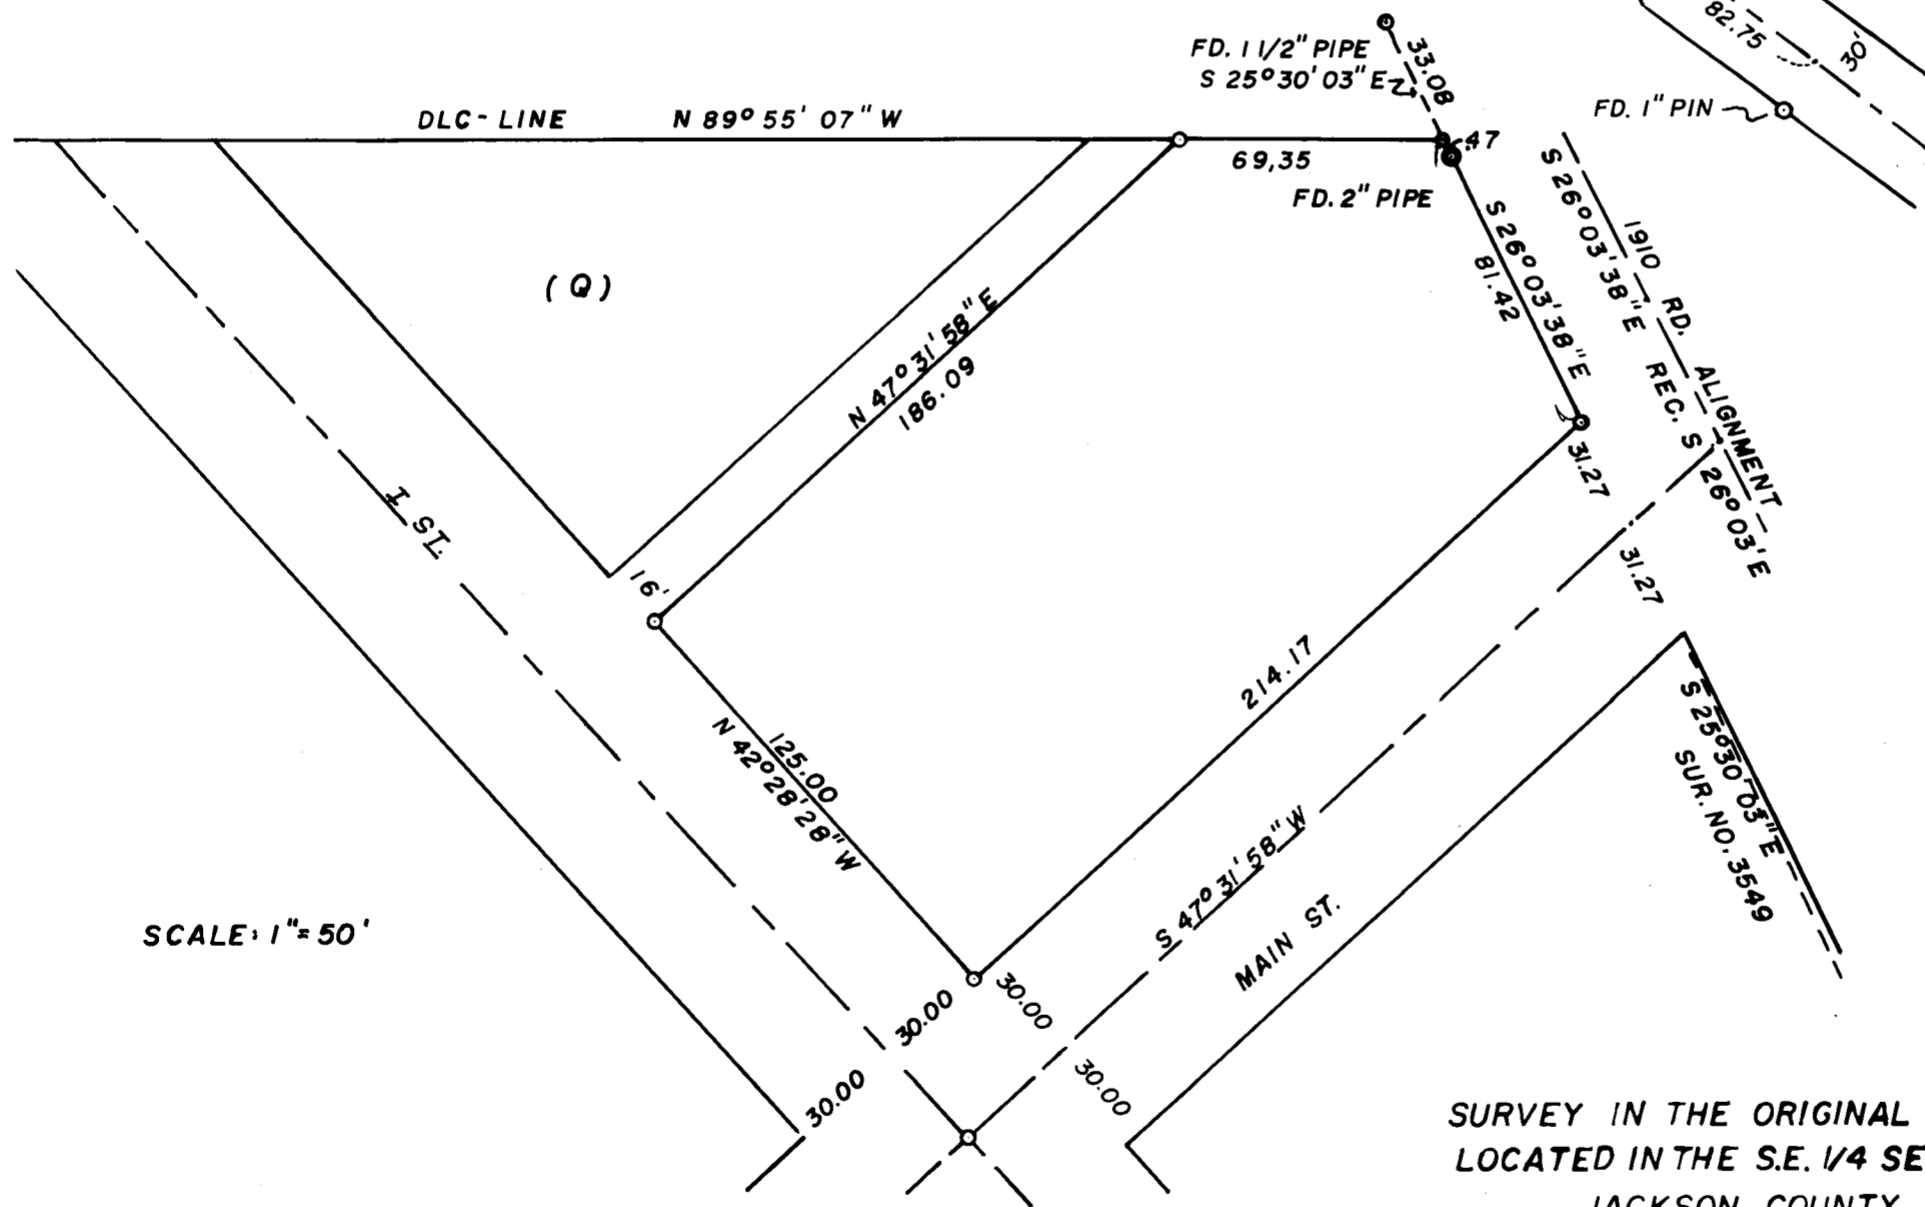
7280

E.A. MCGINTY REG. L.S. MEDFORD, OREGON
 APRIL 25, 1978 ○ = SET 5/8" IRON PIN

Basis of Bearing: Center line of Main St. N.47°31'58"E.

The center line of Main St is dependent on previous survey No. 5878. This location is in close agreement with previous surveys along Main St. and agrees reasonably close with the improvements as well as the town plat.

The center line of the Old Pacific Hwy. may possibly have four different alignments, the original petition - Original Town of Talent - the 1910 road records and a road relocation which was possibly made in the early twentys by the Highway Dept., as well as other possible locations by various surveys over the years.

By using existing improvements and indirect tie to Rapp Lane, the location shown is near the location and would probably be the best location, agreeing with most of the improvements. The 1910 location was completed at an early date and would be more in harmony with the original plat.

The 1910 survey indicates a certain angle point as being on DLC line; thence calling a distance of 98.5 ft., whether it was mis-transcribed as 89.5 instead of 98.5 or the angle point was north of DLC line, making an assumption it was on the DLC line, was not determined.

Found that the alignment does not agree with Survey No. 1453, 3549 or 3494, which are + or - 0°04' off the re-location by the Hwy. Dept. I made a further check with Jackson Title Co. for changes or whether additional rights were acquired, none could be found.

Found a 2 in. pipe at fence corner, being commonly accepted as the Northeast corner of DLC 63 for many years and generally accepted as the true location by local surveyors.

Fd. a B.C. and concrete monument at the SE. corner of DLC 60 the official re-estab. made the county surveyors office.

In an attempt to analyze the Original Town Plat, it is evident that a number of ambiguities may exist as the exterior closure is poor, which would indicate that part of the sub-div. is 'paper sub-div.' with scale distance of odd size blocks, etc.
