SURVEY IN NW. 1/4 SEC. 7, T. 38S., R2 W., WM.
 78-24
FOR N.A. LIKELY

BY EDWARD A. MC GINTY
 MEDFORD, OREGON
 SEPT 1978

SURVEY NO. 7566

SURVEY NARRATIVE TO COMPLY WITH O.R.S. 209-250

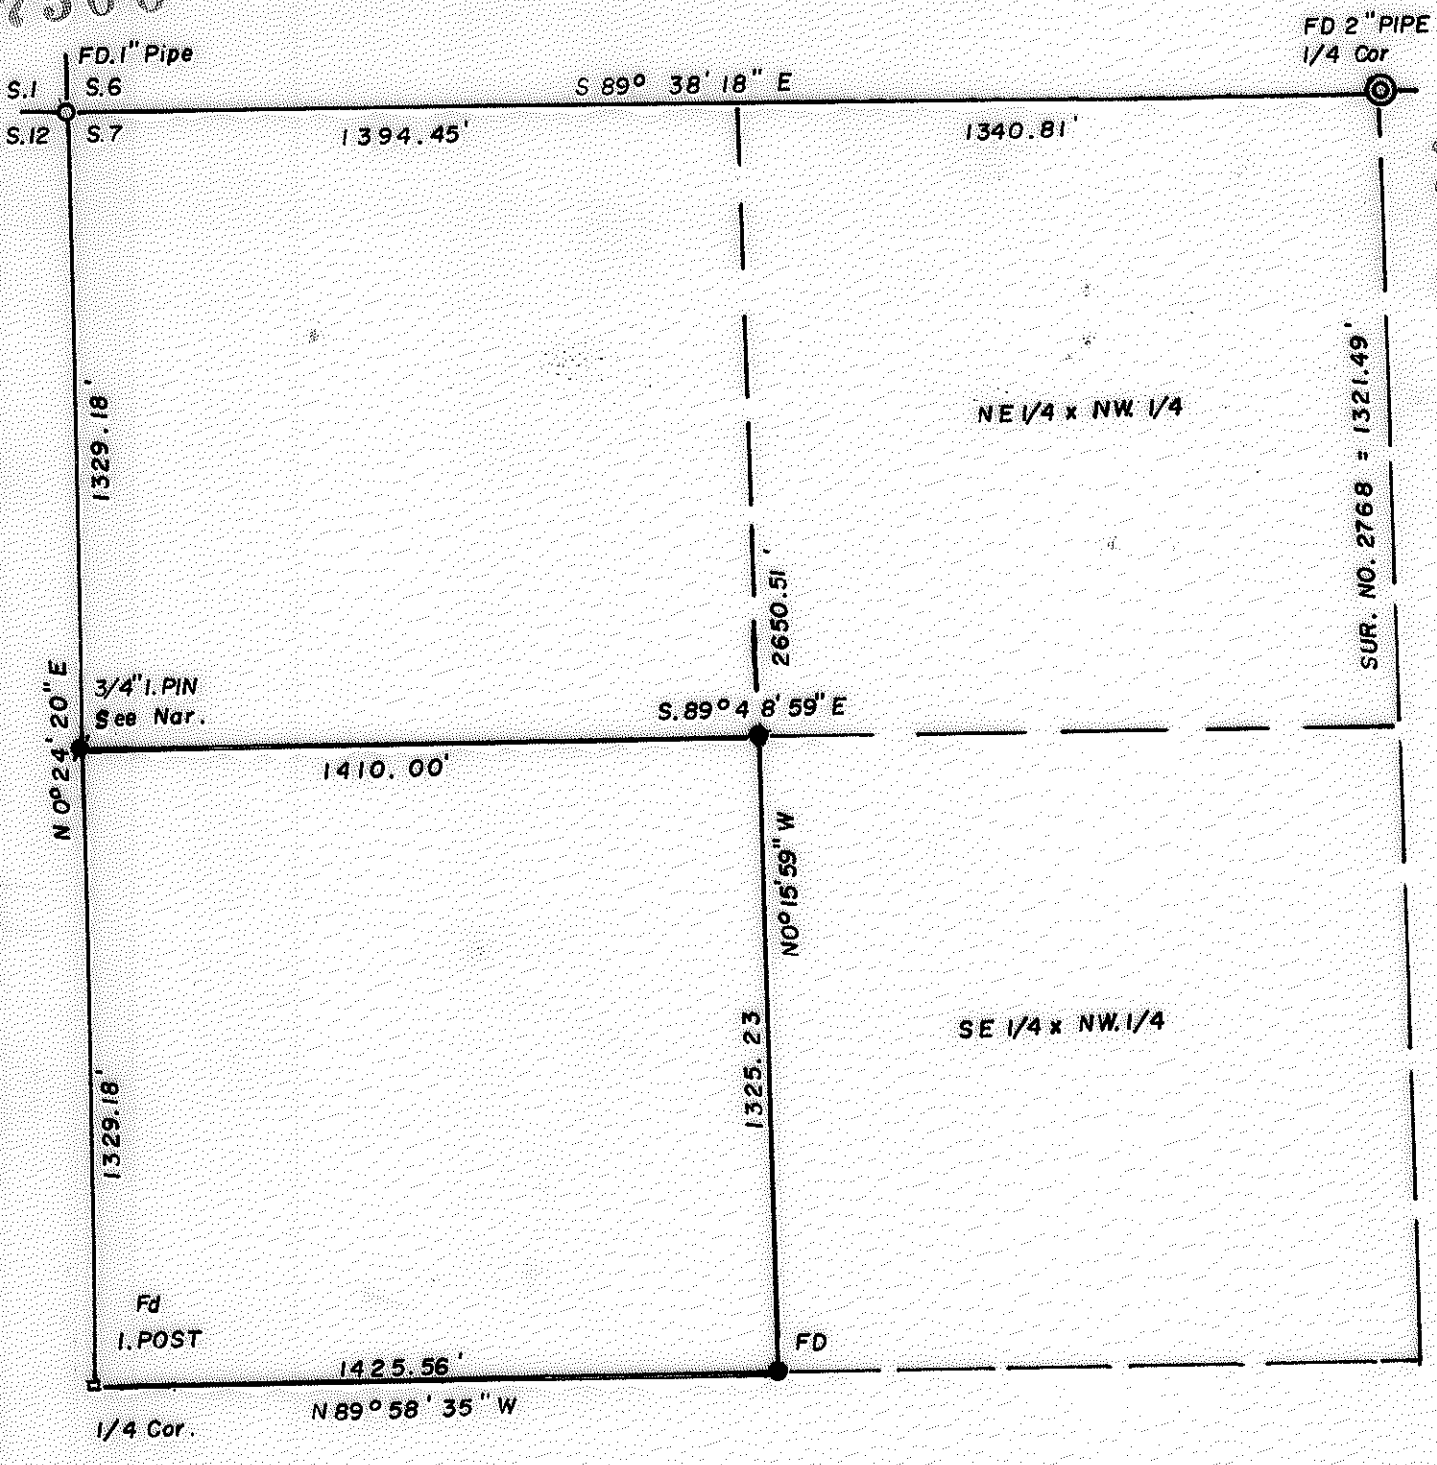
SCALE 1" = 400'
 ● = 5/8" I. PIN

The purpose of this survey was to locate the East line and the North line of the Southwest 1/4 of the Northwest 1/4.

Utilizing previous Survey No. 4643 and retracement data on Survey No. 7180 along the West line and Survey No. 2768 and a traverse beginning at the West 1/4 cor. ~~fixtke~~ Easterly to found monument; thence northerly; thence westerly adjacent to the North line of said SW. 1/4 of the NW. 1/4, with stub tie to the NW. cor. of Sec. 7 and thence Easterly to the N. 1/4 corner.

At the West 1/4 cor. found an iron fence post 6 ins. high.

At the NW Sec. corner a \times 1 in. pipe now 1/2 in. pin (inside)

At the North 1/4 corner, a 2 in. pipe 6 ins. deep with bearings to center of oak being 9 ins. diam., bears N.41°45'E., 36.40 ft. and center of pine, being 12 ins. diam., bearing S.26°53'E., 65.30 ft.

At the NW cor. of the SW 1/4 of the NW 1/4, found remains of where an iron pin was, shown on Survey no. 7180 and Survey No. 4643, that has ~~k~~ recently been removed and reset by persons unknown, N.1°20'W., 4.26 ft. also a traverse point being 1/2 in. iron pin which bears S.21°10' East 0.66 ft.

At the original position shown on Survey No. 4643, set a 3/4 in. x 14 in. iron pin, 2 ins. deep.

There are no fences along the south and East lines, however, a fence line does encroach along the westerly portion beginning at the West corner and running generally through brush and diverging from the true line. The client is aware of this and should contact adjoining owner.
