SURVEY TO DEFINE BOISE CASCADE CORP. PROPERTIES
IN SECTIONS 8 & 9, T.33S, R.2E., W.M., JACKSON CO., OREGON

SCALE: 1 INCH = 400 FEET

JULY - SEPTEMBER, 1979.

ROBERT M. THOMPSON & ASSOC.

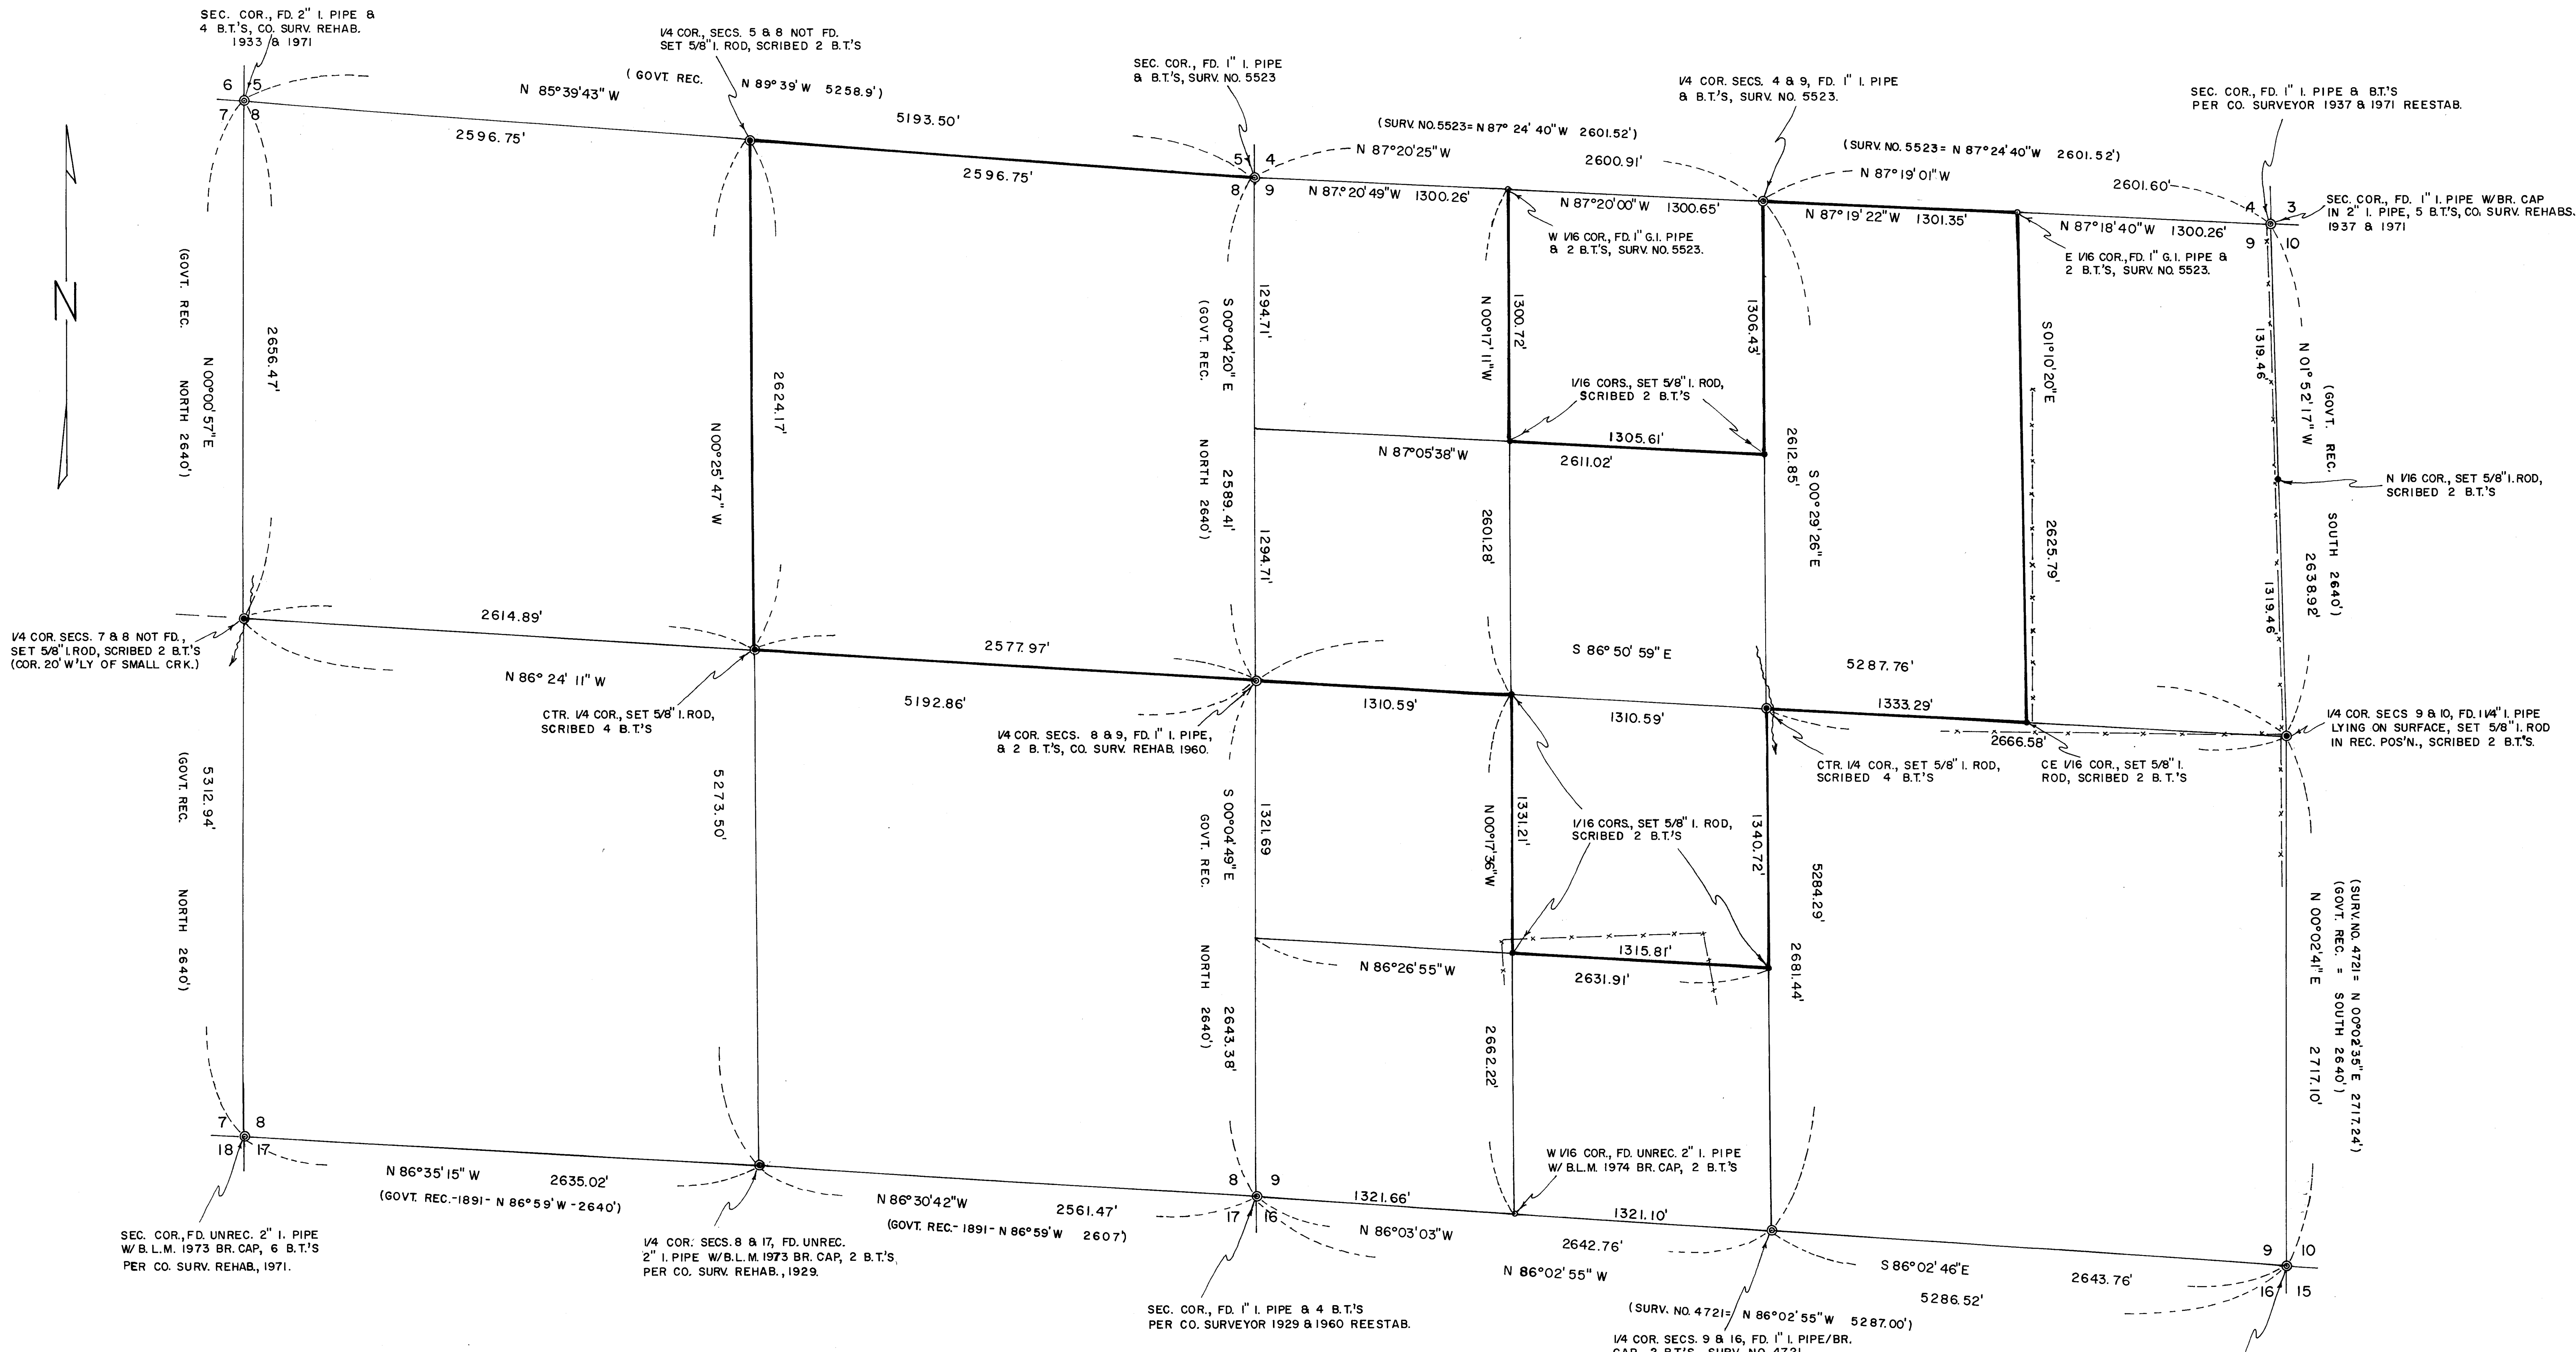
- 5/8" IRON ROD W/YELLOW CAP " PLS 1358" SET IN THIS SURVEY.
- MONUMENT FOUND.
- x—x—x FENCE AS FOUND.
- BEARING BASIS = SOUTH LINE OF SECTION 9, PER RECORD OF SURVEY NO. 4721.
- THIS SURVEY AND MAP WAS COMPLETED FOR THE EXCLUSIVE USE OF
 BOISE CASCADE CORP., TBR. & WOOD PROD. GROUP, P.O.B. 100, MEDFORD, ORE. 97501.
- LINE BLAZED, YELLOW-PAINTED & FLAGGED, 1/2" X 4" ALUM. TAGS.

My survey began by locating and identifying all of the record corners that could be found, in these 2 sections. Two major closed loop traverses were run for boundary and corner control and ties, both originating from a point on Flounce Rock. Tellurometer CA-1000 and "Beetle" 1000 E.D.M. equipment were used, with a Kern one-second theodolite. An exhaustive search was made for the west and north quarter corners of Section 8, both during and after the computation of my traverses, to no avail. These corners were reset by single proportionate measurement.
