MAP OF SURVEY
LOCATED IN
N.W. 1/4 of Sec 14, T39S, R1E, W.M.
JACKSON COUNTY, OREGON
FOR

ORLIN R. CURTIS

HOFFBUHR SURVEYING, INC MEDFORD, OREGON

SURVEY NO. 8063

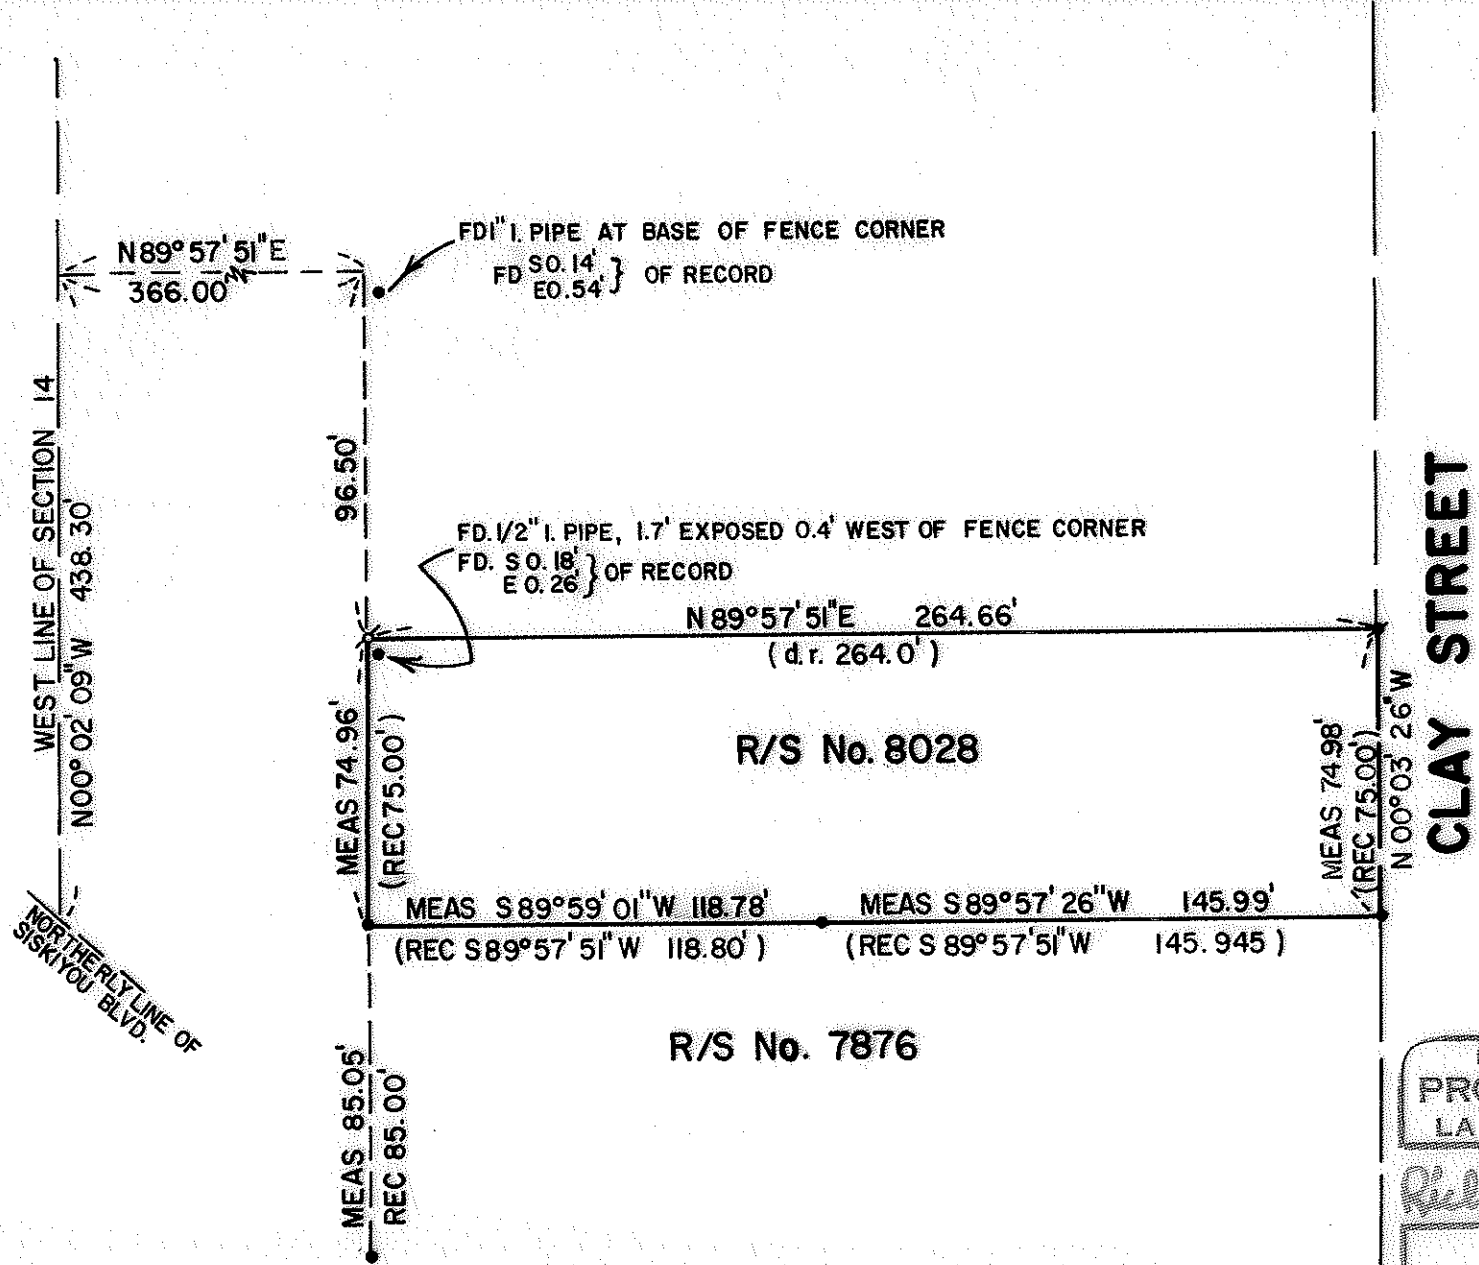
BY: RICHARD L. BATH PLS NO 1069
SCALE: 1" = 50' OCTOBER 22, 1979
BASIS OF BEARING: R/S No 8028

- ♣ = SET 5/8" x 24" IRON PIN TAGGED
R. BATH LS 1069
- ♣ = FD 5/8" IRON PIN per R/S No. 8028
TAGGED R. BATH LS 1069
- = FD. 5/8" IRON PIN per R/S No. 7876
TAGGED RLS 759

PURPOSE: To correct the location of a 1 inch iron pipe and
1/2 inch iron pipe shown on Recorded Survey No.
8028

PROCEDURE: On October 18, 1979, Mr. Curtis informed me that
the line I had established for his North property line per Recorded
Survey No. 8028 was not parallel with the South line of his property
per Recorded Survey No. 7876 when, in fact, the two lines should
be parallel. A field inspection on October 19, 1979, found an angle
"bust" to a random traverse point resulting in the improper posi-
tioning of the Northwest corner of Mr. Curtis's property. This
error was corrected, the monument readjusted to its true position,
and the resulting positions of the two pipes are shown on the
accompanying map.
