SURVEY NO. 8301

Survey Narrative to comply with O.R.S. 209-250

Survey for:

Mr. Alex Boutacoff 16005 Hwy. 62 Eagle Point, Or

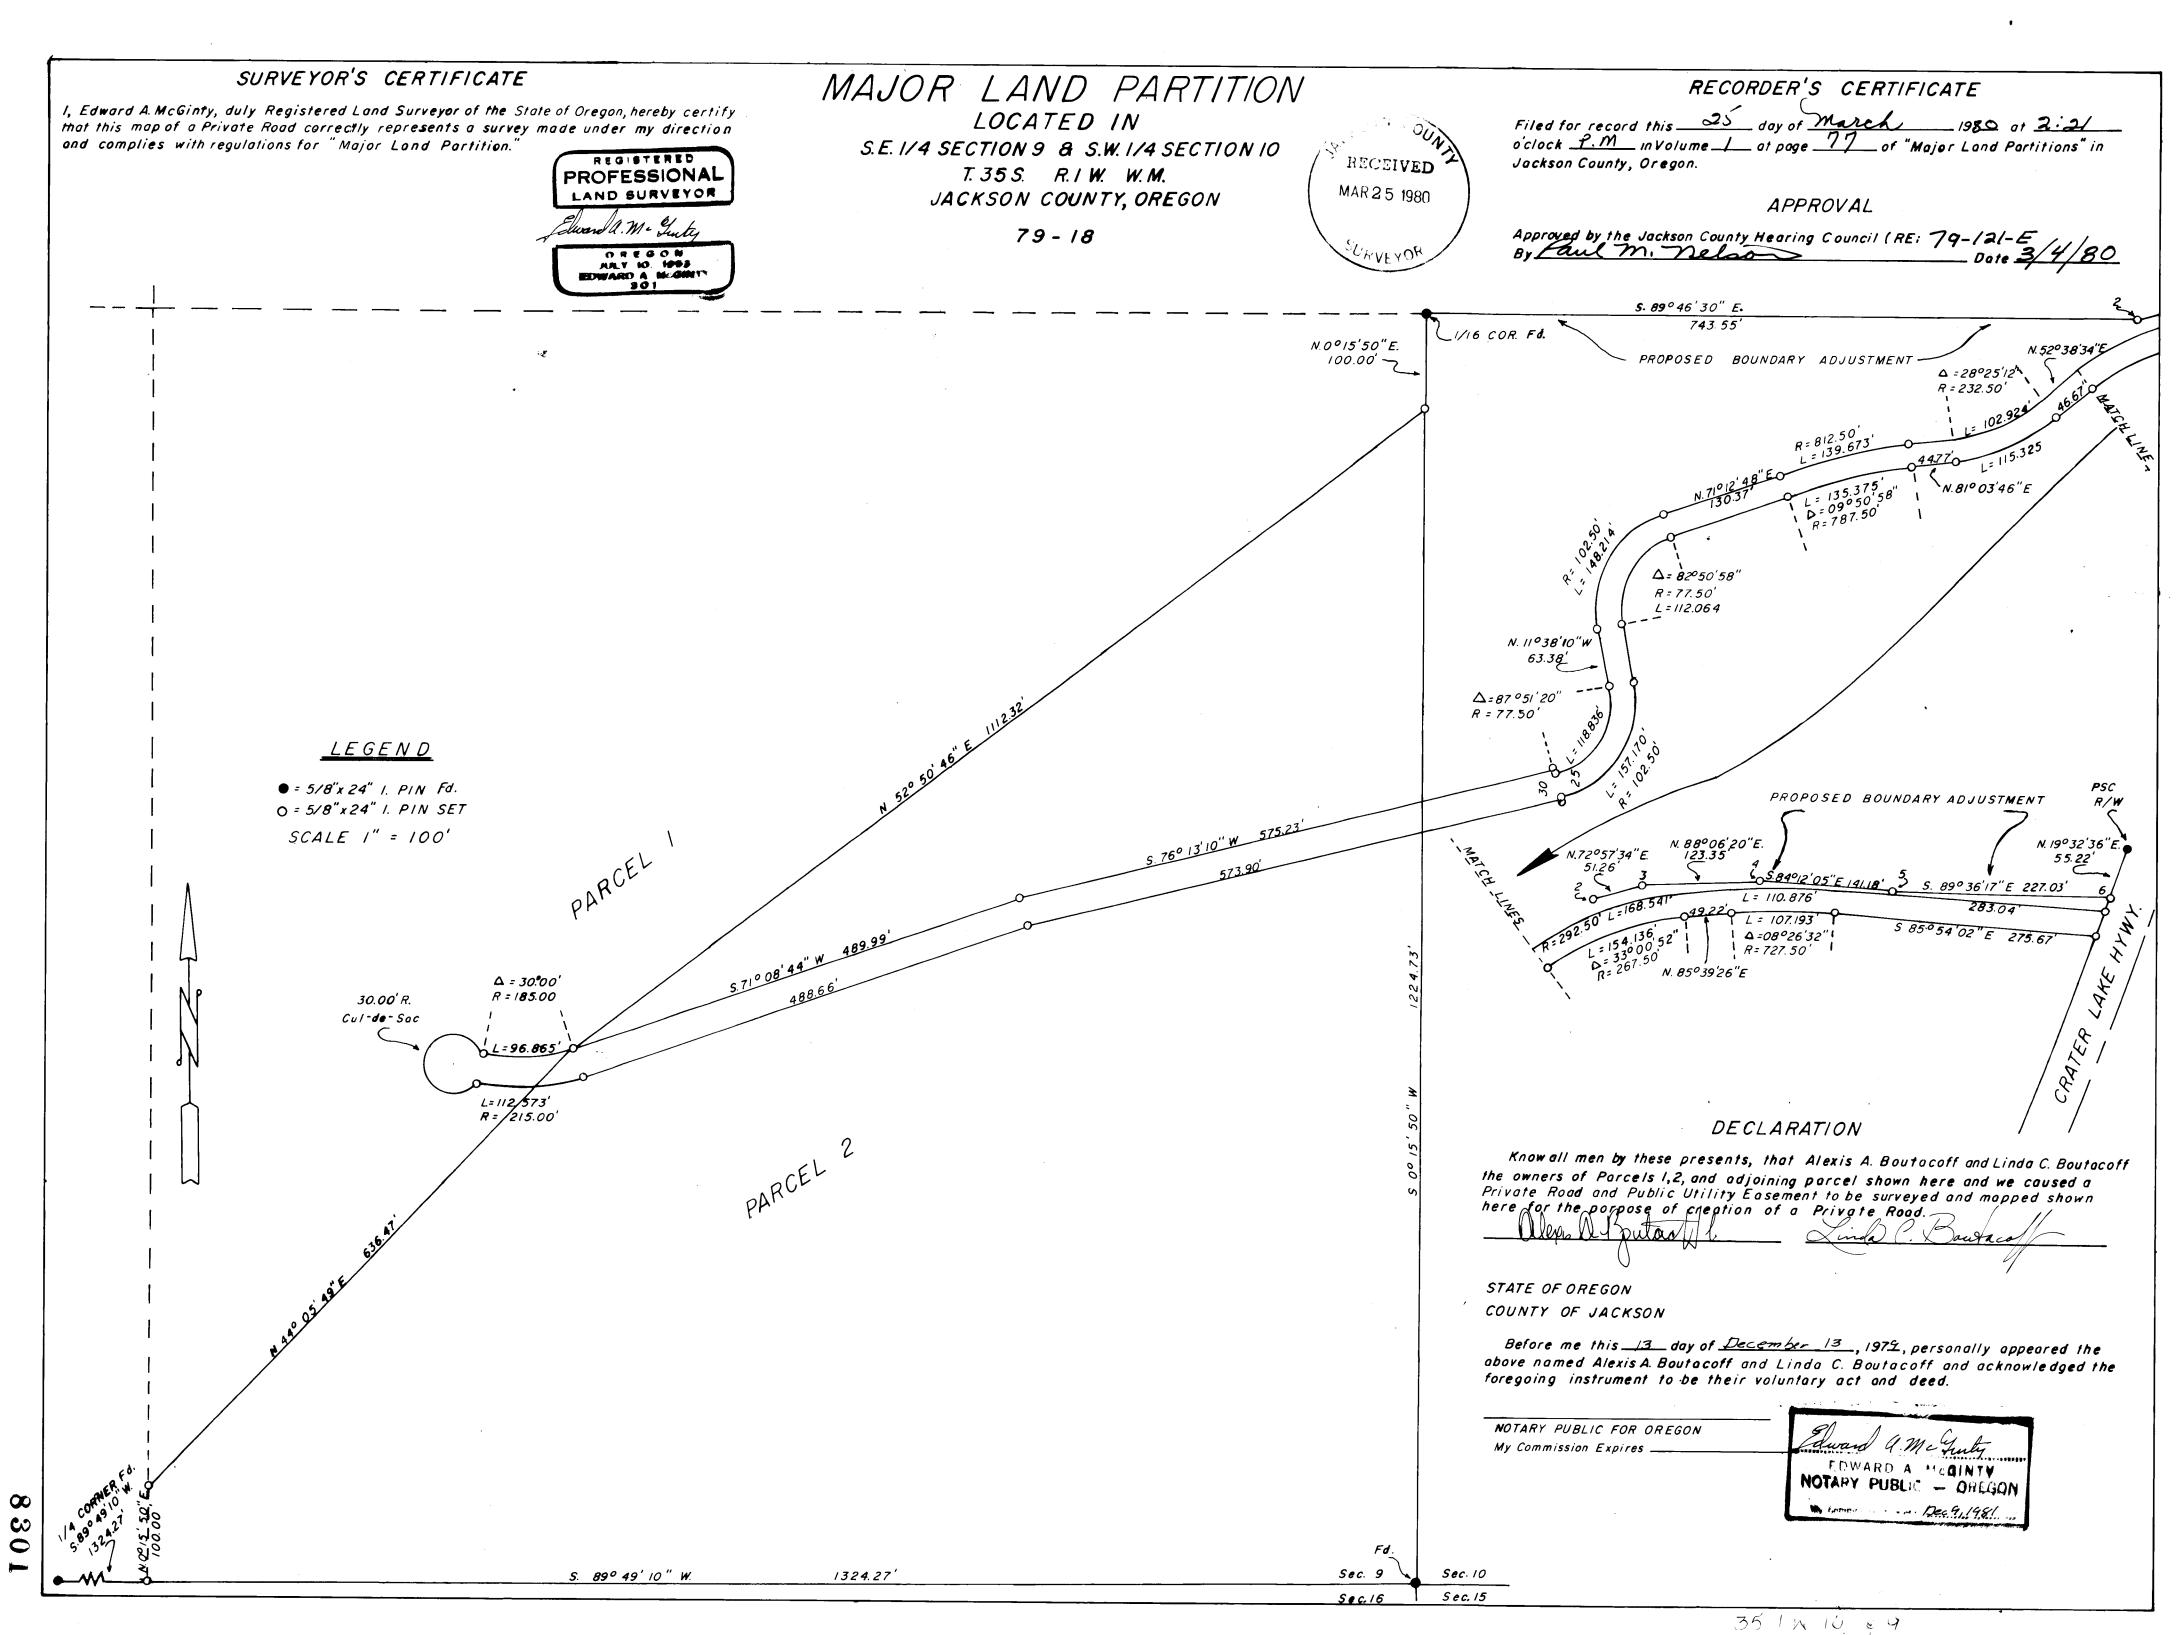
Sec. 9 and SW 1/4 of Sec. 10, T35S, R1W.

Cors. of Sec's. 9, 10, 16 & 15 found a 2 in. pipe with brass cap, approx. 1.8 ft. Easter This location further verified by measuring angles to co. sur. BT's NE, SE. and SW. and measuring northerly to S 1/16 cor. per survey No. 4686.

S. 1/16 cor. betw. Sec's. 9/10, per Sur. No. 4686, it does indicate a conflict with Survey No. 3524 & possibly Sur. No. 938 and Sur. No. 64, this is not a conformation of any possible location previously determined as the client is unconcerned.

1/4 cor. betw. Sec's. 9/16 per County Survey records calls for spike in pitch stake which I made a search for. On survey No. 2781 re-established this corner with 1 in. pipe which was recovered. This location was further verified by ties to bearing tree which would be in the proximity of pipe and according to standard surveying practice, also from which I took new measurments to references

Orig. BT, w.oak, 20 ins. diam., bears N.76°E., 12.3 ft. (2 old blazes, rotten ctr.) Orig. BT, w. oak, 18 ins. diam., bears S.29 1/4°W., 10.2 ft. ("""") CO.Sur. BT. B oak, 24 ins. diam., bears N.83 3/4°W., 50.1 ft. (2heal over blazes) W. oak, 16 ins. diam., bears S.29°W., XM 19.0 ft. (single blaze scribe 483 BT) w. oak, 15 ins. diam., bears N. 38 1/4°W. 39.1 ft. (single blaze scribe 483 BT)

Broken line indicates only the approx. boundary, as neither sections were sub-divided.
