AFFIDAVIT OF CORRECTION pursuant to ORS 209.255

I, Harold L. Center, Registered Professional Land Surveyor in the State of Oregon, Certificate No. 1071 do hereby state that I have discovered errors and ommissions on that survey filed as Record Survey No. 8364 on April 23, 1980 with the Jackson County Surveyor. The corrections are as follows:

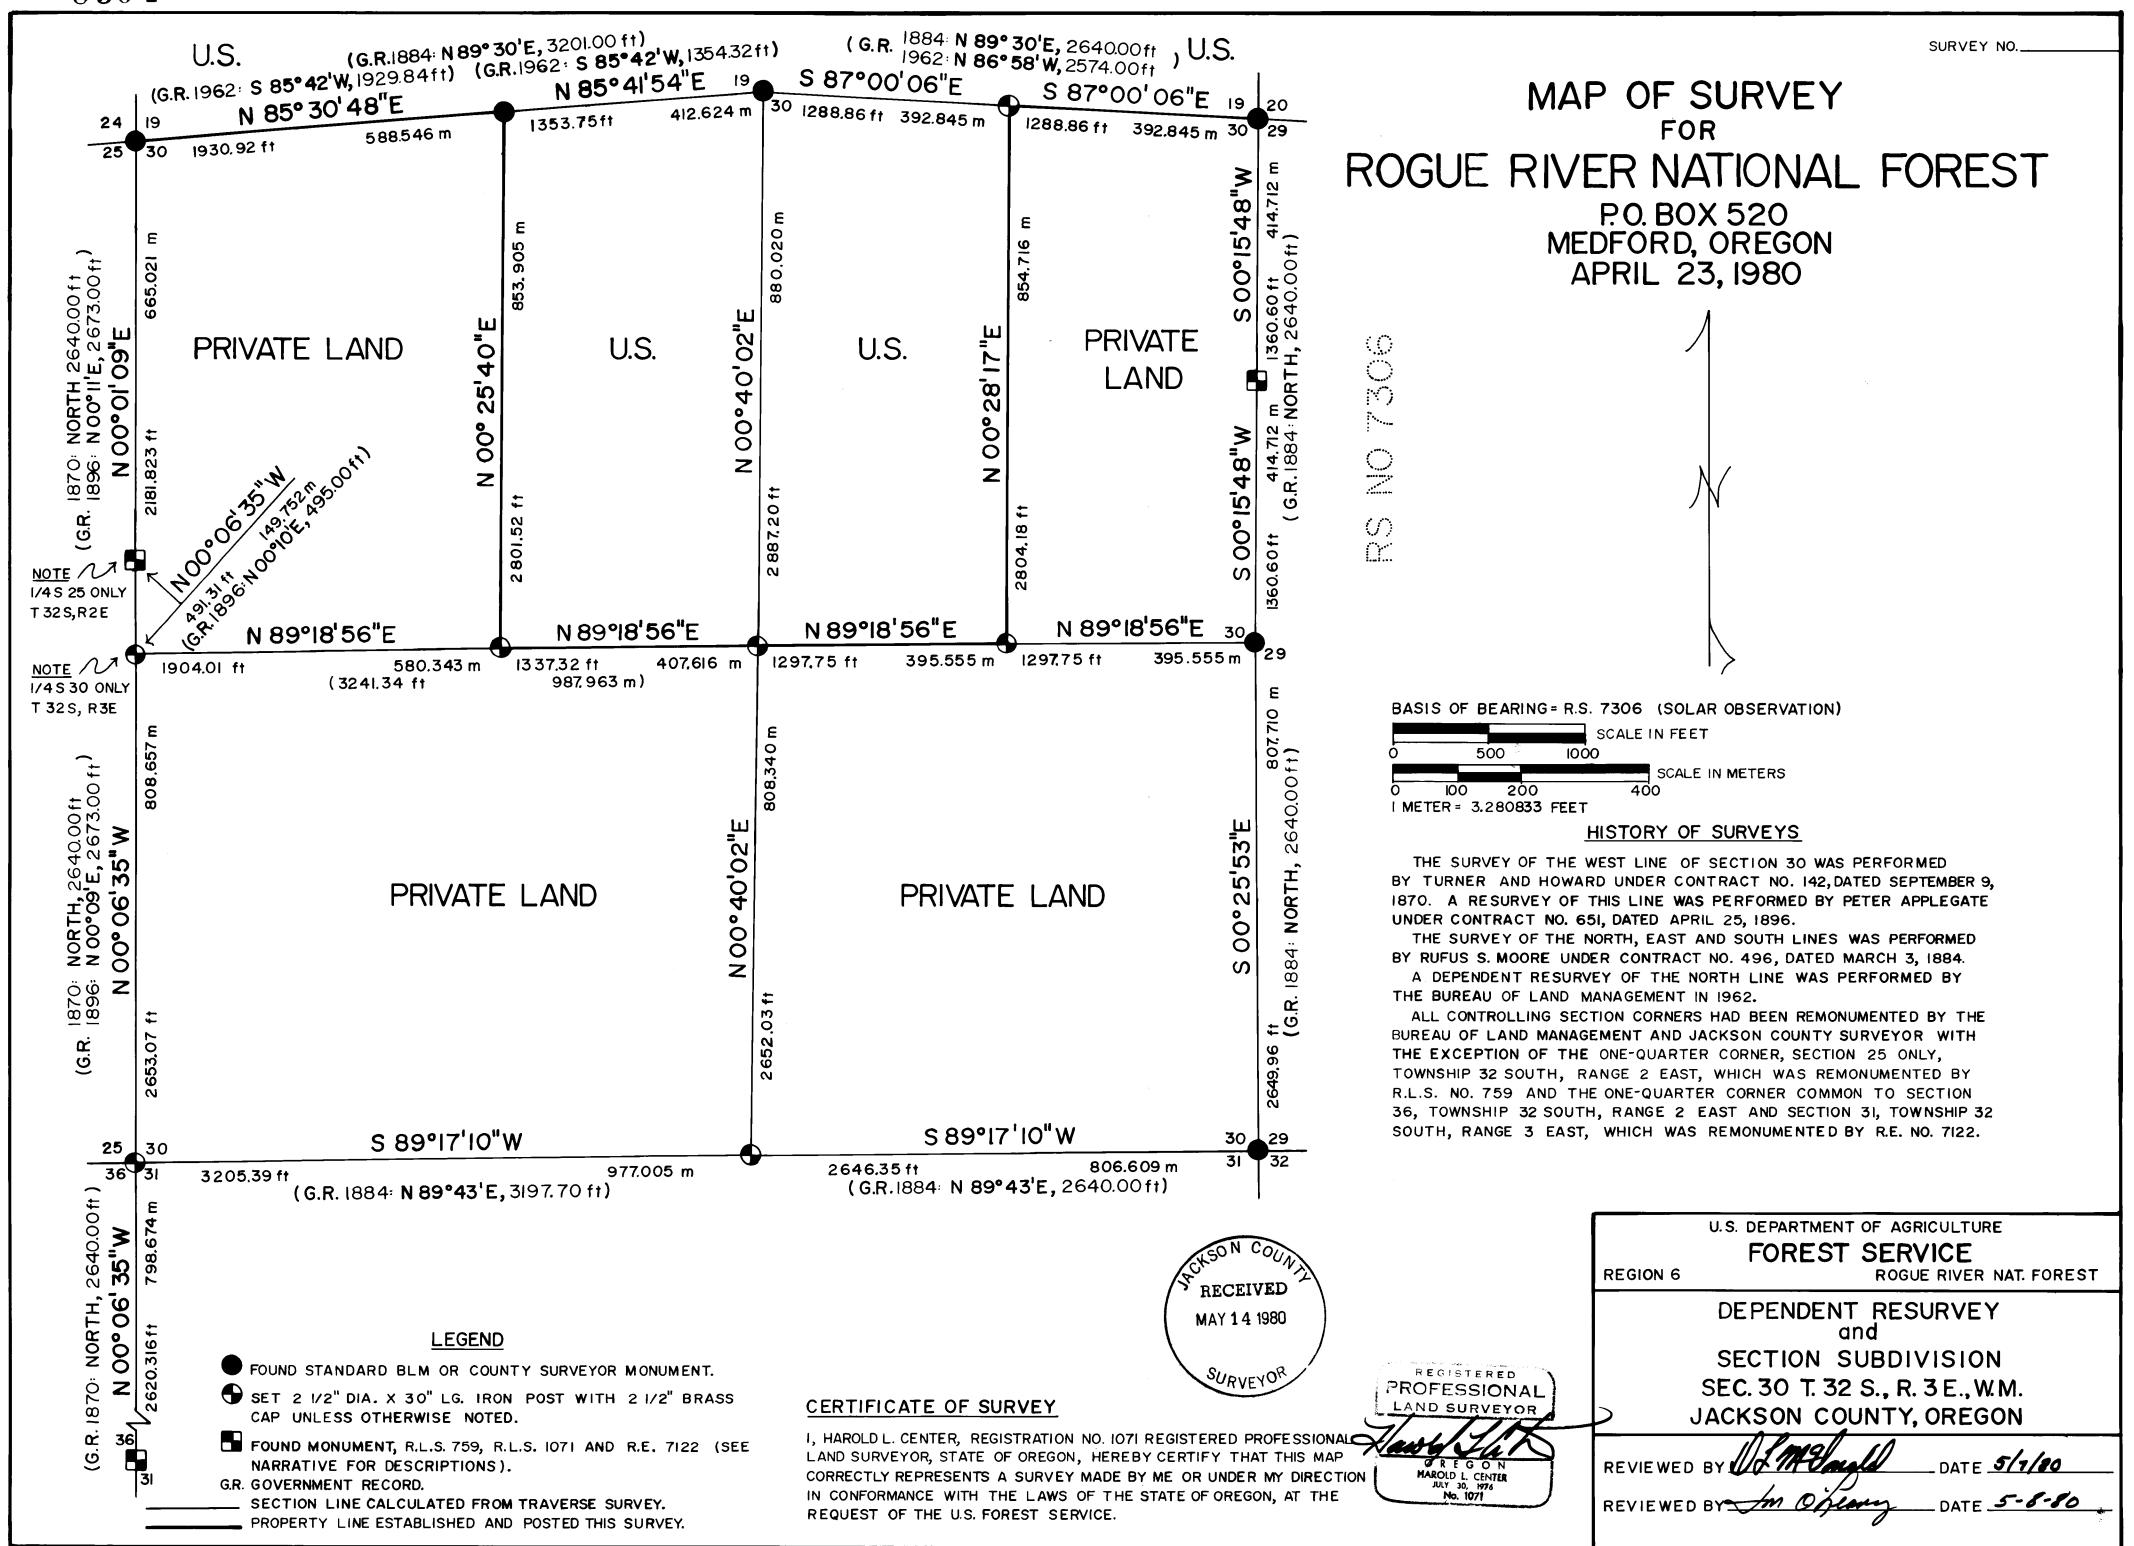
The Center-east one-sixteenth corner for Section 30, Township 32 South, Range 3 East, Willamette Meridian, Jackson County, Oregon. An error was found in the corner move, resulting in the corner to be set $\rm N.71^{\circ}48'41"W.$, 1.84 feet out of the true position as indicated on the map of survey.

At the corner position as indicated on the Map of Survey, I reset the same $2\ 1/2$ " diameter, 30" long iron post 10" below the road surface, from which the following original accessories:

A 16" diameter fir bears $N.53^{\circ}21'W.$, 34.9 feet distance, with a healed blaze.

A 24" diameter fir bears $N.78^{\circ}34$ 'E., 30.1 feet distance, with a healed blaze.
