**MAP OF SURVEY  
FOR  
ROGUE RIVER NATIONAL FOREST**  
P.O. BOX 520  
MEDFORD, OREGON  
JULY 22, 1980

U.S. DEPARTMENT OF AGRICULTURE <b>FOREST SERVICE</b>	
REGION 6	ROGUE RIVER NAT'L. FOREST
DEPENDENT RESURVEY and SECTION SUBDIVISION SEC. 5, T. 38 S., R. 4 E., W.M. JACKSON COUNTY, OREGON	
REVIEWED BY <i>W. J. McCall</i>	DATE 8/20/80
REVIEWED BY <i>Dick Hathaway</i>	DATE 8/21/80

PURPOSE: To establish property corners and mark and  
post National Forest ownership within Section  
5.

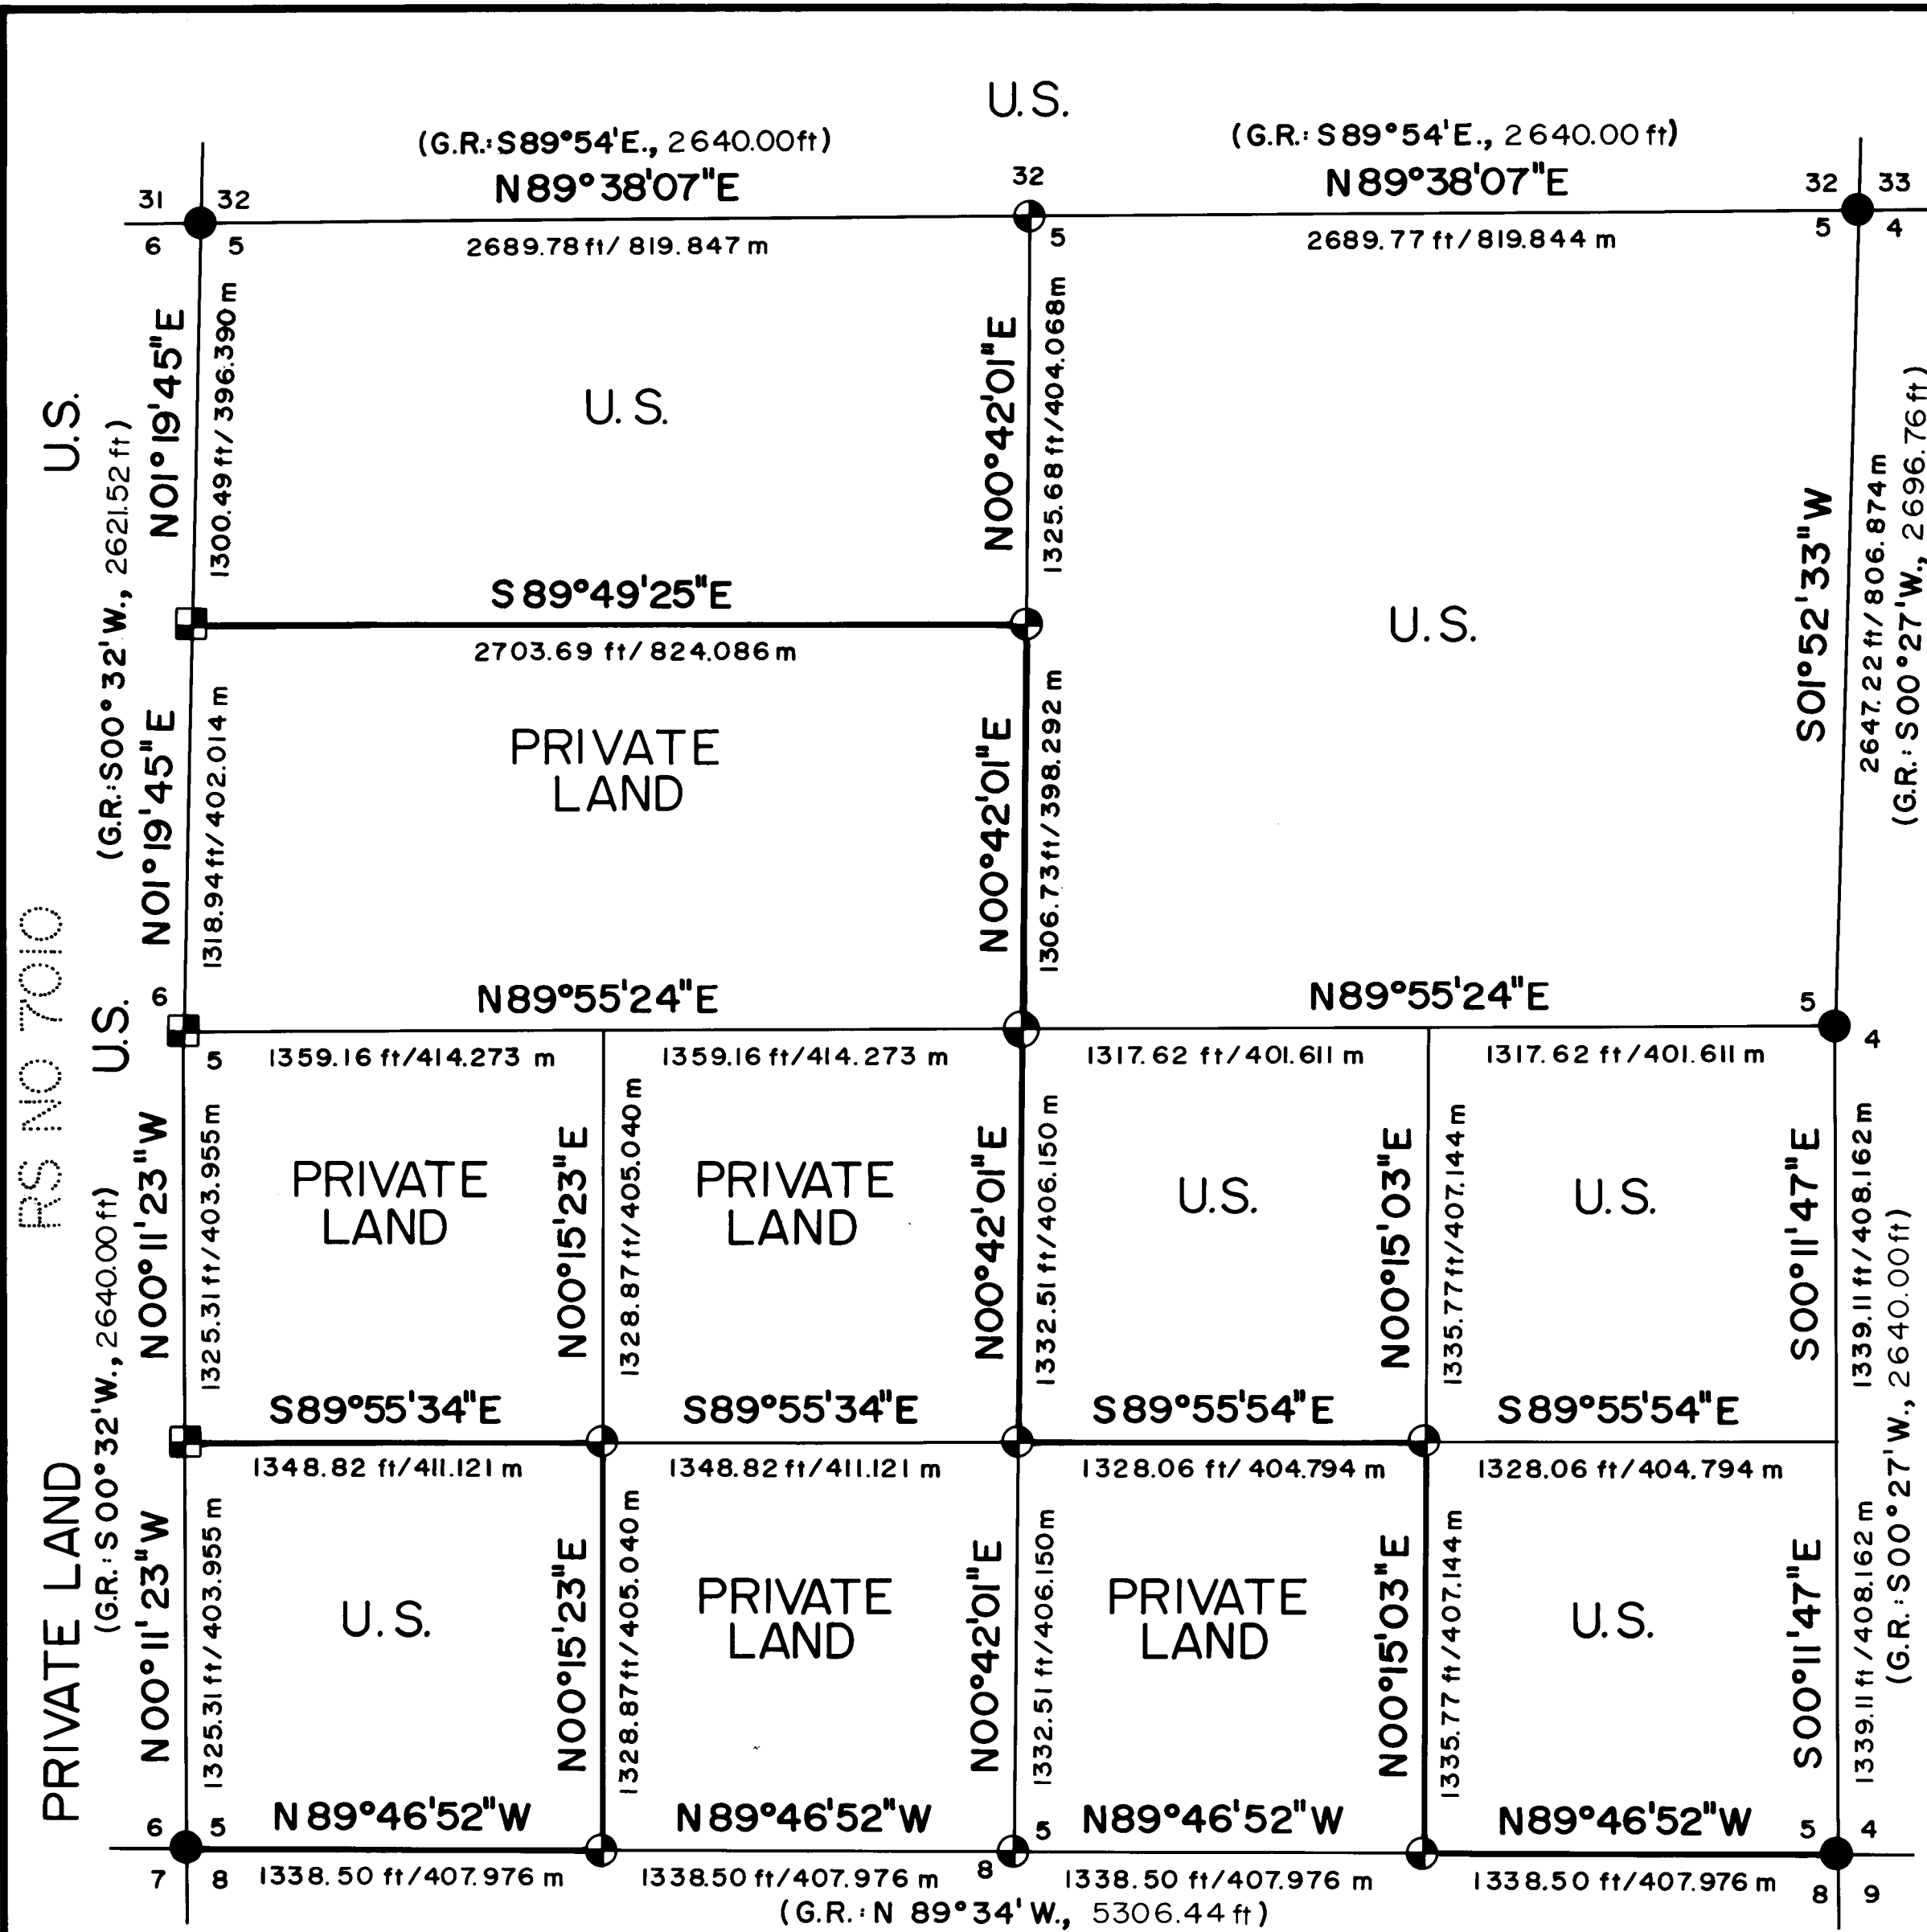
BASIS OF BEARING = SOLAR OBSERVATION  
SCALE IN FEET  
0 500 1000  
SCALE IN METERS  
0 100 200 400  
1 METER = 3.280833 FEET

THE ORIGINAL ESTABLISHMENT OF THE NORTH BOUNDARY AND SUB-DIVISION OF TOWNSHIP 38 SOUTH, RANGE 4 EAST, WAS PERFORMED BY M. L. Mc CALL UNDER CONTRACT NO. 137, DATED AUGUST 18, 1870.  
THE RECOVERED ORIGINAL MONUMENTS WERE REMONUMENTED BY THE BUREAU OF LAND MANAGEMENT, CADASTRAL SURVEYS AND THE JACKSON COUNTY SURVEYOR.

- FOUND STANDARD BLM OR COUNTY SURVEYOR MONUMENT.
- ⊙ SET 2 1/2" DIA. X 30" LG. IRON POST WITH 2 1/2" BRASS CAP UNLESS OTHERWISE NOTED.
- ⊠ FOUND 2 1/2" DIA. X 30" LG. IRON POST WITH 2 1/2" BRASS CAP (SET BY L.S. NO. 1071 UNDER RECORD SURVEY NO. 7010.)
- G.R. GOVERNMENT RECORD.
- SECTION LINE CALCULATED FROM TRAVERSE SURVEY.
- PROPERTY LINE ESTABLISHED AND POSTED THIS SURVEY.

With the above corner control identified I computed true corner positions and ran interior lines establishing corners as shown on the attached map.
