SURVEY FOR:

JOHN M. BLACK

LOCATED IN SECTION 5,
T.38S., R.3W., W.M.

BOYDEN SURVEYORS

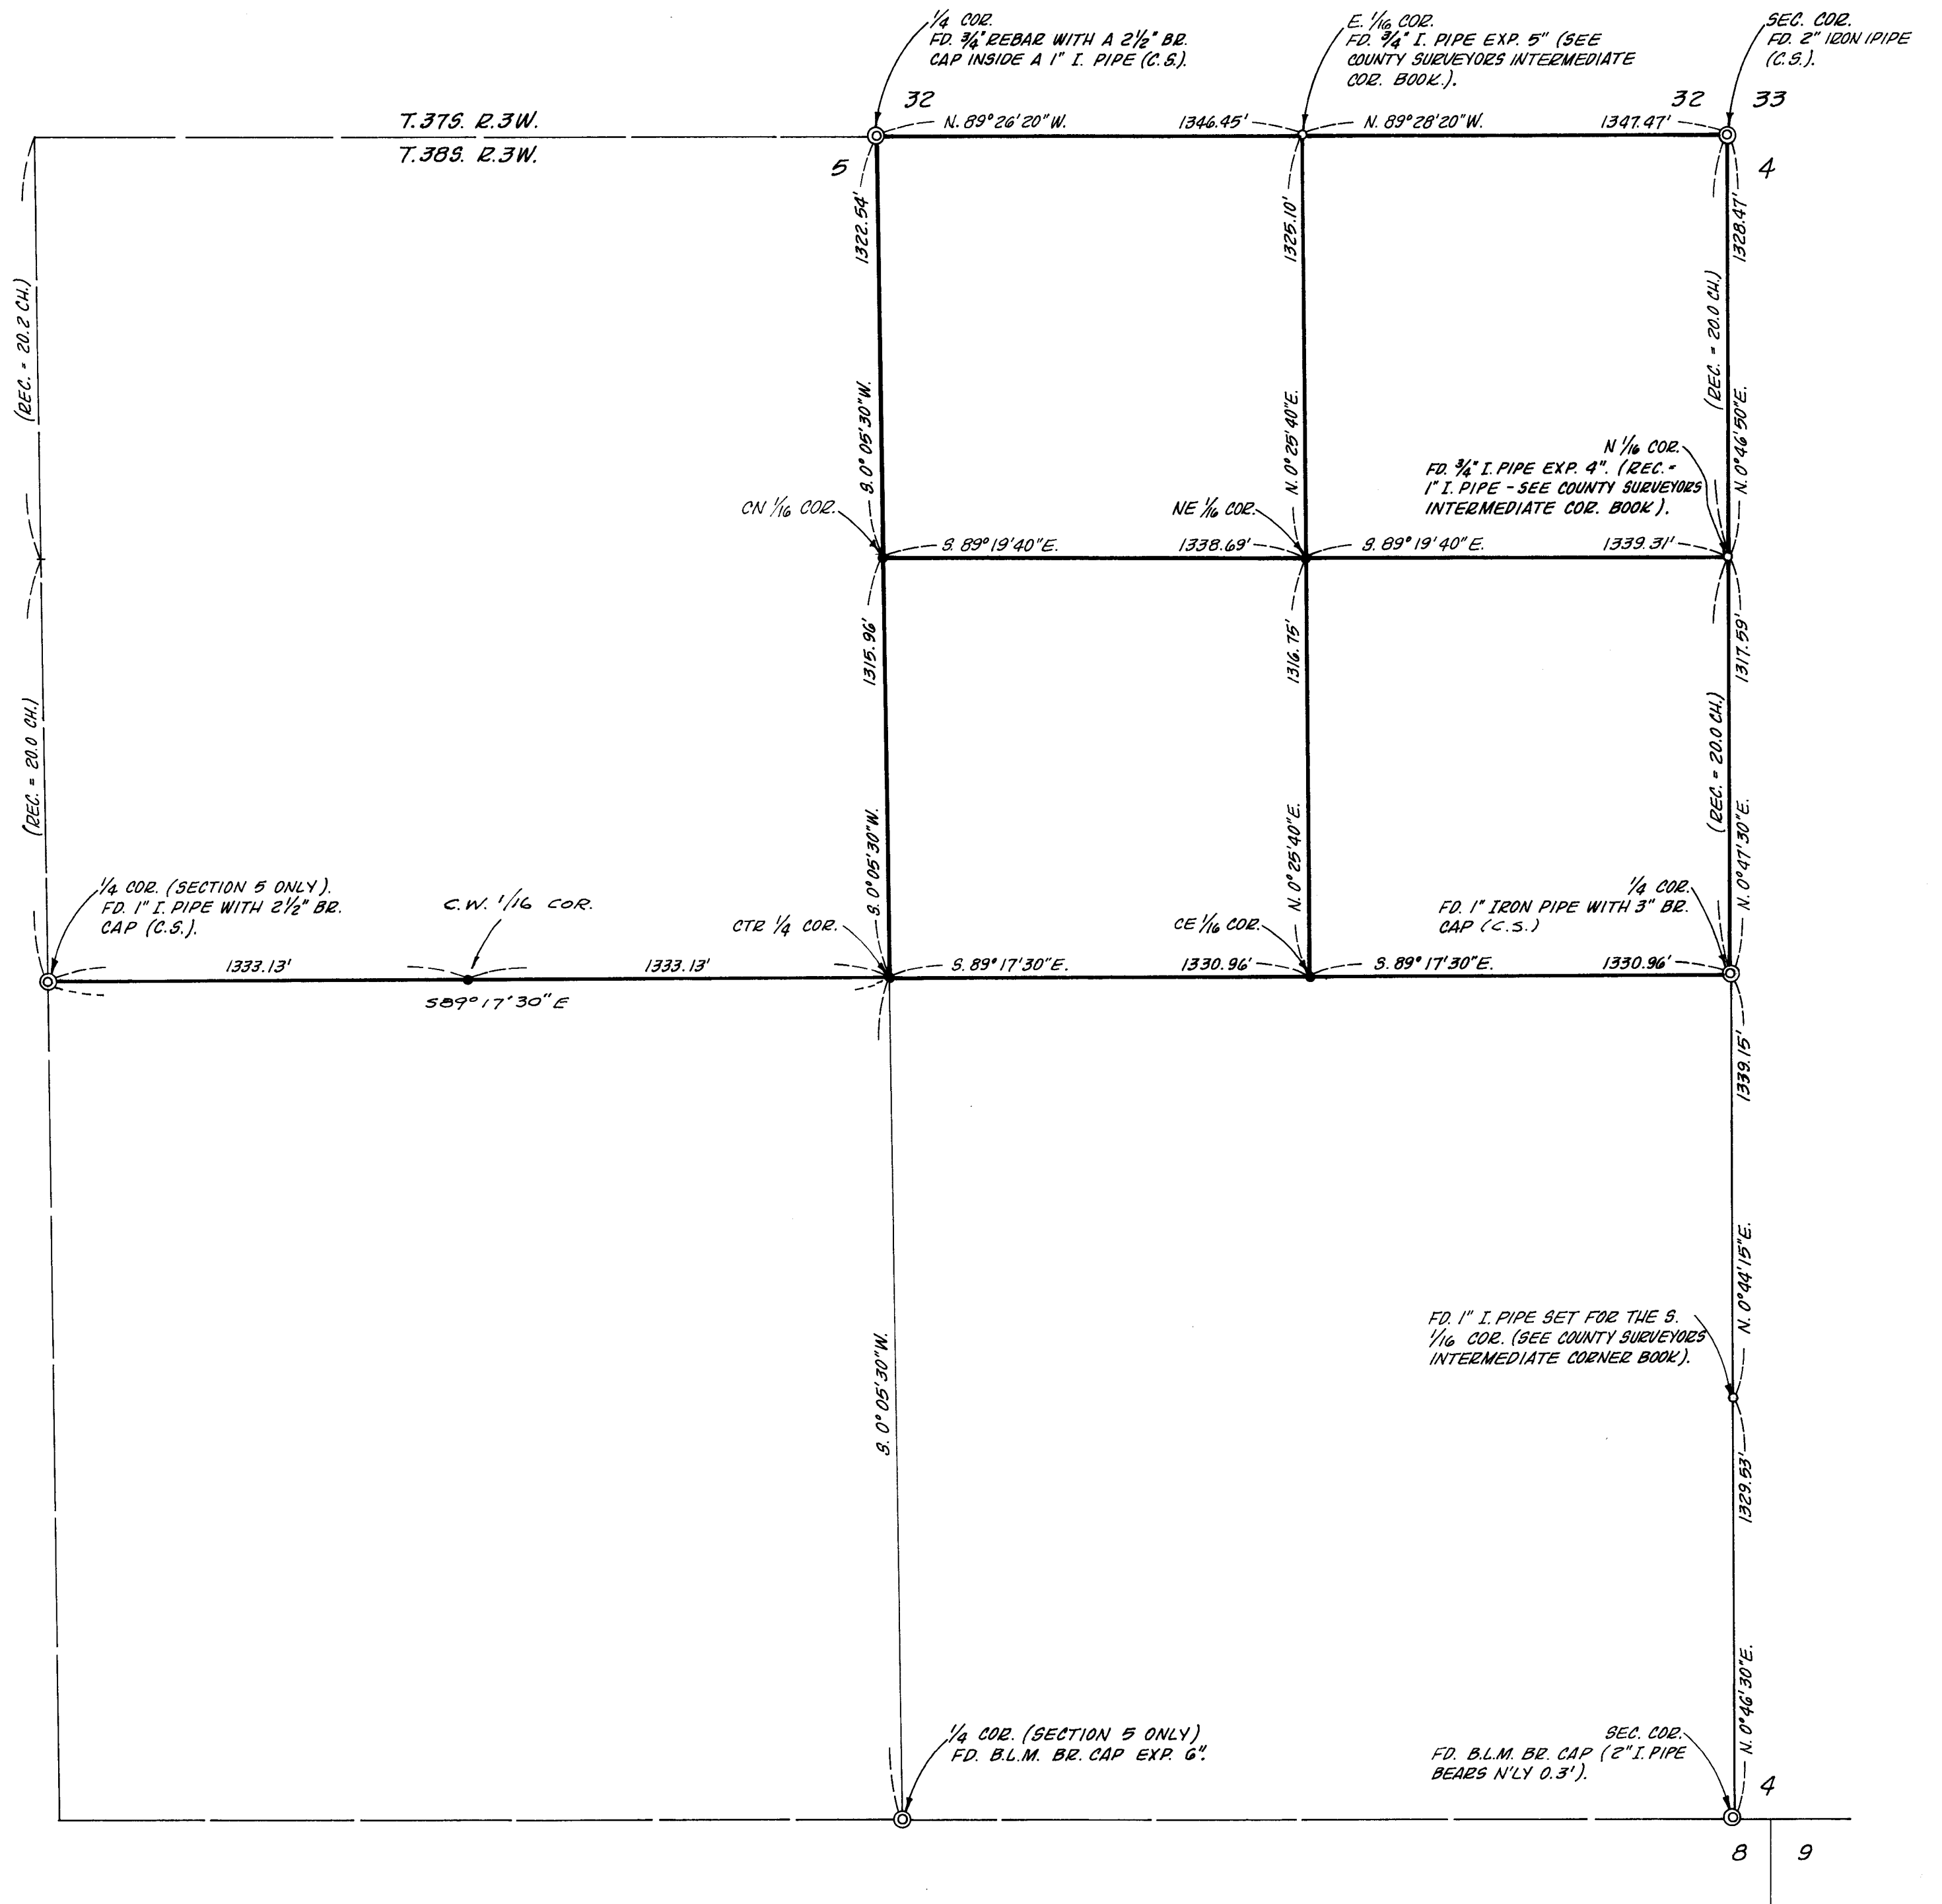
BASIS OF BEARINGS:
FILED SURVEY NO. 7772

- SET 3/4" x 36" GALV. IRON PIPE WITH 2" BR. CAP

PROCEDURE: Controlling corners shown as "found" on the annexed map were tied via closed random traverses utilizing a one-second theodolite, E.D.M. equipment and chain.
