Survey for CAROL VORHEIS

Located in the NW 1/4, NW 1/4, Sec. 28, T. 37S., R. 1W., W.M.,
City of Medford, Jackson County, Oregon, in Lots 10, 11, 12
of GETCHELL SUBDIVISION (unrecorded)

Boundary Line Adjustment Plat

SURVEY NO. 8938

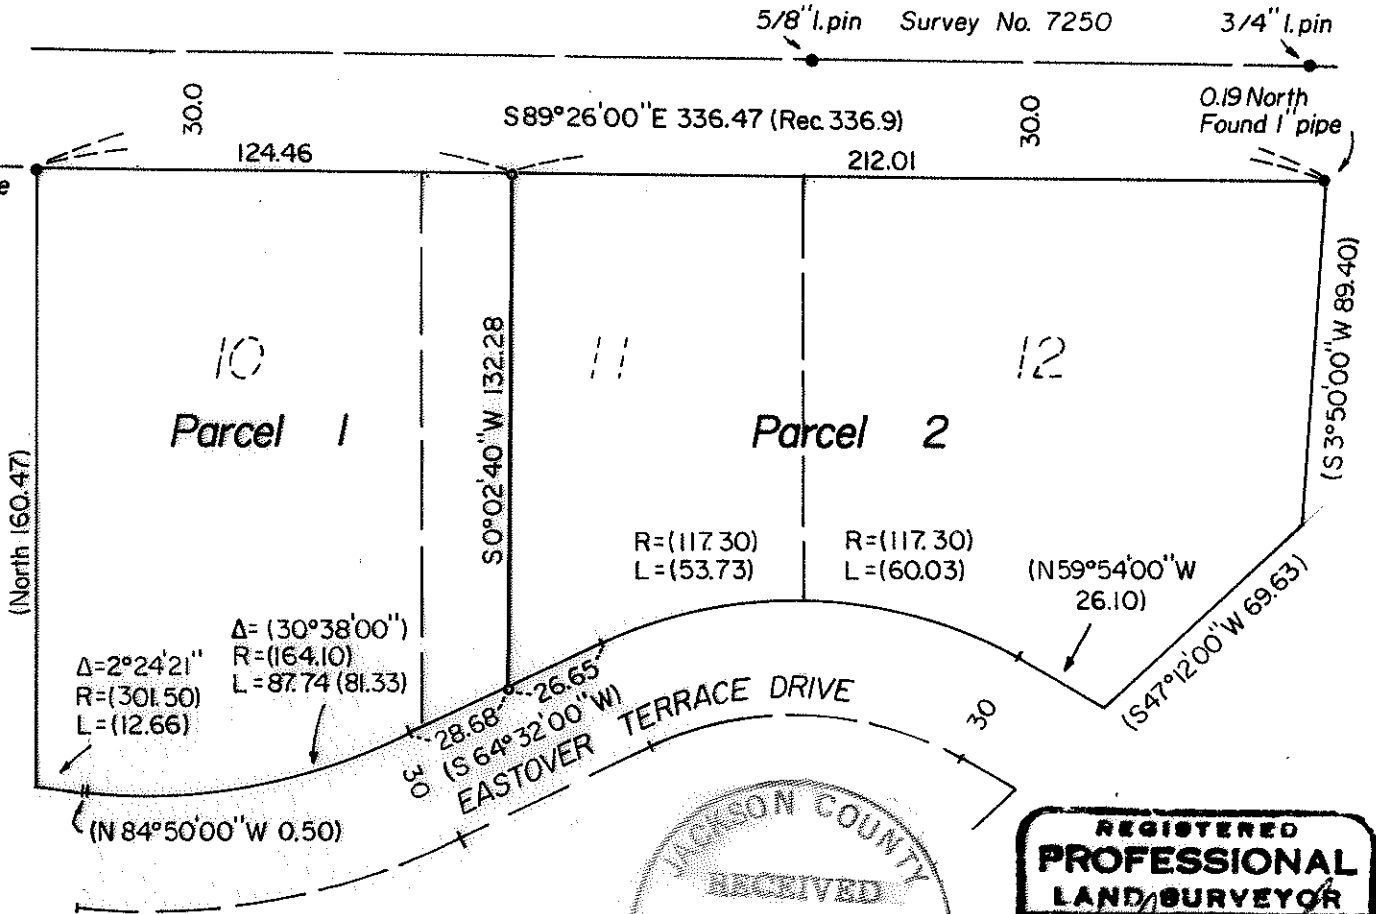
- Set 5/8" x 24" iron pin
- Original property line
- () = Record

The monument set for the southerly end of the division line should be treated as a Witness Corner, and does not necessarily indicate the true right-of-way line for Eastover Terrace Drive.

PURPOSE: To survey and monument a division line in Lot 11, GETCHELL SUBDIVISION (unrecorded), as directed by client, and prepare a " Boundary Line Adjustment Plat " for approval by the City of Medford.

PROCEDURE: Although the legal descriptions furnished by the client are metes and bounds descriptions, they were prepared from the unrecorded plat of " GETCHELL SUBDIVISION ", surveyed by Herman Powell for Harvey & Watkins, engineers, in March 1948.

It should be noted that various segments of this subdivision do not close mathematically, and that monuments found along the southerly boundary of Eastover Terrace Drive do not check mathematically with the location of lots as monumented north of Eastover Terrace Drive.
