**SURVEY FOR UNIVERSITY OF OREGON
LOCATED: NW. 1/4, SEC. 2, T. 36 S., R. 1 E., WM.**

SURVEY NO. 8996

SURVEY NARRATIVE

Location: in the NW 1/4 of Sec. 2, T36S, R1E, WM.

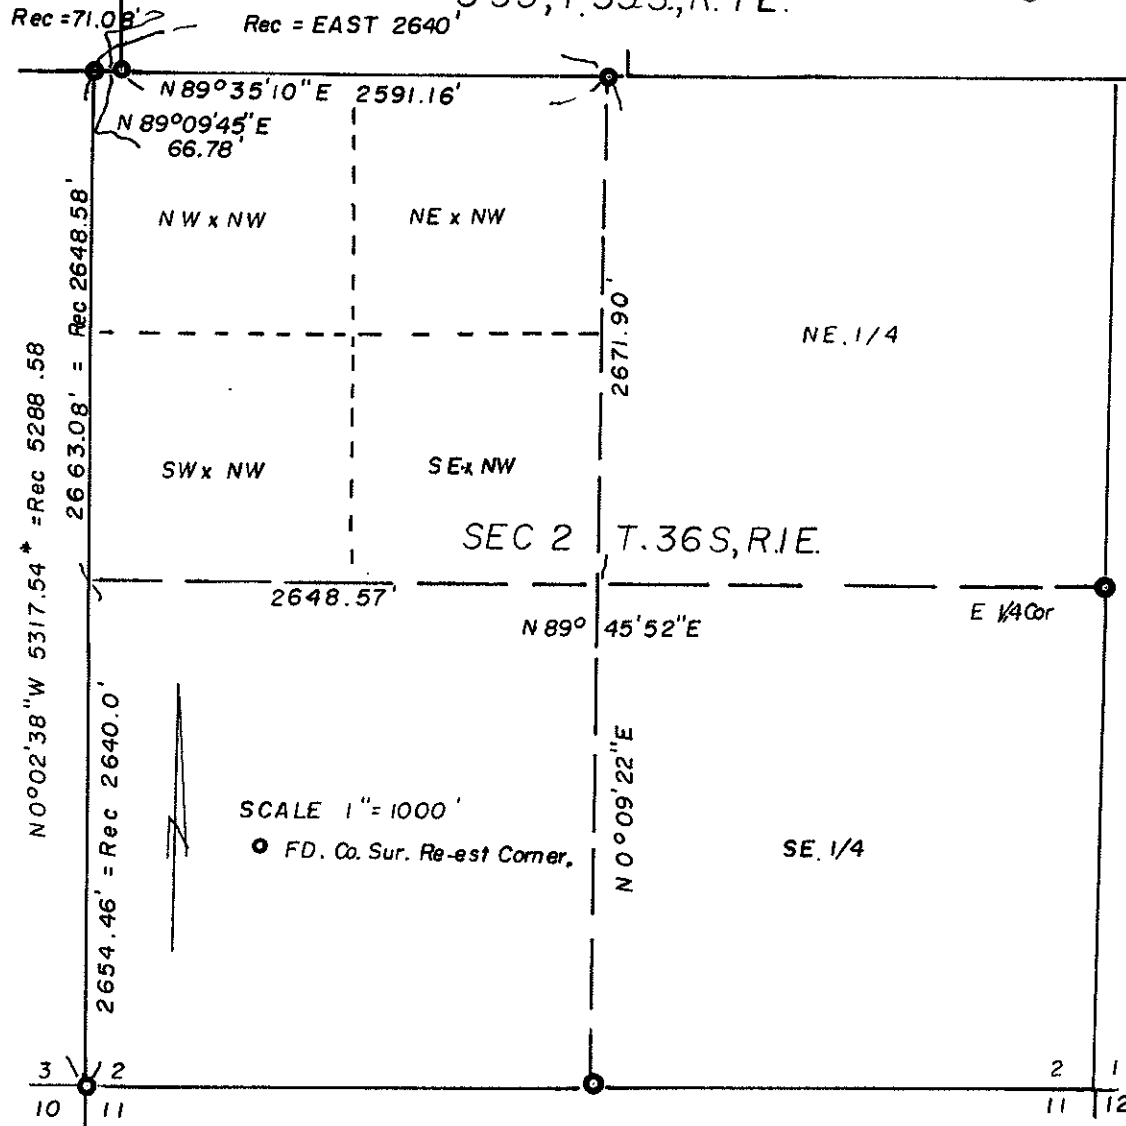
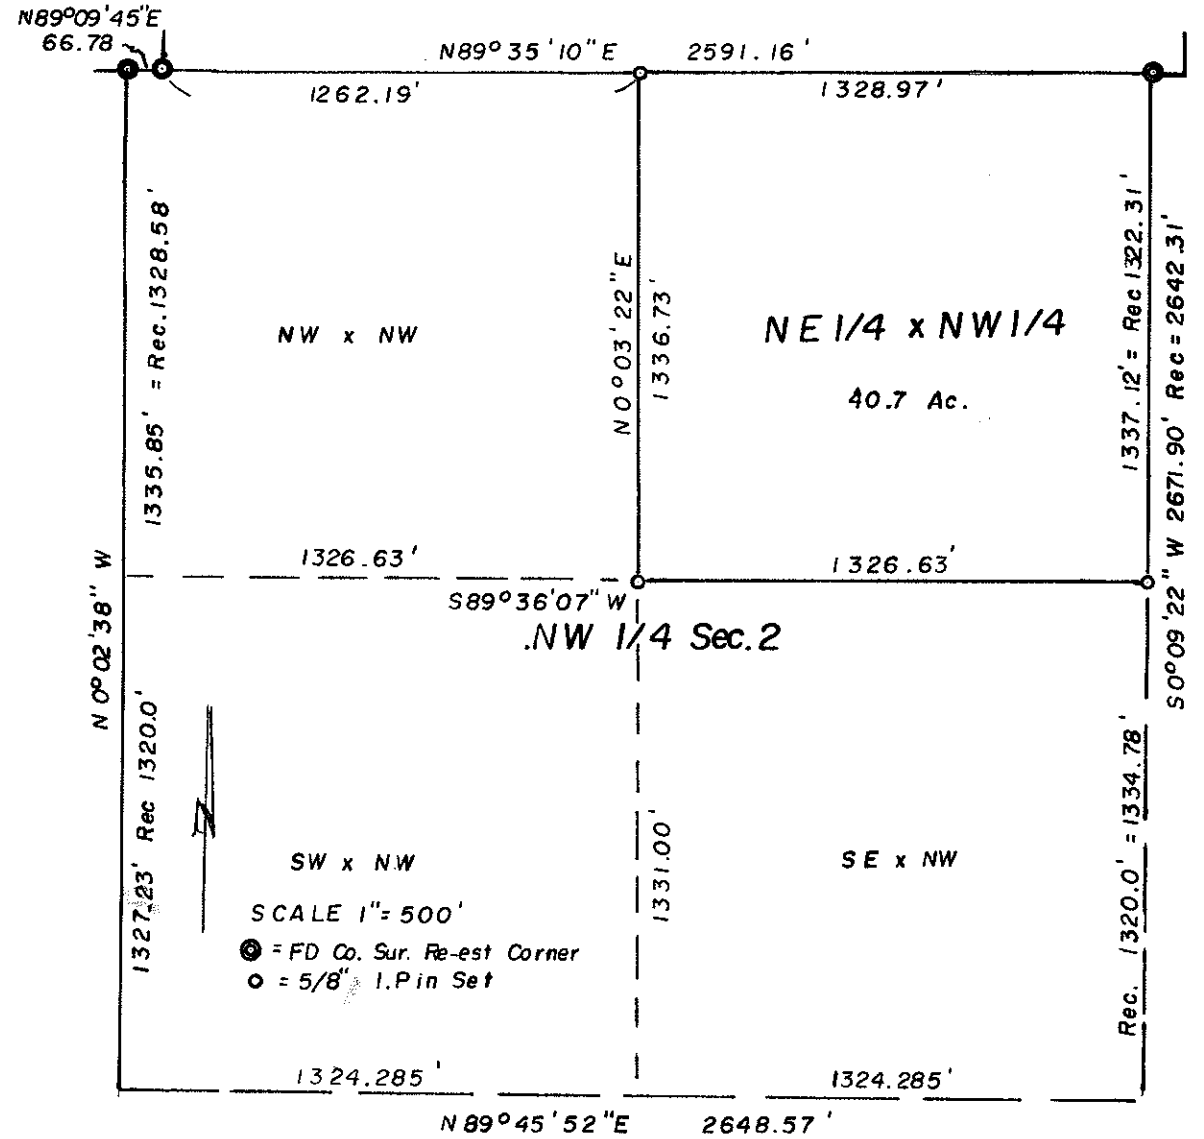
Aug 1981
○ = 1. PIN SET 5/8" x 24"
BEARING = SOLAR OBSER.

Monuments set being 5/8 x 24 in. iron pins, set approx. flush with the surface.

Basis of Bearing: Solar Observation at the NE 1/4 Cor. of Sec. 2

Ties to the existing corners were performed with EDM equipment on an open-ended or stub-line traverse. The probable accuracy exceed that of the Standard of Practice by BLM.

A search for the West 1/4 corner revealed no evidence, apparently the original position has been considered lost for many years, according to local residence. This position was prorated in harmony with the record measurement.
