MINOR LAND PARTITION

LOCATED IN
A PORTION OF LOTS 1, 2 & 3 IN BLK. 3 IN PRACHTS ALASKA ADDITION
TO ASHLAND & IN THE SE 1/4 OF SEC. 9, TWP. 39S., R.I E.W.M.
JACKSON COUNTY OREGON

SURVEY NARRATIVE TO COMPLY WITH PARAGRAPH 209.250 OREGON REVISED STATUTES

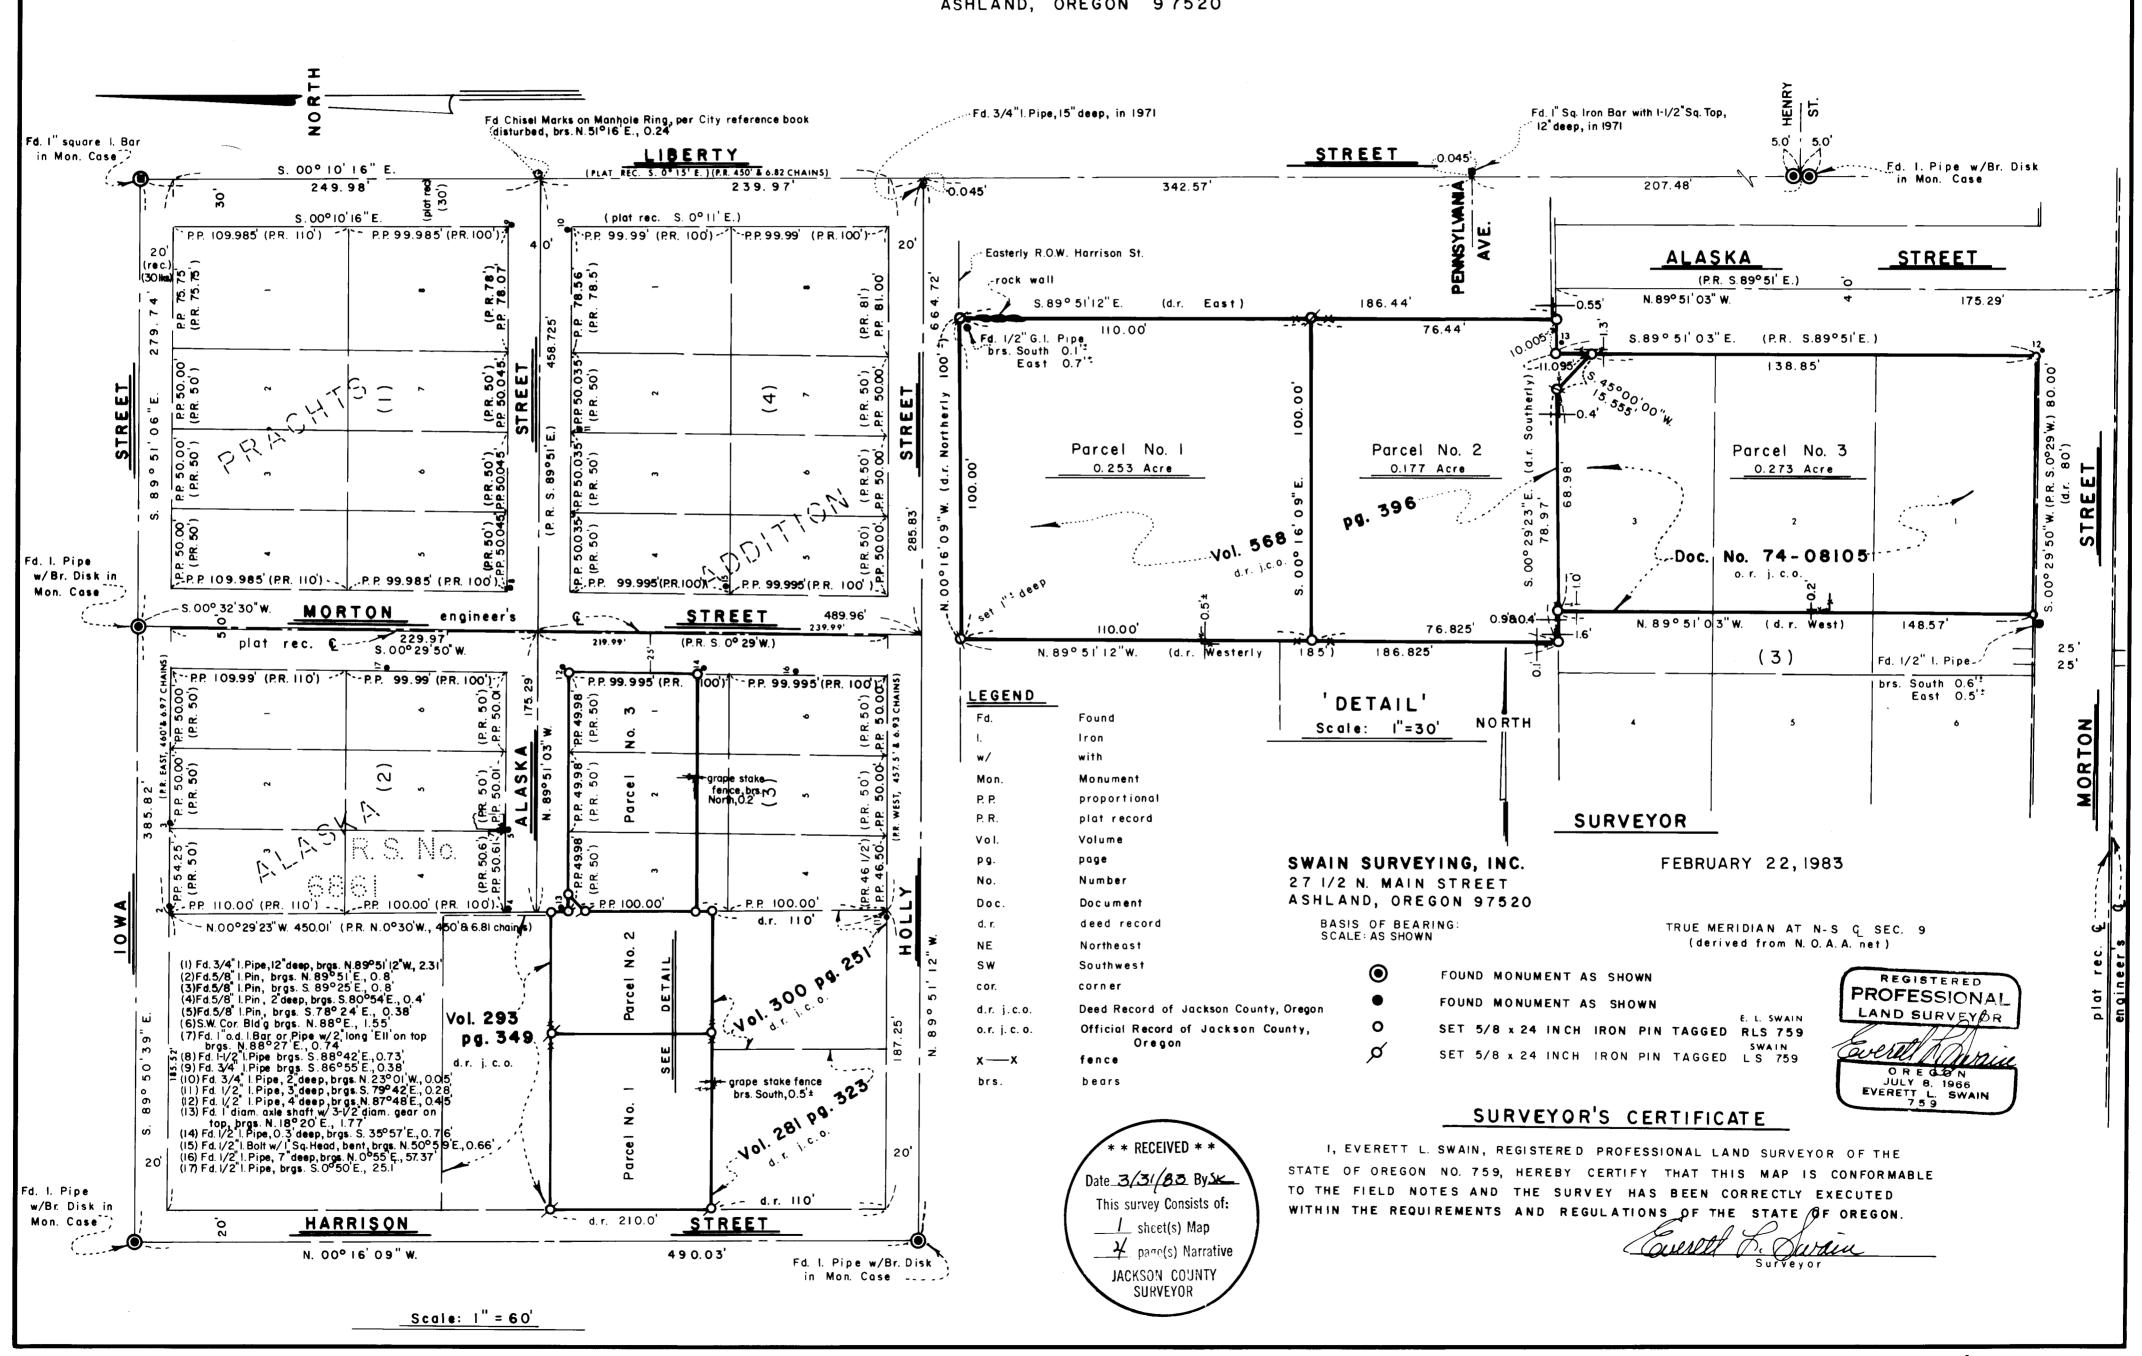
BASIS OF BEARING:

True Meridian at the N-S centerline of Section 9 as derived from the National Oceanic and Atmospheric Administration (formerly Coast and Geodetic Survey) survey net established in 1968 and filed in the office of the Jackson County Surveyor.

The remainder of the survey is as shown on the accompanying map.
