MAP of SURVEY

Located in the northwest and the northeast quarters of Section 4, Township 39 South, Range 2 West of the Willamette Meridian, Jackson County, Oregon.

JOHN & LIZ HENDERSON

SURVEY NARRATIVE TO COMPLY WITH O.R.S. 209.250.

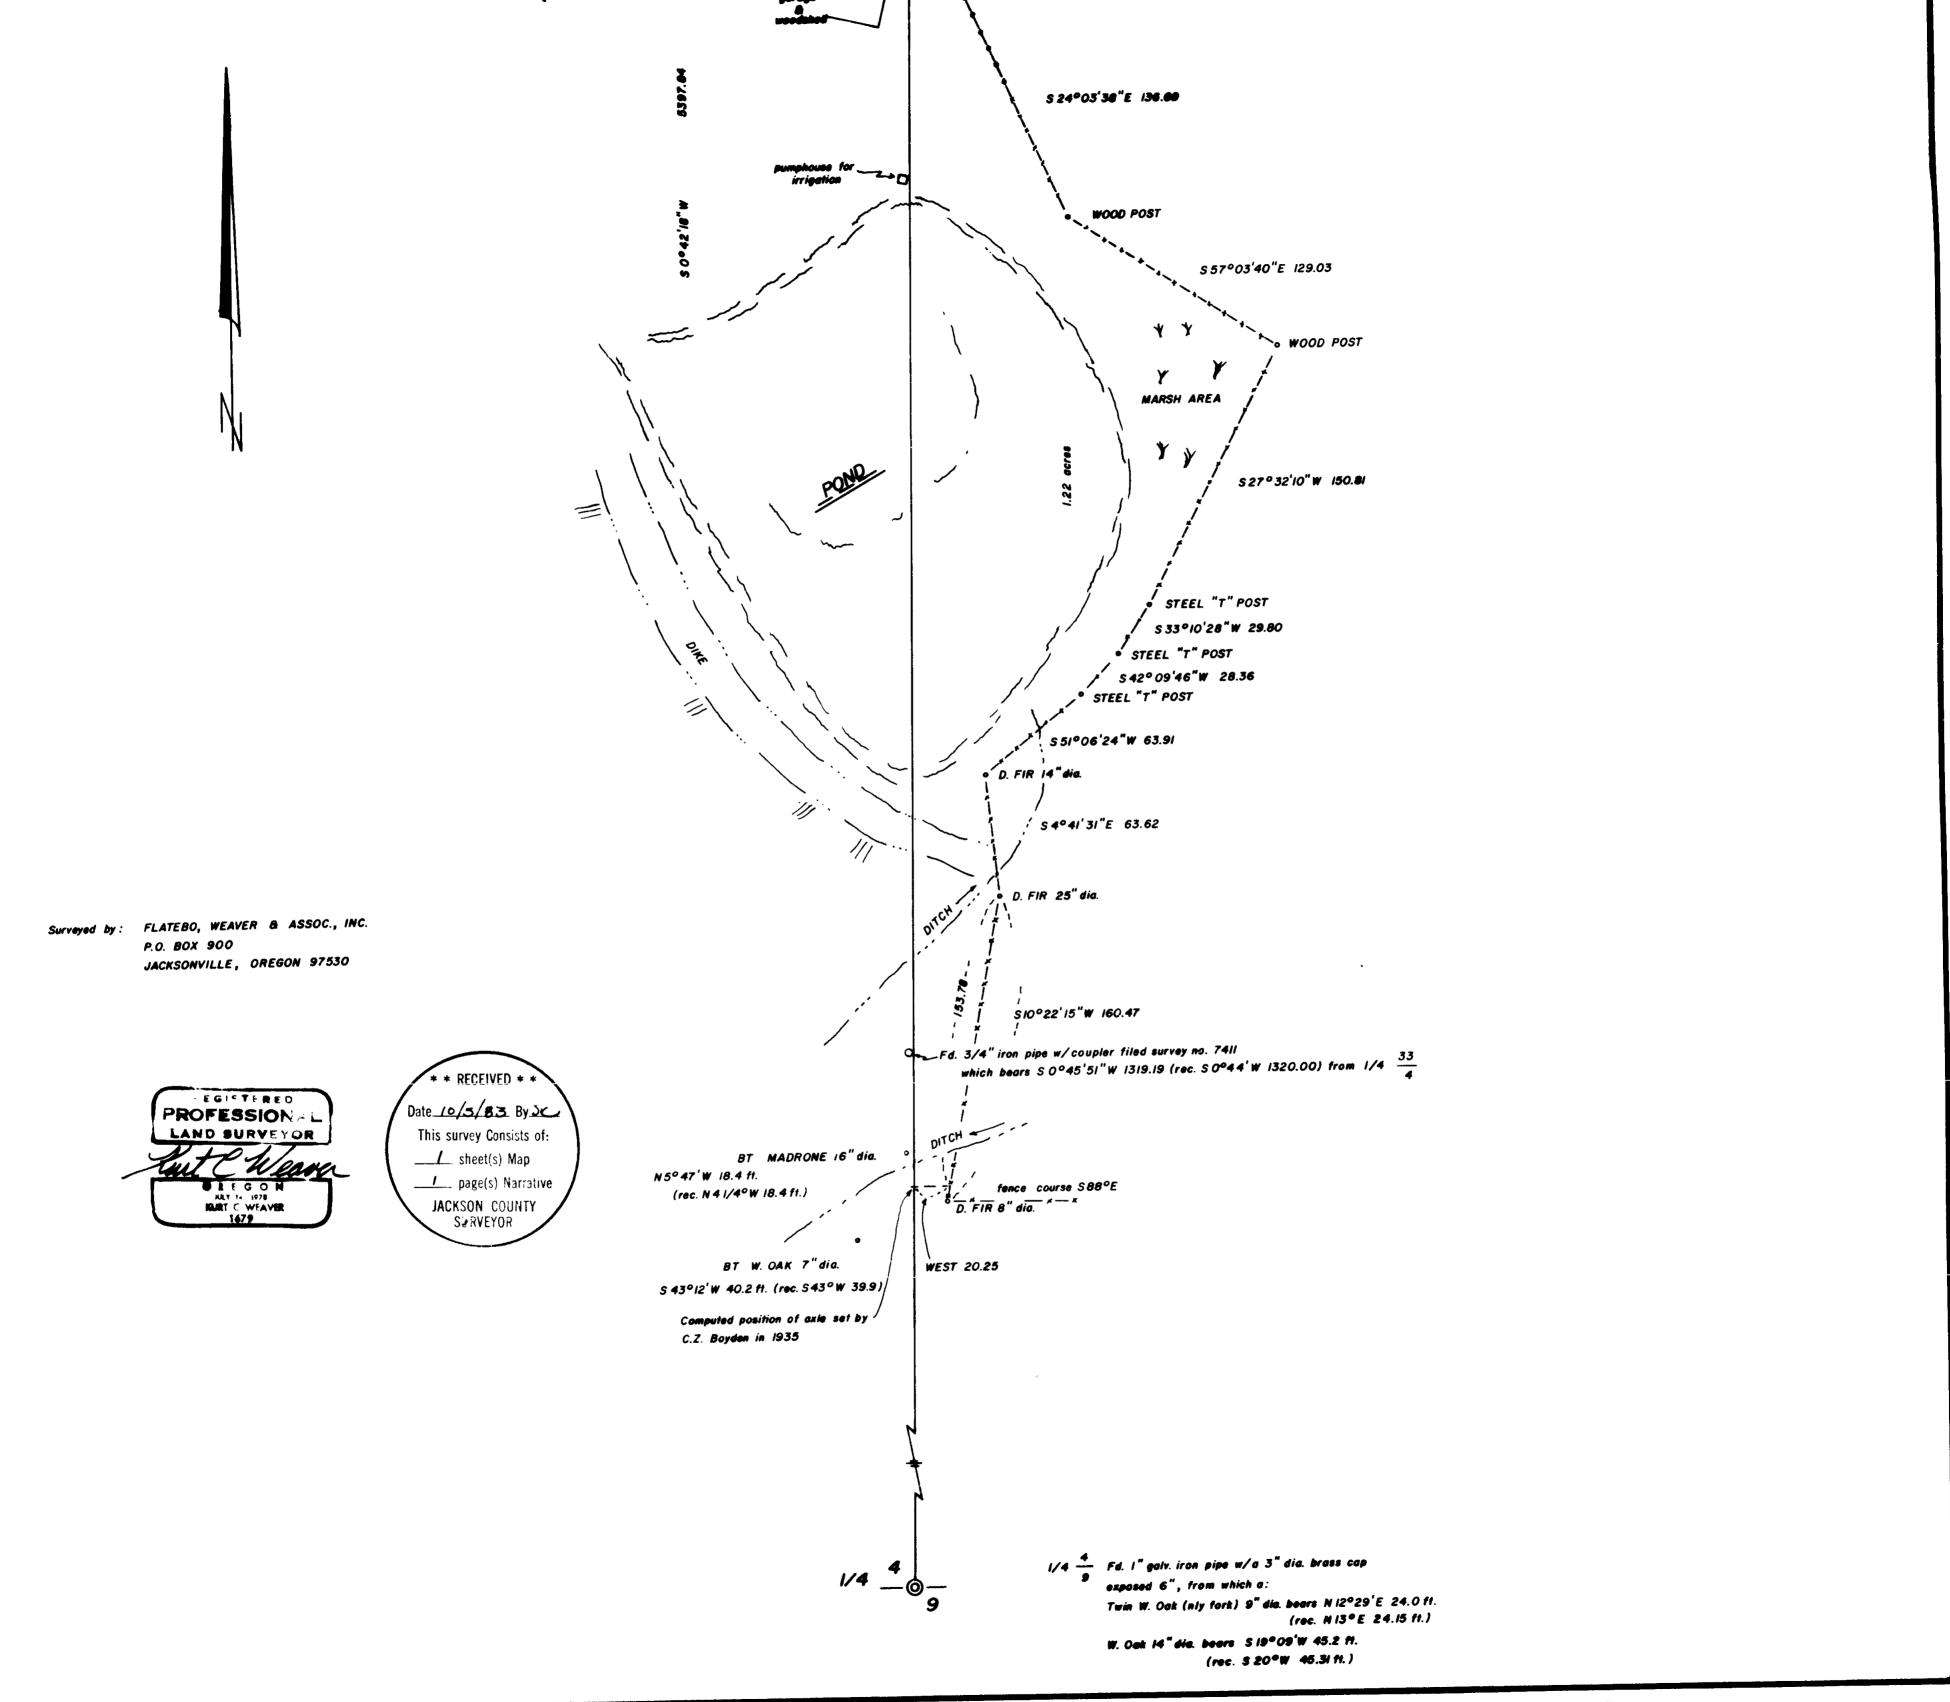
BASIS OF BEARING: Solar observation MONUMENTS: Found as shown BARBED WIRE FENCE = -x-x-x-CYCLONE FENCE = ----SCALE: | inch = 50. feet

The north and south quarter corners of said Section 4 were incorporated in a closed traverse. These corners were surveyed through in order to locate the north-south centerline of Section 4. The fence line was surveyed from this closed traverse. The fence is predominantly 5 strands of barbed wire, meandering from tree to tree. Portions of the fence have been replaced with cyclone fencing. According to Mr. Henderson the cyclone fencing was placed in the same position as the barbed wire fence. The barbed wire portion is generally in good repair.
