SURVEY NARRATIVE TO COMPLY WITH O.R.S. 209.250.

MARTY AND JESSIE GEISZLER

THE SOUTH ONE-HALF (1/2) OF THE NORTH ONE-HALF (1/2) OF THE SOUTHEAST ONE-QUARTER (1/4) OF THE SOUTHWEST ONE-QUARTER (1/4) OF SECTION 35, TOWNSHIP 36 SOUTH, RANGE 3 WEST, WILLAMETTE MERIDIAN, JACKSON COUNTY, OREGON.

TO SURVEY AND SET THE CORNERS OF THE

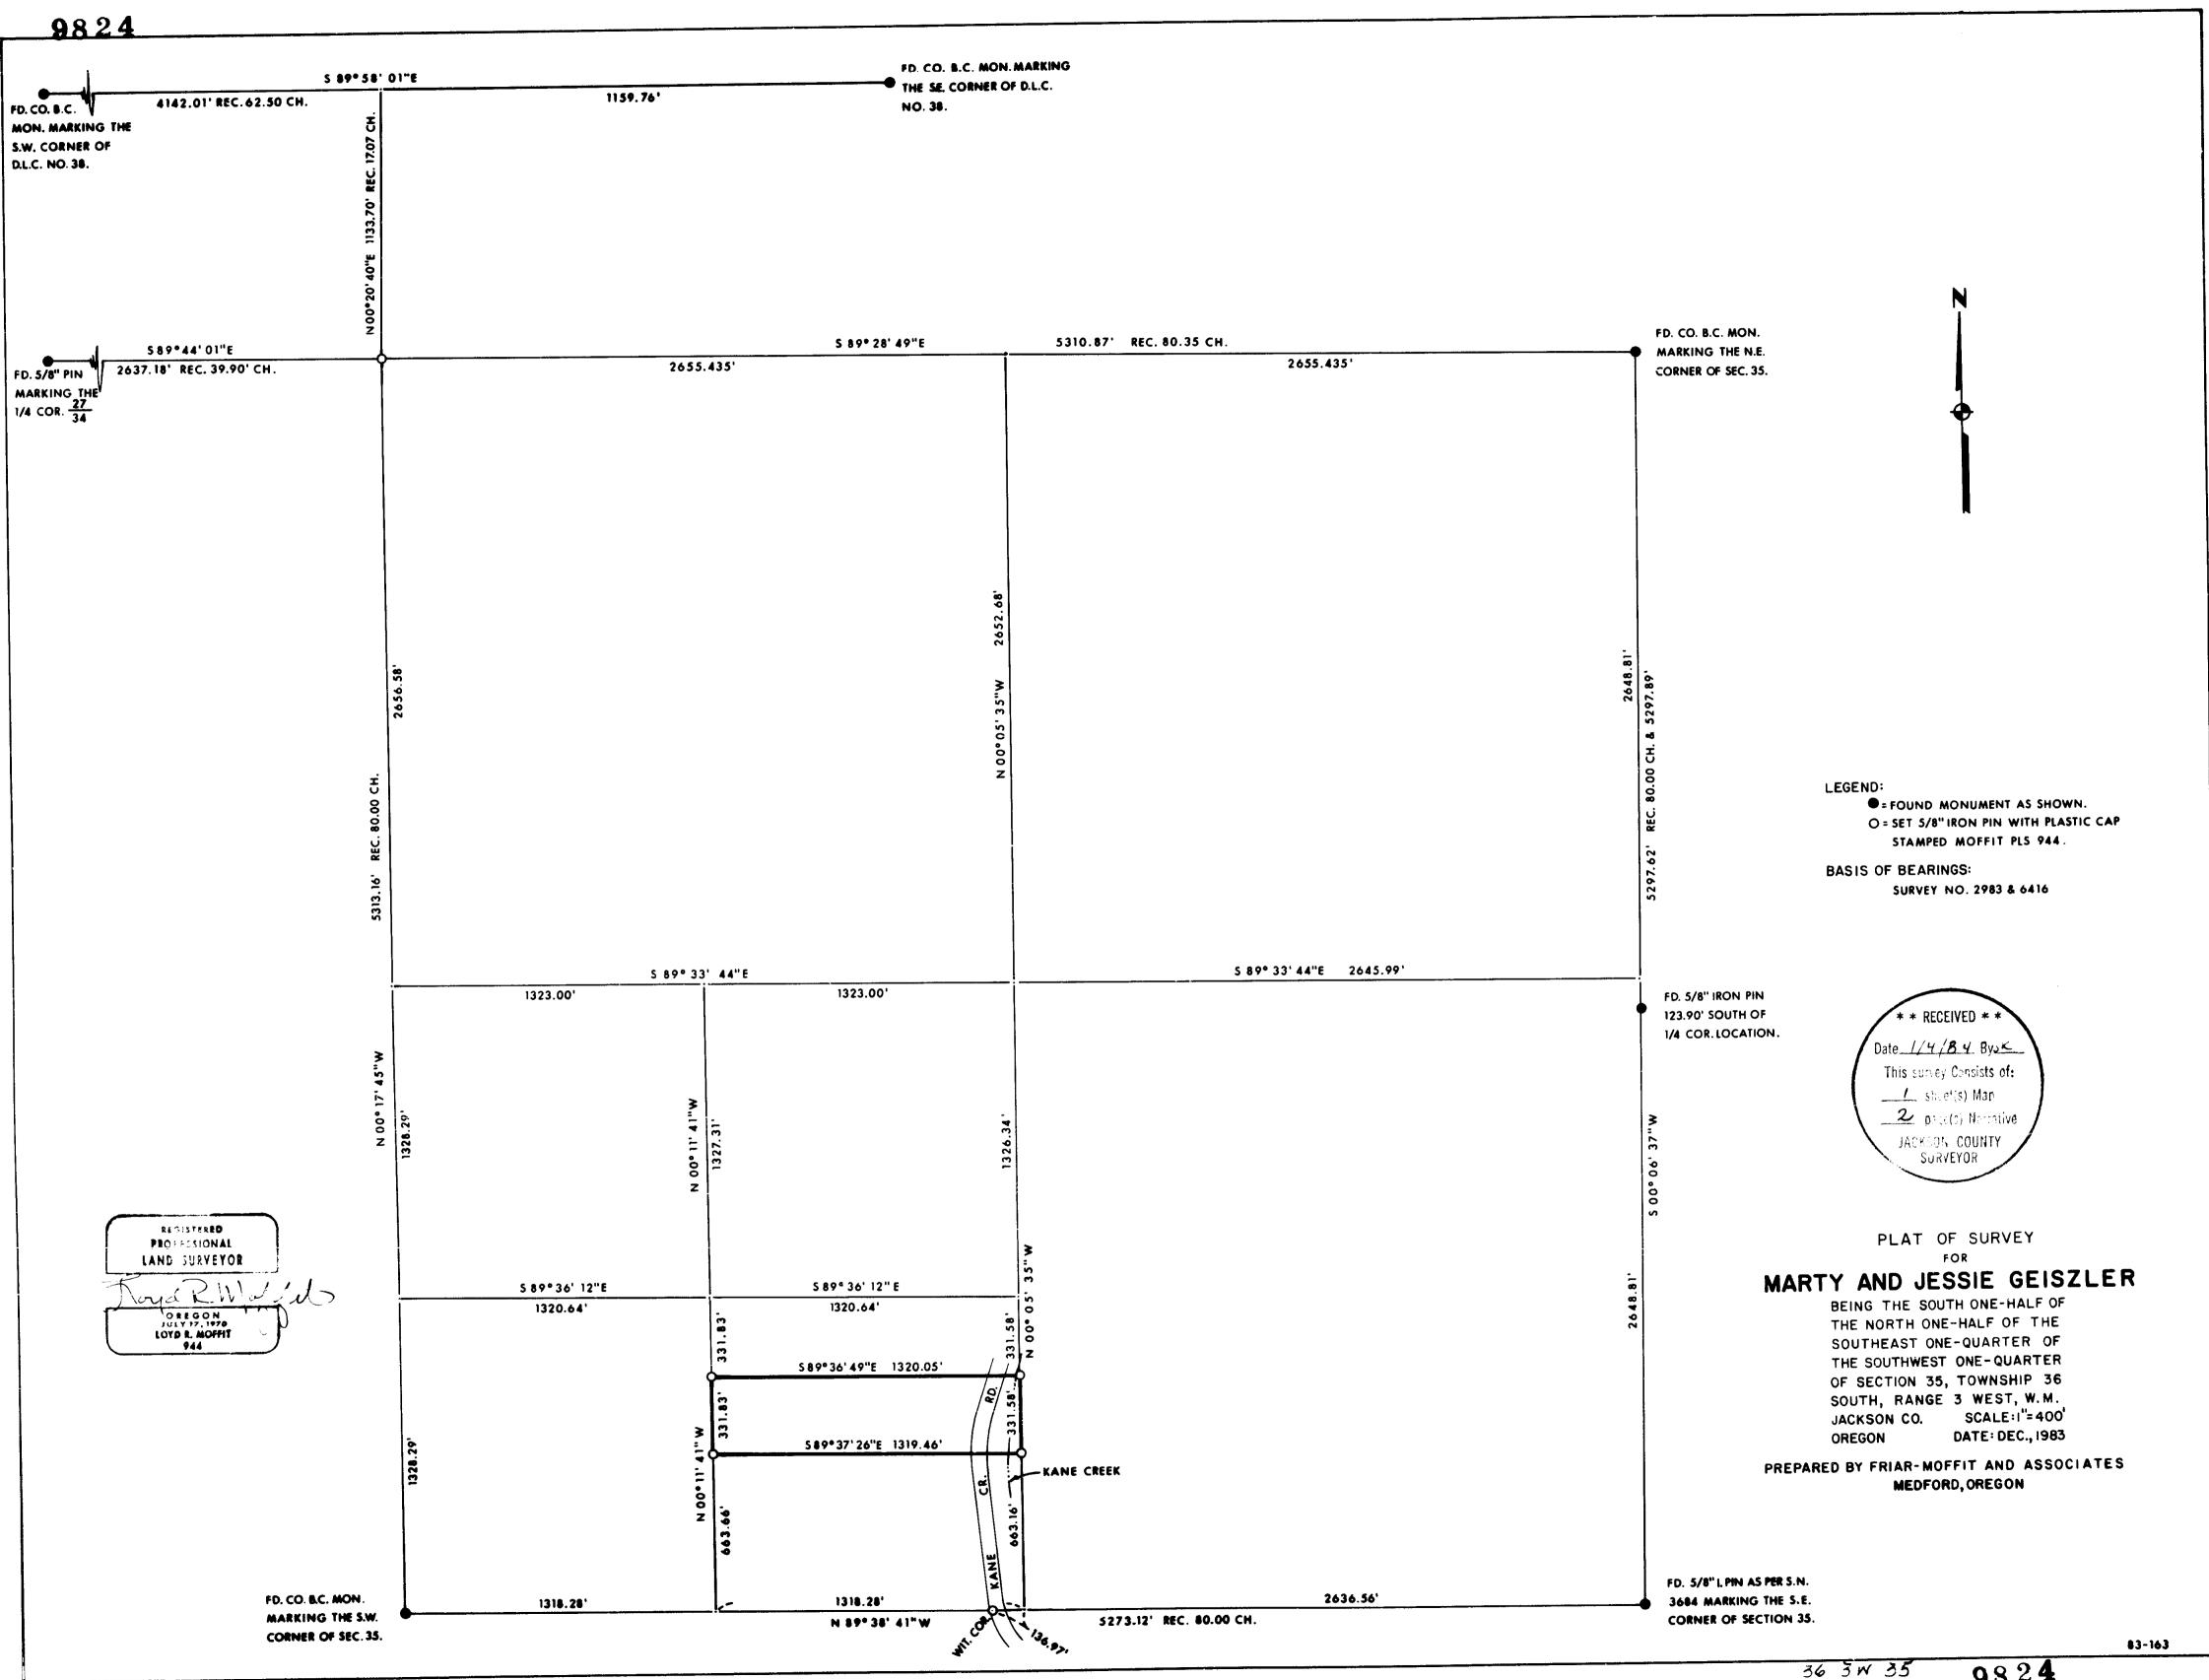
CORNERS WERE THEN SET AS SHOWN ON THE ATTACHED MAP. THE PIN SET AT THE NORTHWEST CORNER OF SECTION 35 IS BURIED 0.8 FEET AND HAS ROCKS AND BROKEN CONCRETE BLOCKS AROUND IT. IT ALSO HAS A FENCE POST DRIVEN IN THE GROUND CLOSE TO THE CORNER. THE 5/8 INCH PIN SET DURING SURVEY NO. 6416 BEARS NORTH 65° 10' 13" EAST 6.81 FEET.
