SURVEY NARRATIVE TO COMPLY WITH O.R.S. 209.250

Melrose Orchards, Inc. 619 South Grape Street Medford, Oregon 97501 Tippett Land & Mortgage Co. P. O. Box 3027

Boyden Surveyors 108 Mistletoe Street Medford, Oregon 97501

1. To monument a portion of the overall property being purchased by Melrose Orchards, Inc. from Tippett Land & Mortgage Co., being located in D.L.C. No. 47, and the North-half of Section 7, T38SRlW, W.M.

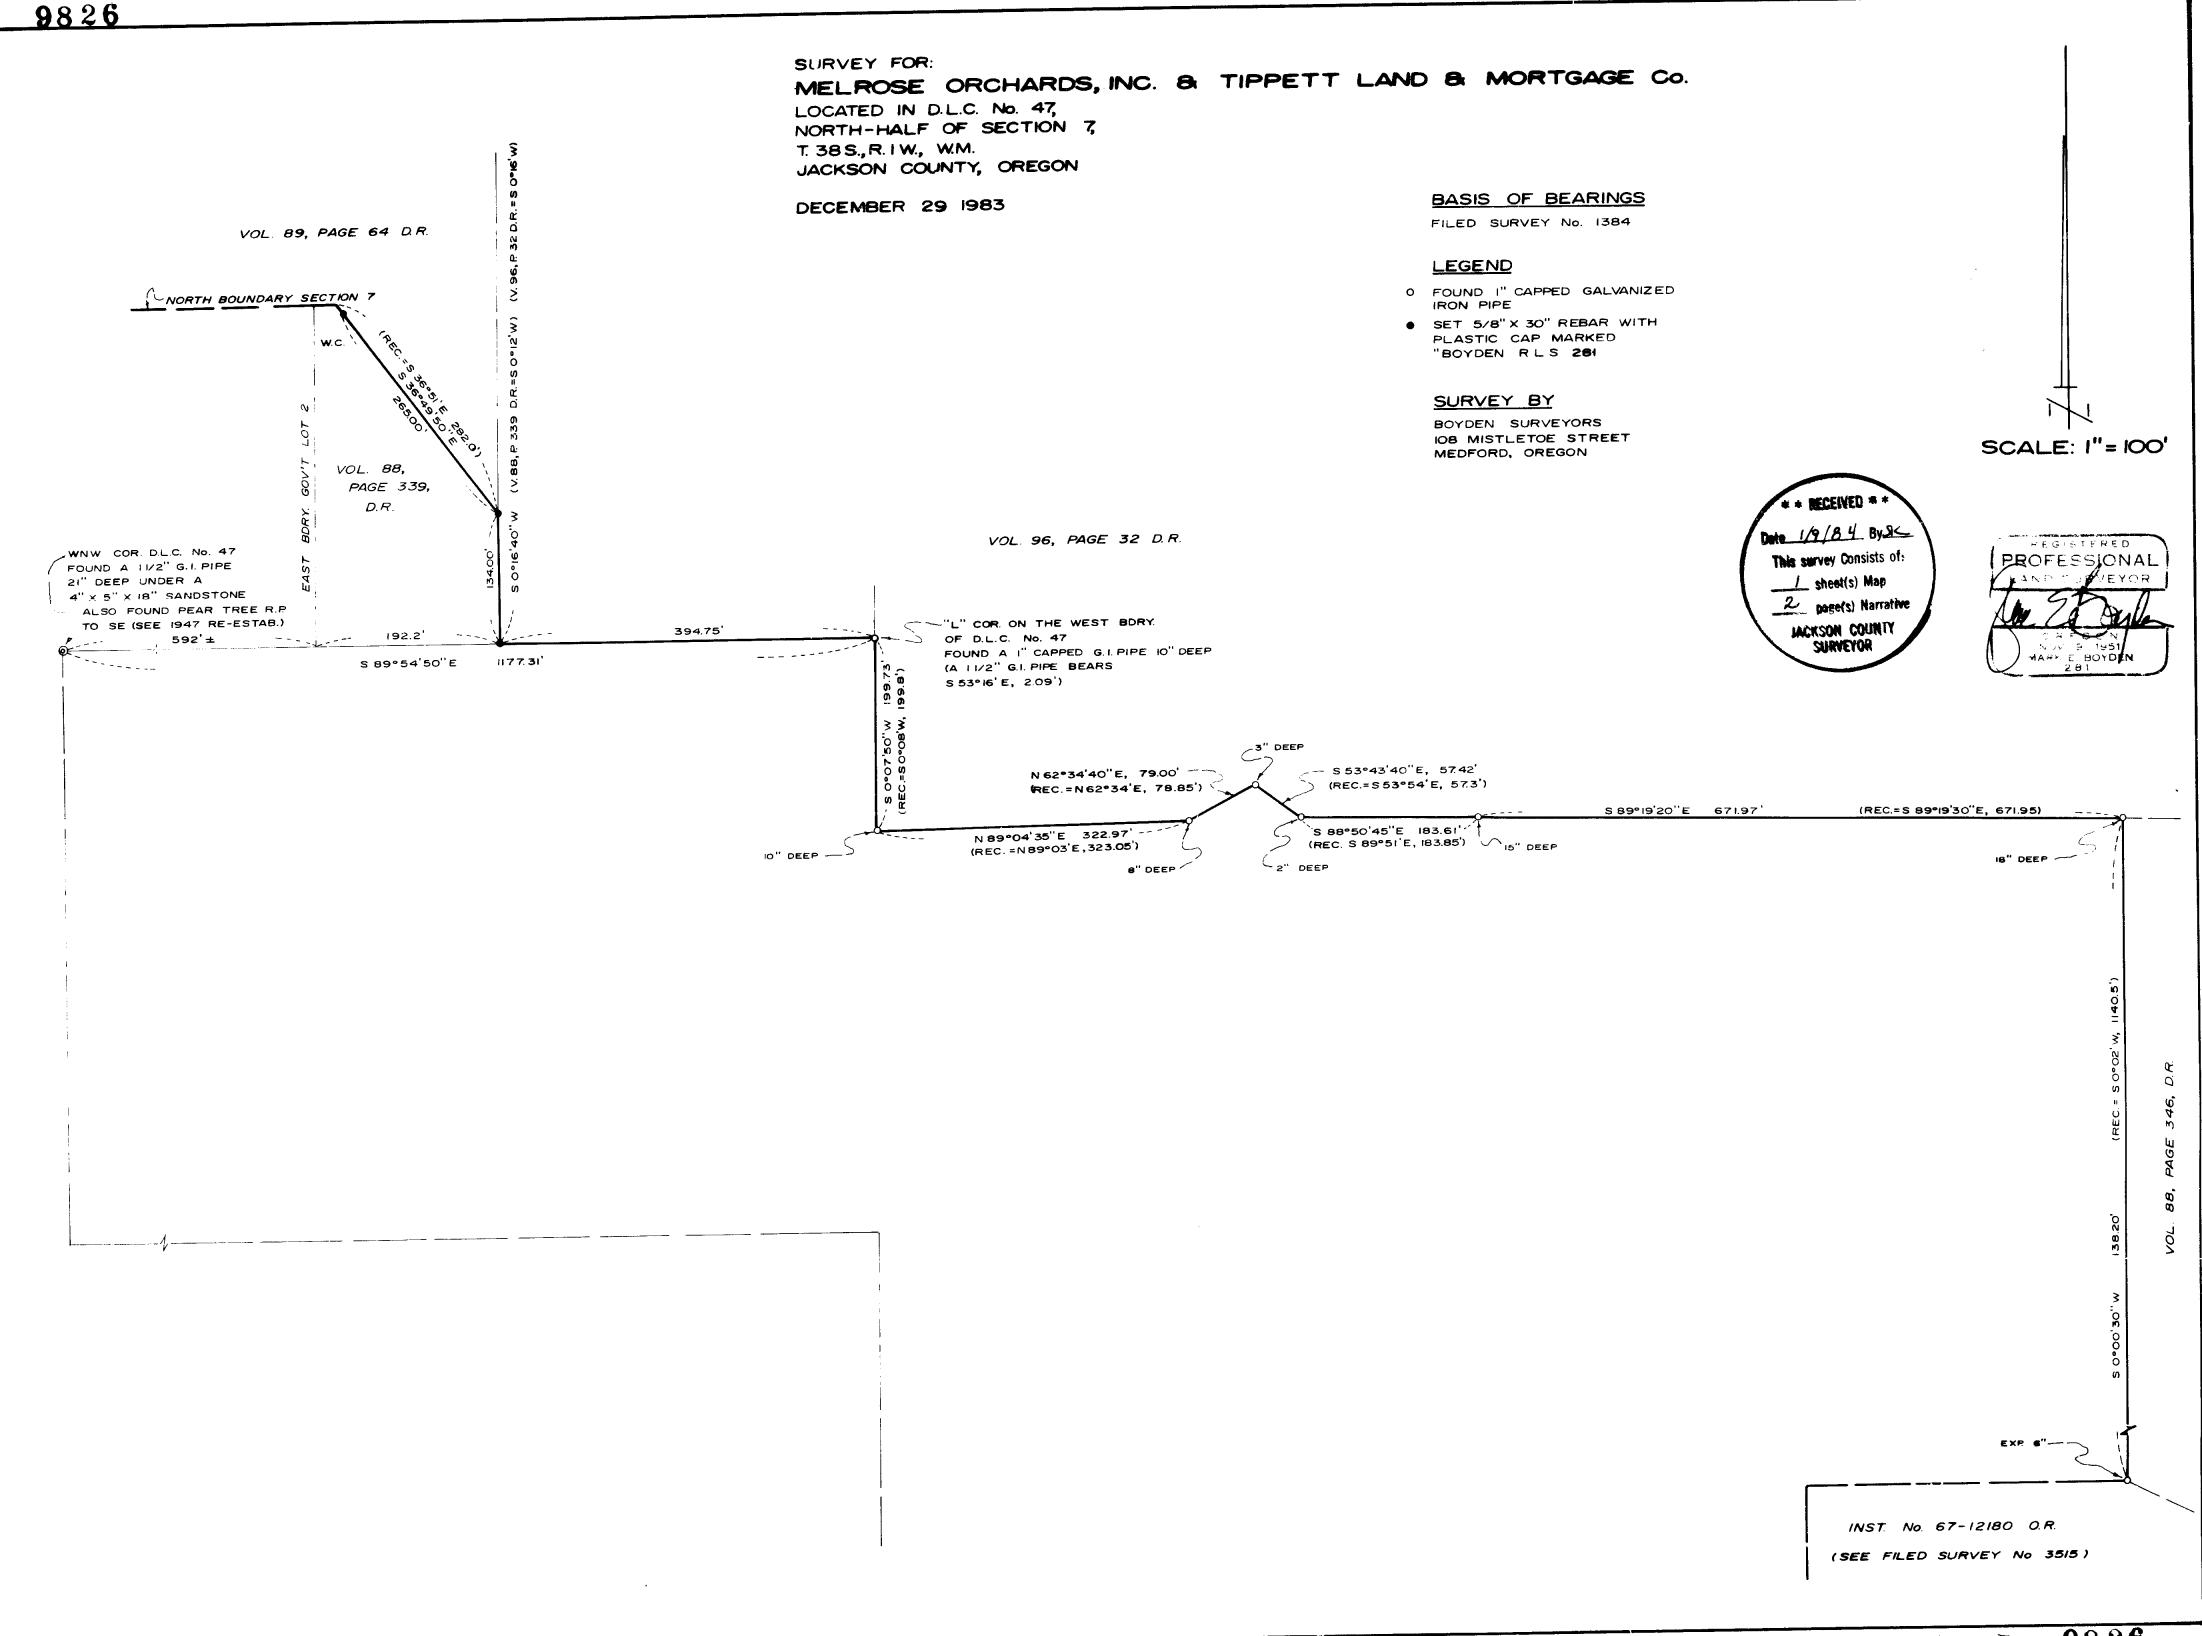
PROCEDURE: Utilizing E.D.M. equipment, traversed the Northerly boundary of the property, tying to monuments found as shown.

The original monuments of the parcel described in Volume 88 Deeds, Page 339 could not be found, and were partially monumented at positions shown on the annexed map.
