Survey for GREAT WESTERN SAVINGS BANK
S.W. 1/4 Sec. 16, N.W. 1/4 Sec. 21, T.36S., R.1W., W.M.
Jackson County, Oregon
August, 1988

SURVEY NO. 11341

SURVEY NARRATIVE TO COMPLY WITH O.R.S. 209.250

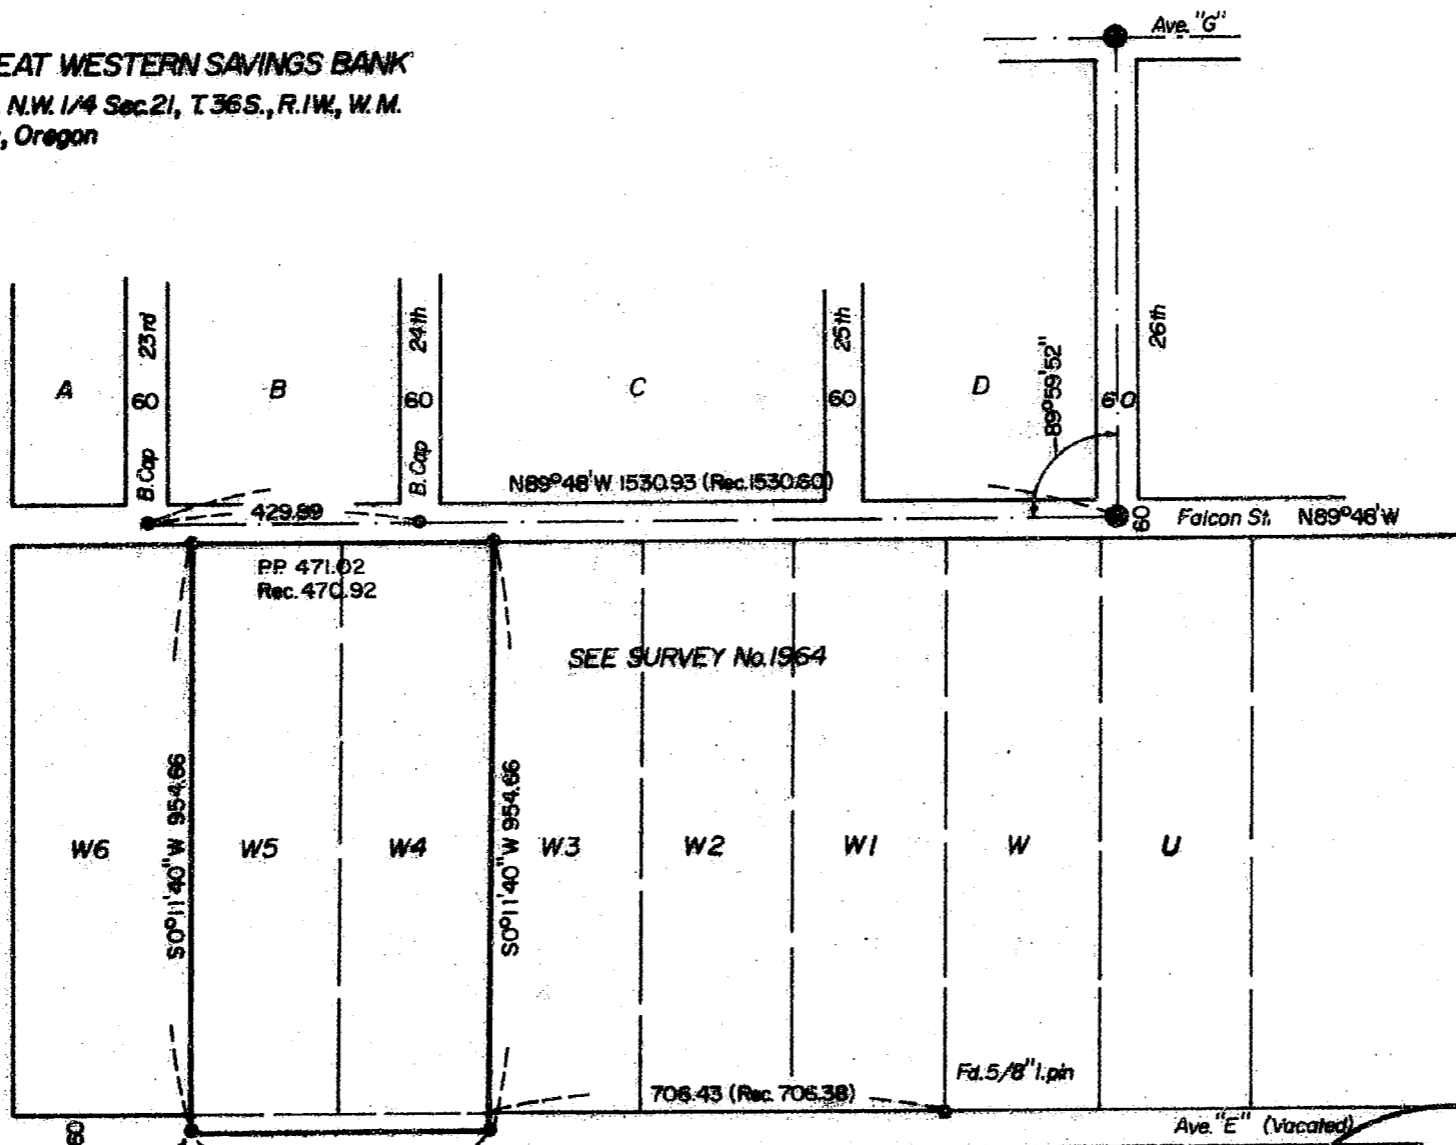
5/8" x 13" iron pin/plastic cap
 stamped L.S. 505 driven to refusal,
 exposed 0.1 ft.

PURPOSE: To survey and monument parcel according to legal description
furnished by client.

PROCEDURE: The subject parcel was originally surveyed and monumented by
Survey No. 1964 as tracts W4 and W5. All original monuments
on the subject parcel have apparently been destroyed.

The centerline of Falcon Street (formerly "F" Street) was
established from brass cap monuments found. The origin of
the two brass cap monuments at 23rd and 24th Streets is un-
known at this time.

Although Survey No. 1964 is not a formal Subdivision, some
53 tracts are shown thereon. Therefore, pro-rate dimensions
were computed for the subject parcel based on the measure-
ments between brass cap street monuments as compared to
record.
