Survey for David S. Souza 157 Renault Ave. Medford, Oregon 97501

Lots 2 3, Block 1 Renault Subdivision SW1/4, Section 26, T. 375., R. 2 W., W.M., Jackson County, Or.

SURVEY NARRATIVE TO COMPLY WITH O.R.S. 209.250

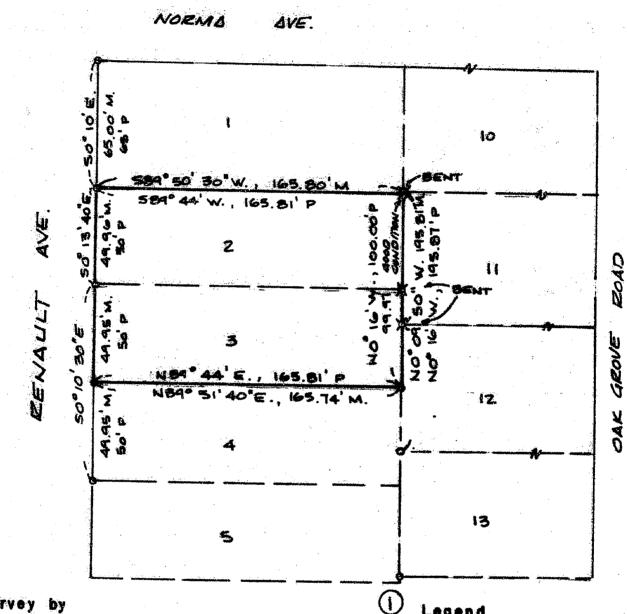
existing lot Τo locate monuments and remonument the missing Southwest and Southeast corners of

Lot 3.

lot corner monuments for RENAULT SUBDIVISION as shown.

The plat calls for 1/2" iron pipes and all lot corners found were monumented with 3/4" iron pipes.

Those monuments found in good condition were used for control and the missing corners proportioned as shown.
