SURVEY NARRATIVE TO COMPLY WITH O.R.S. 209.250

Randall & Elizabeth Collings

Block 5, BRITTSAN SUBDIVISION in the

To locate and monument the corners of Lot 9, Block 5,

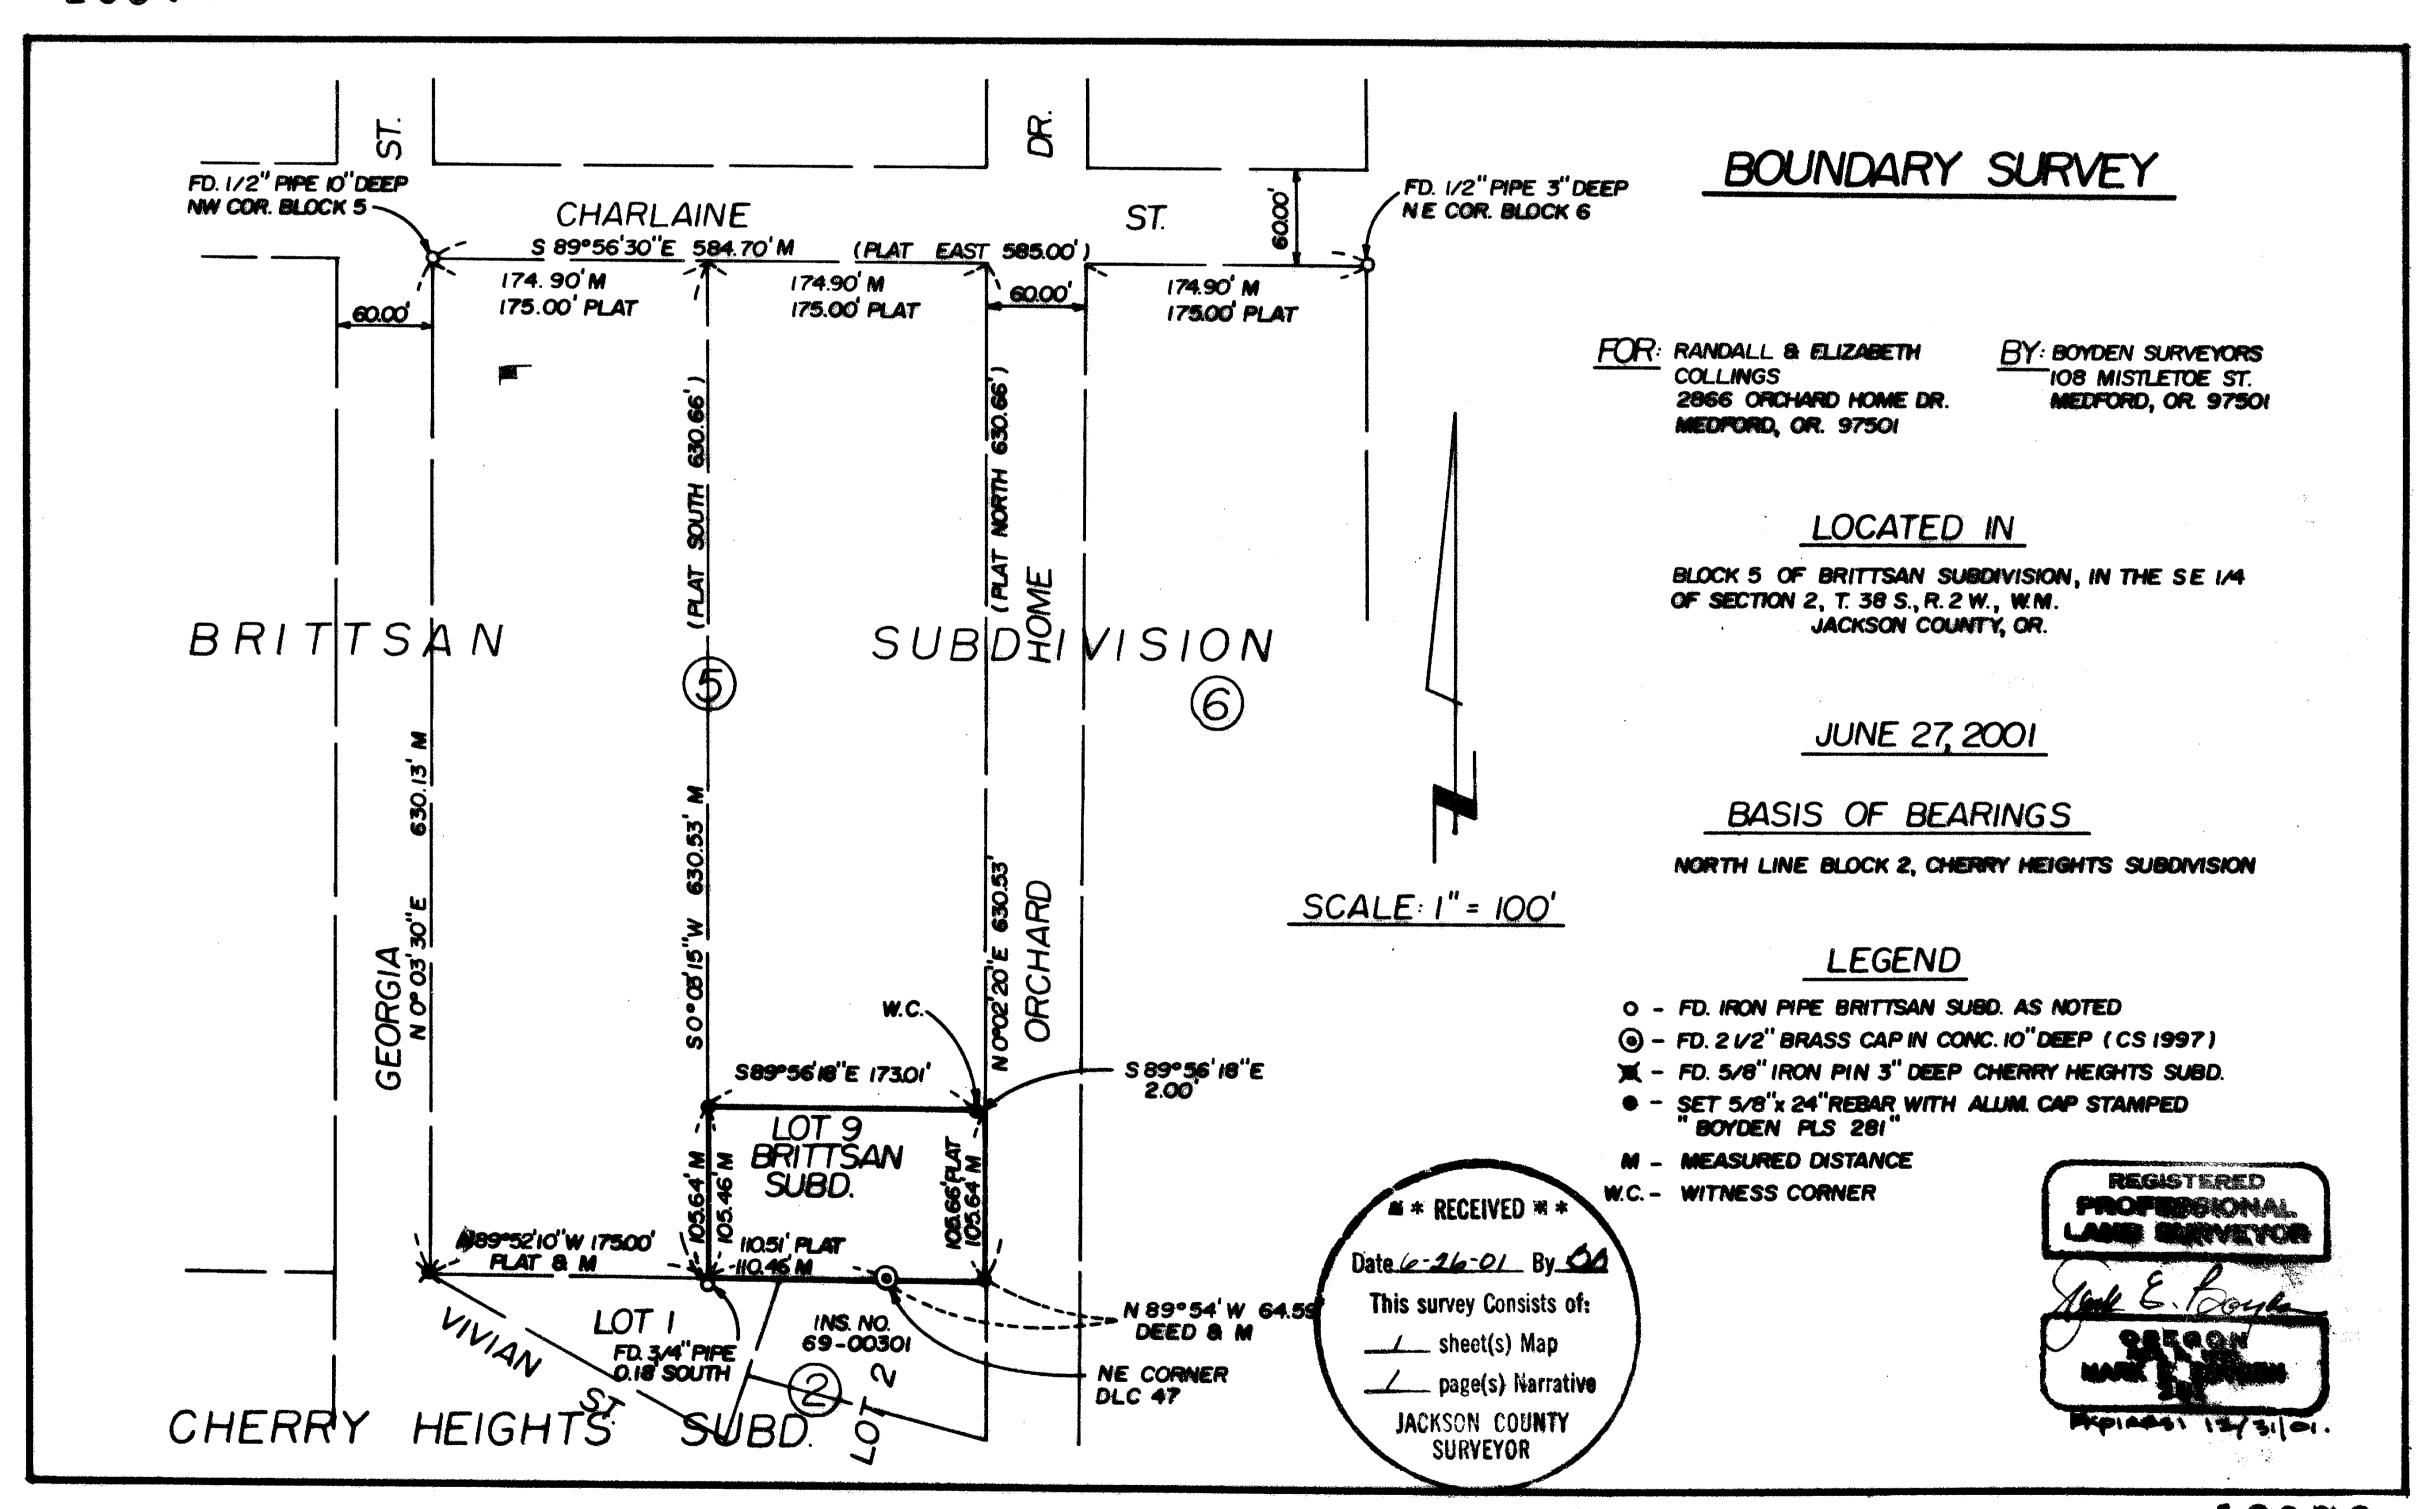
From iron pipes found, proportioned the lot corner

positions as shown.

The true Southwest corner of Lot 9 was located on the North boundary of Block 2 of CHERRY HEIGHTS SUBDIVISION (0.18 feet Northerly) from the 3/4" iron pipe set on BRITTSAN SUBDIVISION (See the Second re-establishment of the Northeast corner of D.L.C. No. 47 by the Deputy County Surveyor on Sept. 21, 1954). It should be noted that the official plat of BRITTSAN SUBDIVISION shows a circle for "regulation iron pipes set", which circles show only on the block corners and not on the lot corners. It's possible that the BRITTSAN SUBDIVISION surveyor set iron monuments at several of the lot corners also (as indicated by the above mentioned

From this data, monumented said Lot 9, Block 5 at positions shown on the plat to accompany this report.
