SURVEY IN E. 1/2 SEC. 25, T36S, R3W, WM.  
 FOR  
 ROGUE RANCHOS, INC.  
 66-18 A-114

BY EDWARD MCGINTY  
 MEDFORD, OREGON  
 JULY 1966

Survey Narrative to comply with O.R.S. 209-250:

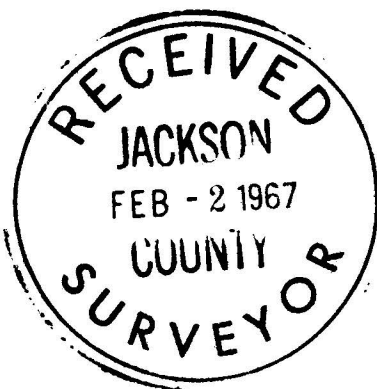
SCALE 1" = 200'  
 ○ = 5/8" IRON PIN

Exterior dashed lines shown are intended to be the approx. boundary lines only and should not be construed otherwise. The client is aware of this felt a complete sub-division of the section would not warrant the expense at this time.

A, B, and C, state highway monuments found.

North one quarter corner of Sec. 25, according to Happy Hollow Sub-division, Found 2 x 2 inch wood hub with tack (almost completely deteriorated) 6 inches deep in an old mound of stone, drove a 5/8 x 24 inch iron pin in old hub to preserve said monument.

Northeast corner of Sec. 25, found a 2 in. iron pipe.  
East 1/4 corner, found a 1 in. iron pipe  
Southeast corner of Sec. 25, found a 2 in. iron pipe.

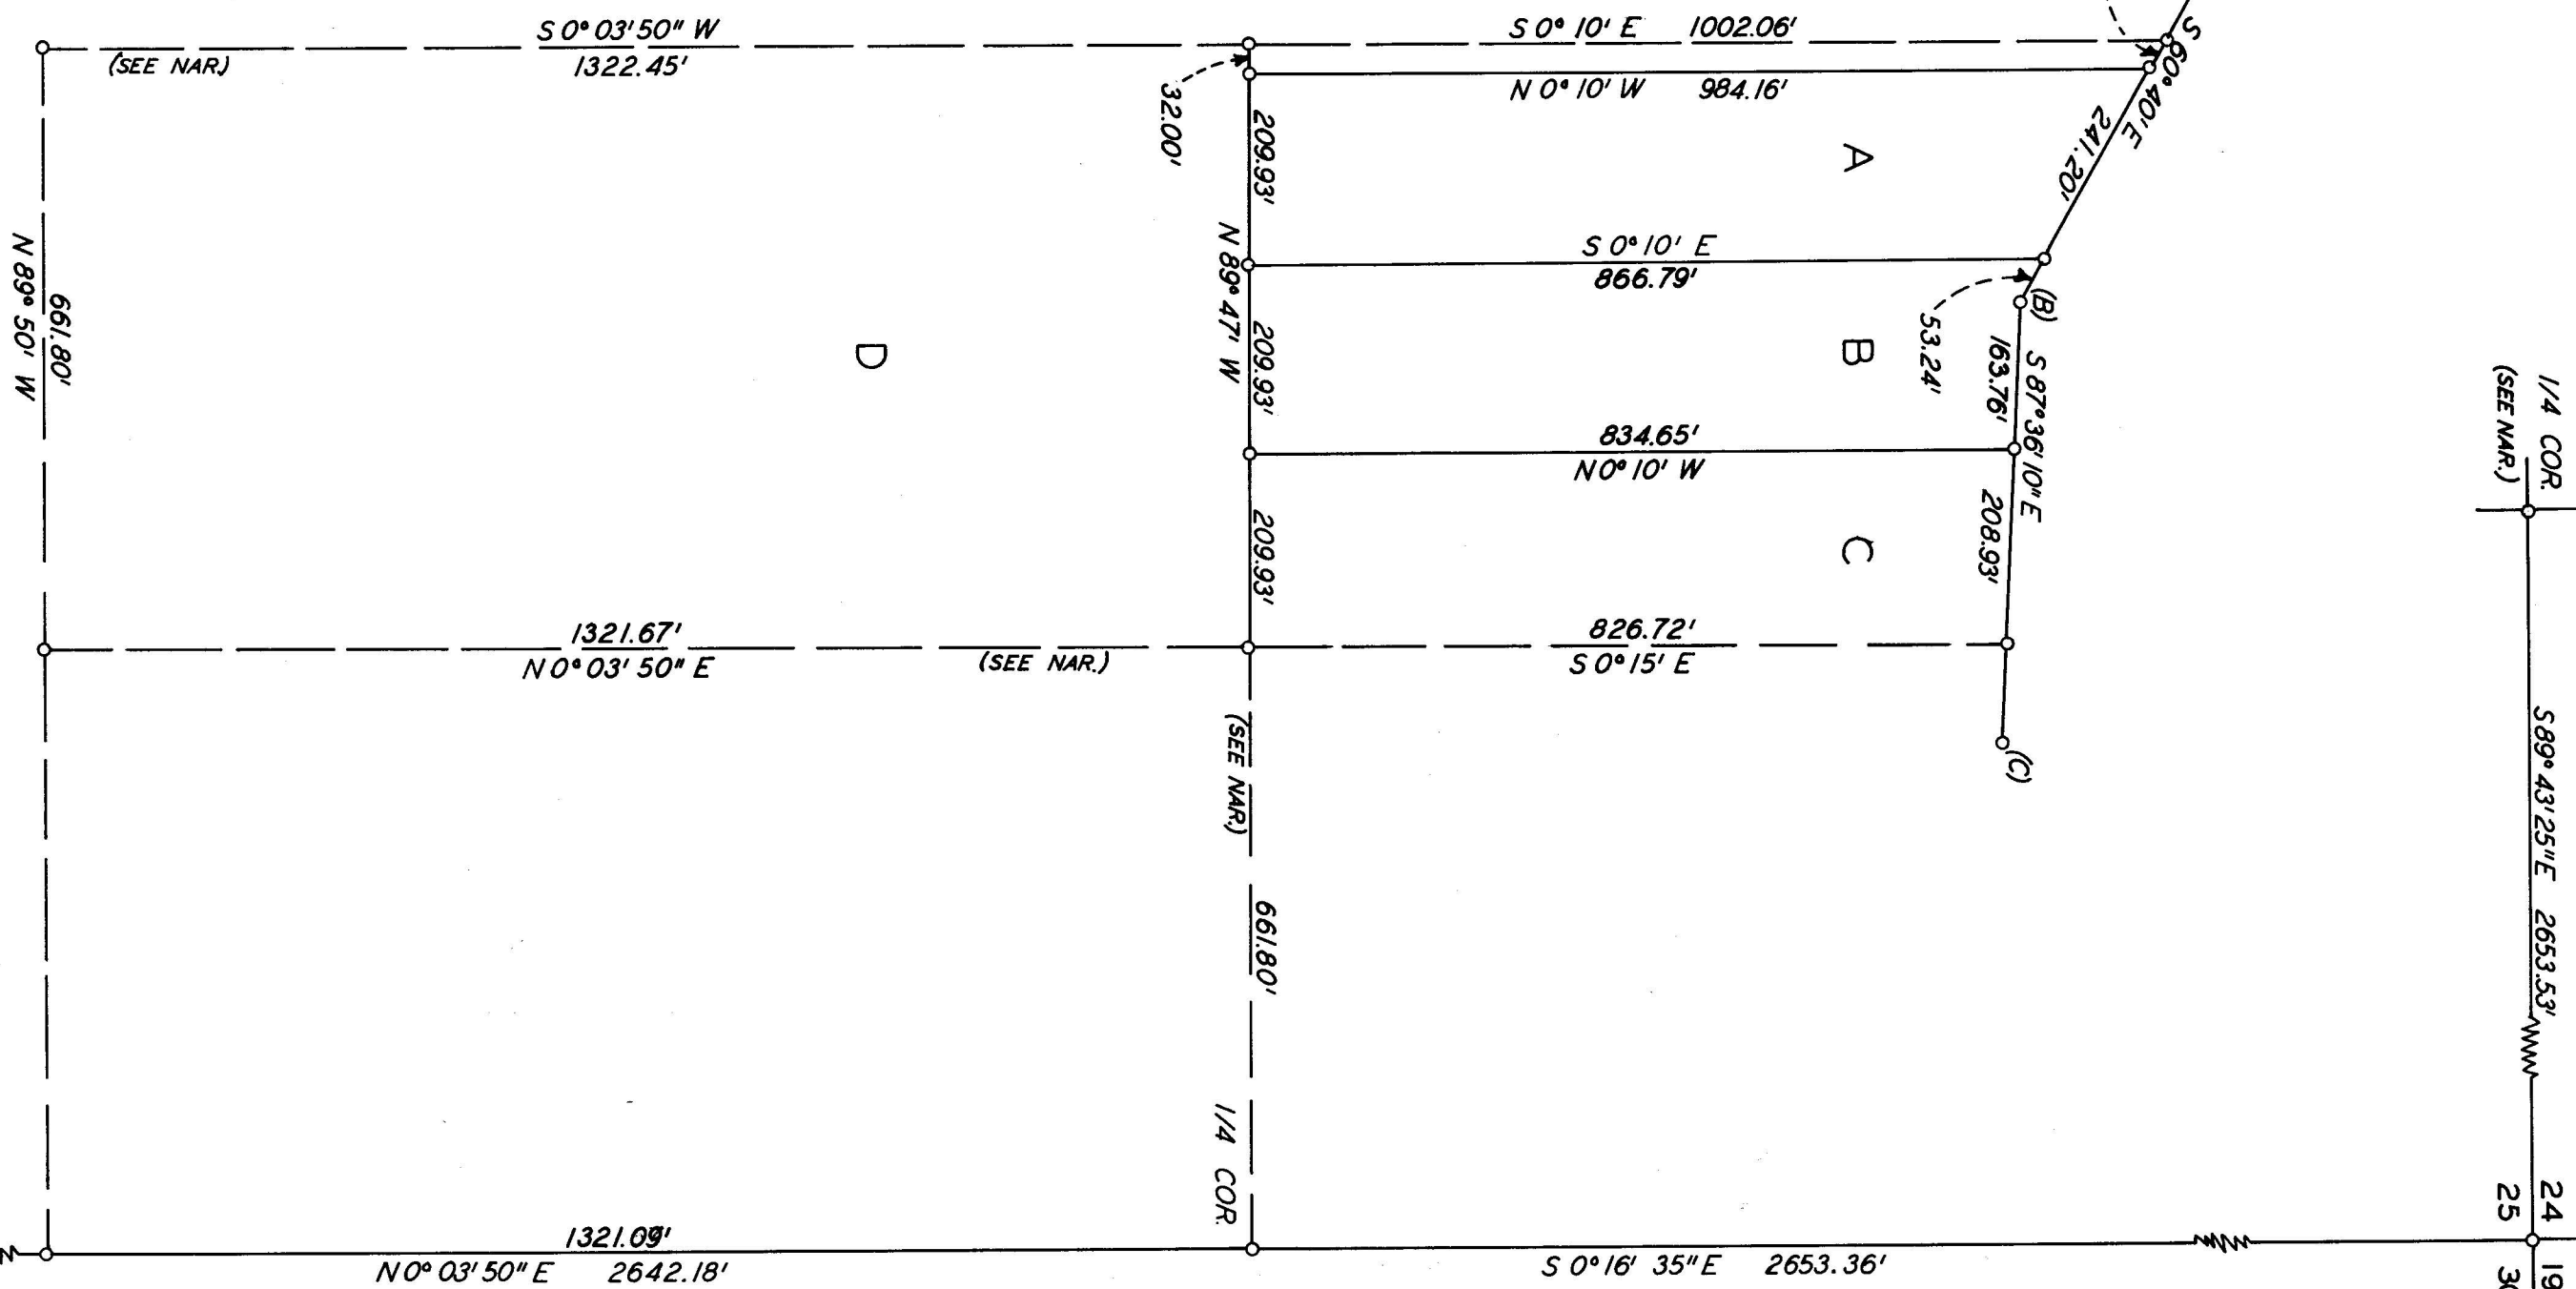
BASIS OF BEARING: Solar observation
