SURVEY OF PROPERTY LOCATED IN THE NW 1/4 OF SEC. 22, T. 36 S., R. 4 W., W.M., JACKSON CO., ORE.

SURVEY NO. 6412

SURVEY NARRATIVE to comply with the Paragraph 209.250,
Oregon Revised Statutes.

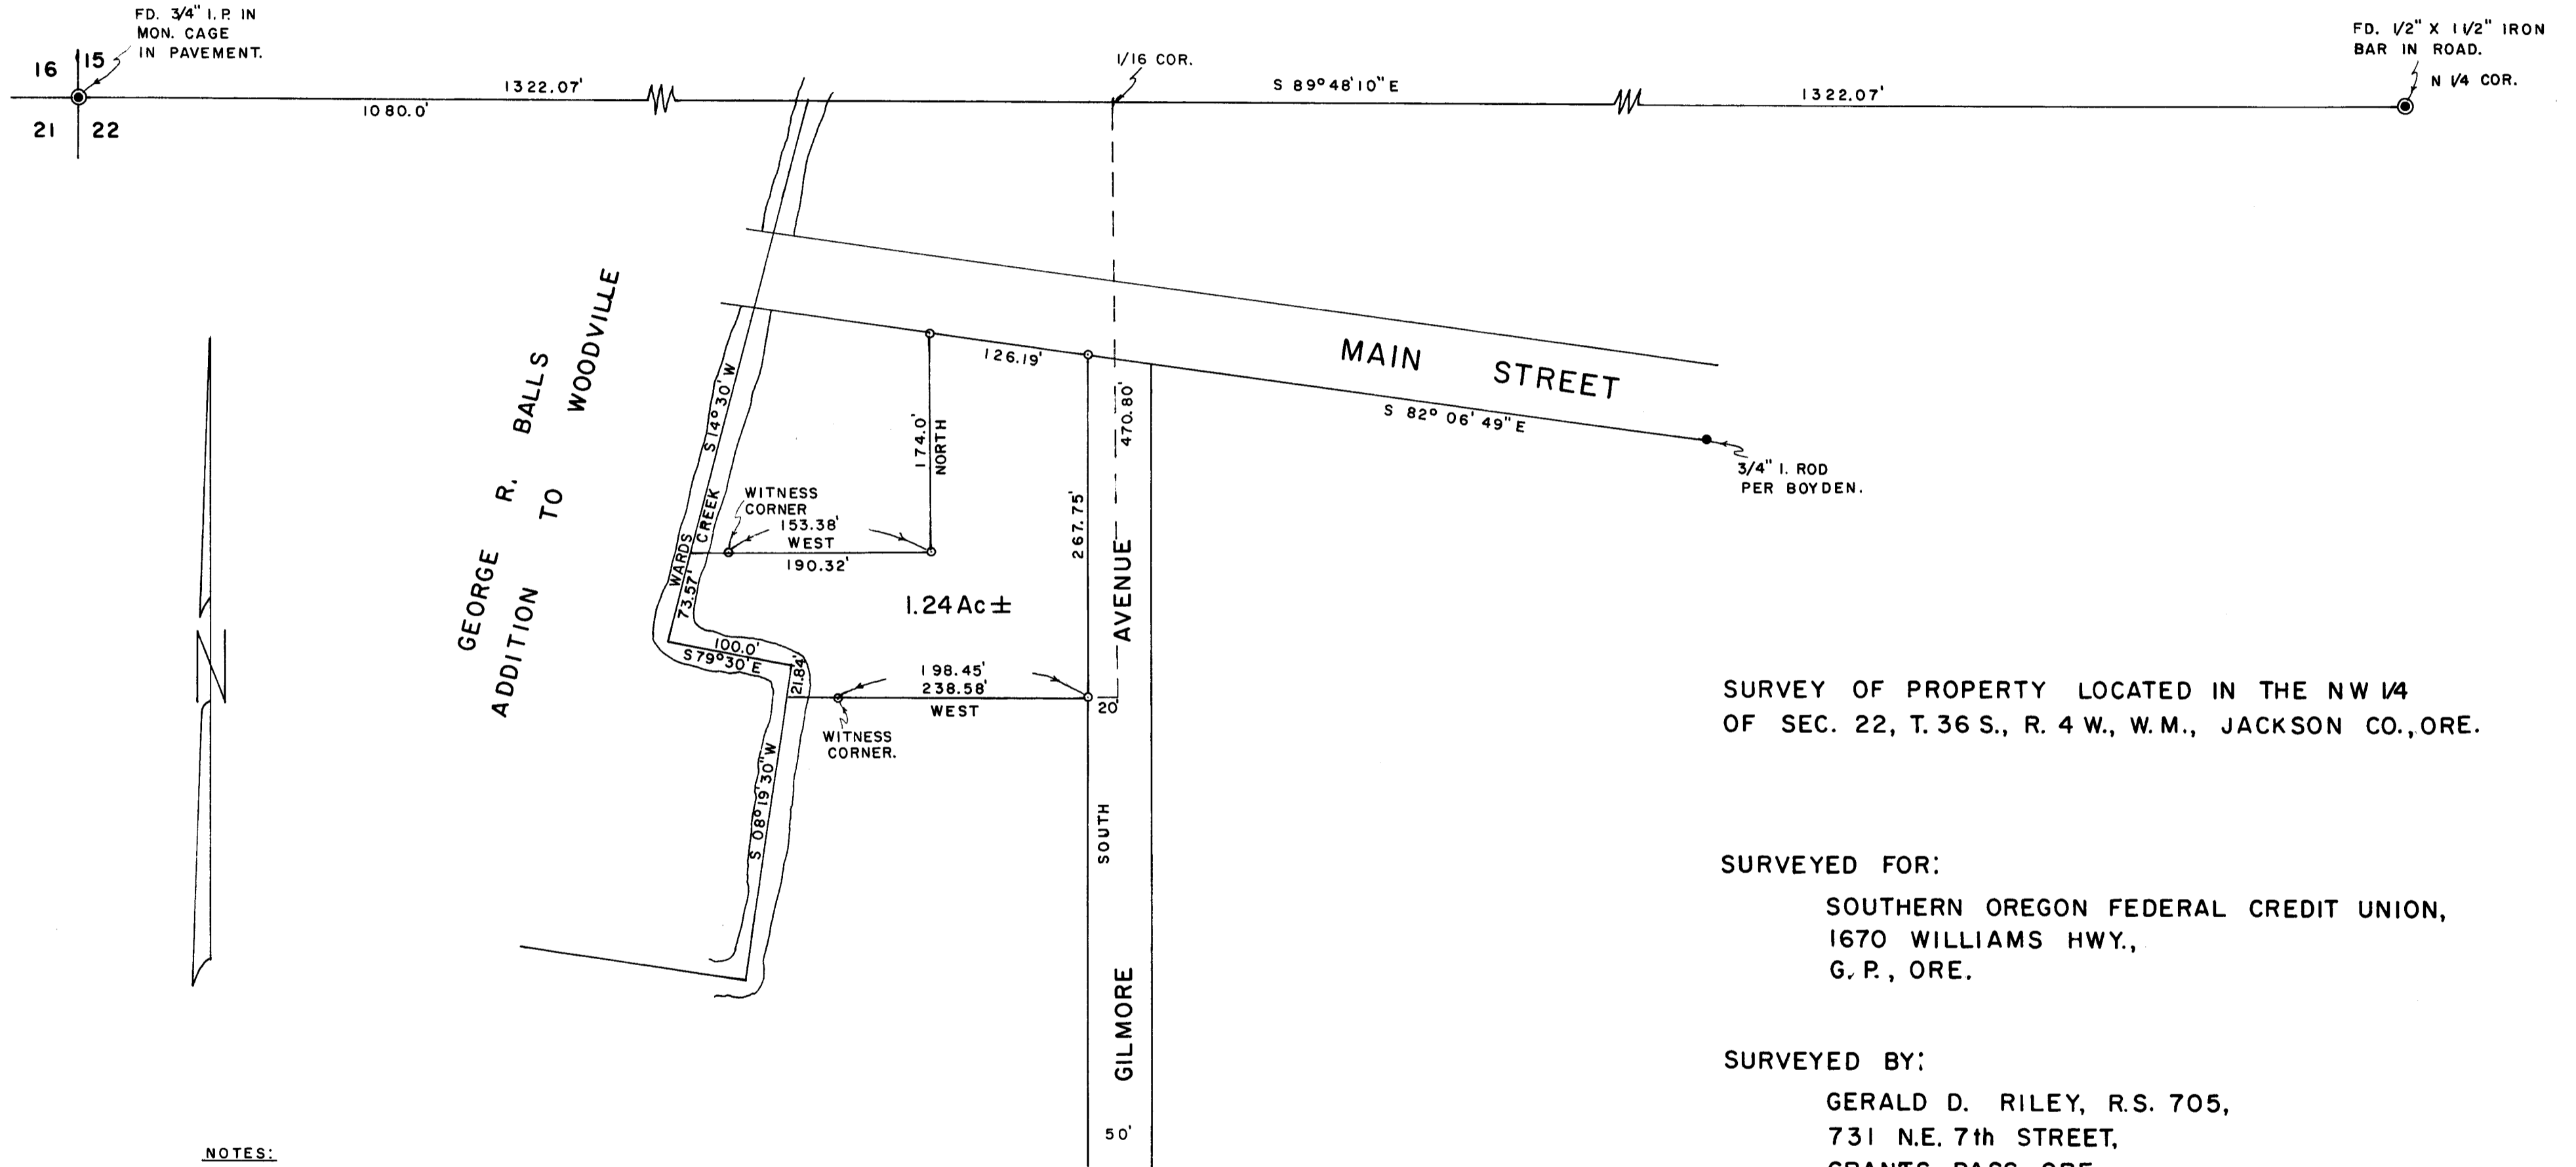
- MONUMENTS FOUND AS SHOWN.
- SET 5/8" REBAR WITH RED CAP MARKED "RILEY RS 705"
- BEARINGS ARE REFERENCED TO SURVEY NO. 1473.

SCALE: 1" = 100'

PURPOSE: To locate and monument that property being
purchased by Southern Oregon Federal Credit
Union, in the North West $\frac{1}{4}$ of Section 22,
Township 36S., Range 4 West, W.M., Jackson
County Oregon.

PROCEDURE: I began at the Northwest corner of the section
and traversed Easterly to the North $\frac{1}{4}$ corner as
shown. I then compute the true location of the
 $\frac{1}{16}$ corner and traversed Southerly and Westerly
to the property to be surveyed, per the deed
descriptions and run the lines and set the cor-
ners as shown.
