MAP OF SURVEY
LOCATED IN
SEC. 22 & 23, T. 40 S., R. 2 W., W.M.
JACKSON COUNTY, OREGON
FOR
ROGUE RIVER NATIONAL FOREST
NOVEMBER 26, 1979

Survey Narrative to Comply With
Paragraph 209.250 Oregon Revised Statutes

Location: Sections 22 and 23, Township 40 South, Range 2 West,
Willamette Meridian, Jackson County, Oregon.

Purpose: To reestablish the one quarter corner common to Sections
22 and 23, Township 40 South, Range 2 West, Willamette
Meridian.

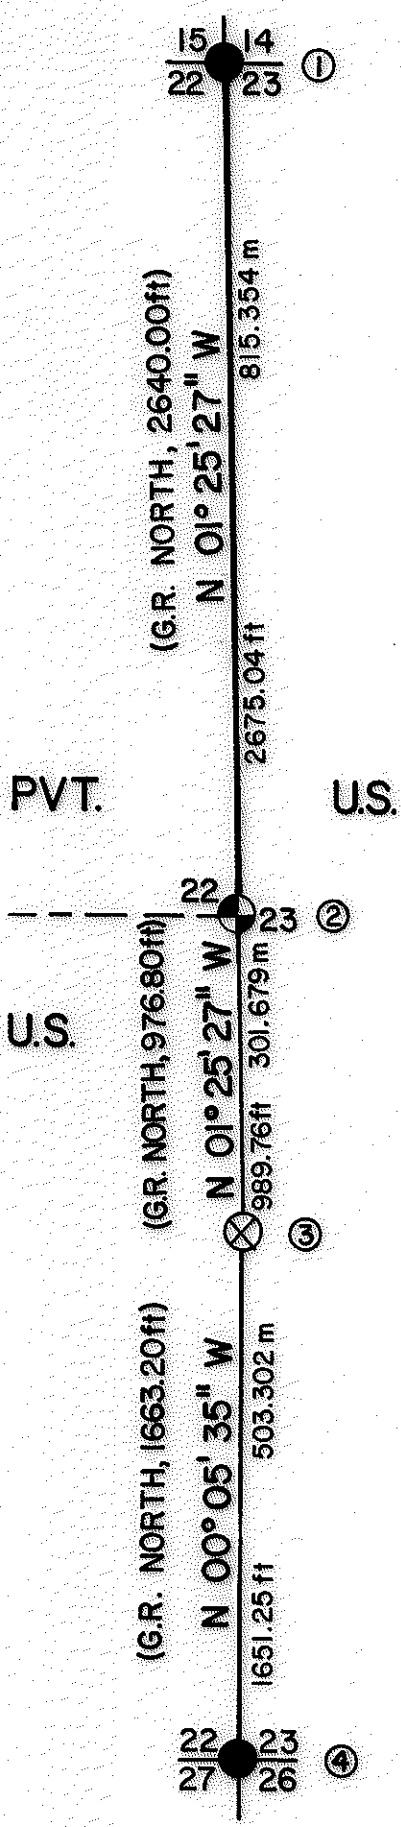
- ① FOUND MONUMENT
REFERENCES:
22" DIA. FIR N 61° 00' E 15.84ft
16" DIA. MADRONE S 61° 30' E 55.00ft
14" DIA. FIR S 43° 00' E 25.74ft
7" DIA. FIR S 11° 15' W 40.92ft
24" DIA. PINE STUMP S 21° 00' W 23.40ft
8" DIA. FIR N 56° 00' W 25.00ft

- ② SET MONUMENT
MARKED: T. 40 S. R. 2 W.
1/4 S 22 S 23
1979
LS 1071

- REFERENCES:
11" DIA. D. FIR S 84° 43' E 45.80ft,
SCRIBED 1/4 S 23 LS 1071 BT.
11" DIA. D. FIR N 47° 16' W 53.15ft,
SCRIBED 1/4 S 22 LS 1071 BT.

- ③ LINE TREE
41" DIA. P. PINE WITH TWO HEALED NOTCHES
ON NORTH AND SOUTH FACES.

- ④ FOUND MONUMENT
REFERENCES:
13" DIA. W. FIR N 63° 45' E 15.60ft
21" DIA. D. FIR S 14° 23' E 10.00ft
25" DIA. D. FIR S 16° 45' W 13.80ft
33" DIA. D. FIR N 14° 56' W 31.00ft

Procedure: Performed a closed traverse tying controlling section
corners; from this data search areas were determined
for the one quarter corner and a line tree situated
southerly of the one quarter corner. A thorough search
for the one quarter corner was made without success; a
search for the line tree recovered a 41-inch diameter
pine with 2 healed notches on north and south faces
of tree. Borings were made in the respective notches
with ring counts dating to Circa 1883.

Utilizing the recovered line tree new search
areas were determined for the one quarter
corner. A thorough search was again made of
these areas without success. I therefore
reestablish this corner as shown on the
attached map of survey.
