MAP OF SURVEY
 LOCATED IN
SEC. 13, T. 40 S., R. 3 W., W.M.
 AND
SEC. 18, T. 40 S., R. 2 W., W.M.
JACKSON COUNTY, OREGON

FOR
ROGUE RIVER NATIONAL FOREST
 JULY 16, 1981

SURVEY NARRATIVE TO COMPLY WITH
PARAGRAPH 209.250 OREGON REVISED STATUTES

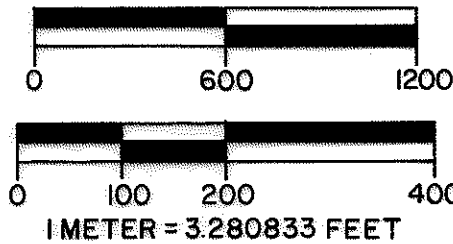
BASIS OF BEARING—SOLAR OBSERVATION

- FOUND STANDARD BLM MONUMENT
- ⊙ SET 2 1/2" DIA. X 30" LG. IRON POST WITH 2 1/2" DIA. BRASS CAP
- PROPERTY LINE ESTABLISHED AND POSTED THIS SURVEY

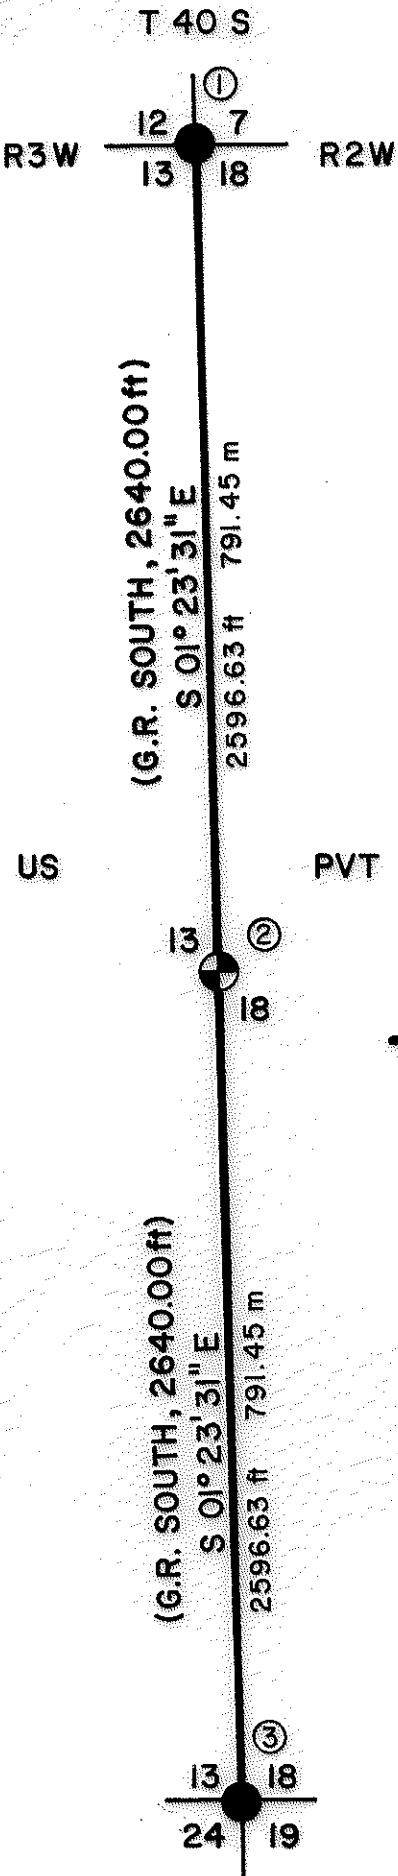
① FOUND MONUMENT REFERENCES:

- 22" DIA. DOUGLAS FIR N 37°10' E 26.1 ft
- 16" DIA. DOUGLAS FIR S 36°21' E 5.7 ft
- 12" DIA. DOUGLAS FIR S 26°12' E 3.2 ft
- 5" DIA. LIVE OAK S 50°57' W 16.2 ft
- 15" DIA. DOUGLAS FIR S 56°28' W 35.9 ft
- 22" DIA. DOUGLAS FIR N 83°14' W 32.2 ft

② SET MONUMENT MARKED:

T40 S.
 1/4
 R3W | R2W
 S13 | S18
 1981
 LS 1071

REFERENCES:

- 7" DIA. DOUGLAS FIR N 42°35' W 72.1 ft
 SCRIBED 1/4 S13 LS 1071 BT
- 8" DIA. DOUGLAS FIR S 42°26' E 15.7 ft
 SCRIBED 1/4 S18 LS 1071 BT

③ FOUND MONUMENT REFERENCES:

- 21" DIA. PONDEROSA PINE N 40°28' W 7.0 ft
- UNDETERMINED SIZE SAWED PINE STUMP N 69°02' E 26.9 ft
- 6" DIA. DOUGLAS FIR S 81°46' E 40.12 ft
- 10" DIA. PONDEROSA PINE S 18°31' E 35.3 ft
- 23" DIA. PONDEROSA PINE S 13°04' W 9.2 ft

PROCEDURE: Performed a closed traverse tying controlling
section corners; from this data search areas
were determined for the one-quarter corner. A
thorough search for the one-quarter corner was
made without success. I therefore reestablish
this corner at proportion position as shown on
attached map of survey.
