MAP OF SURVEY
FOR

ROGUE RIVER NATIONAL FOREST

DEPENDENT RESURVEY

SECTION 7, T. 32 S., R. 3 E., W.M.

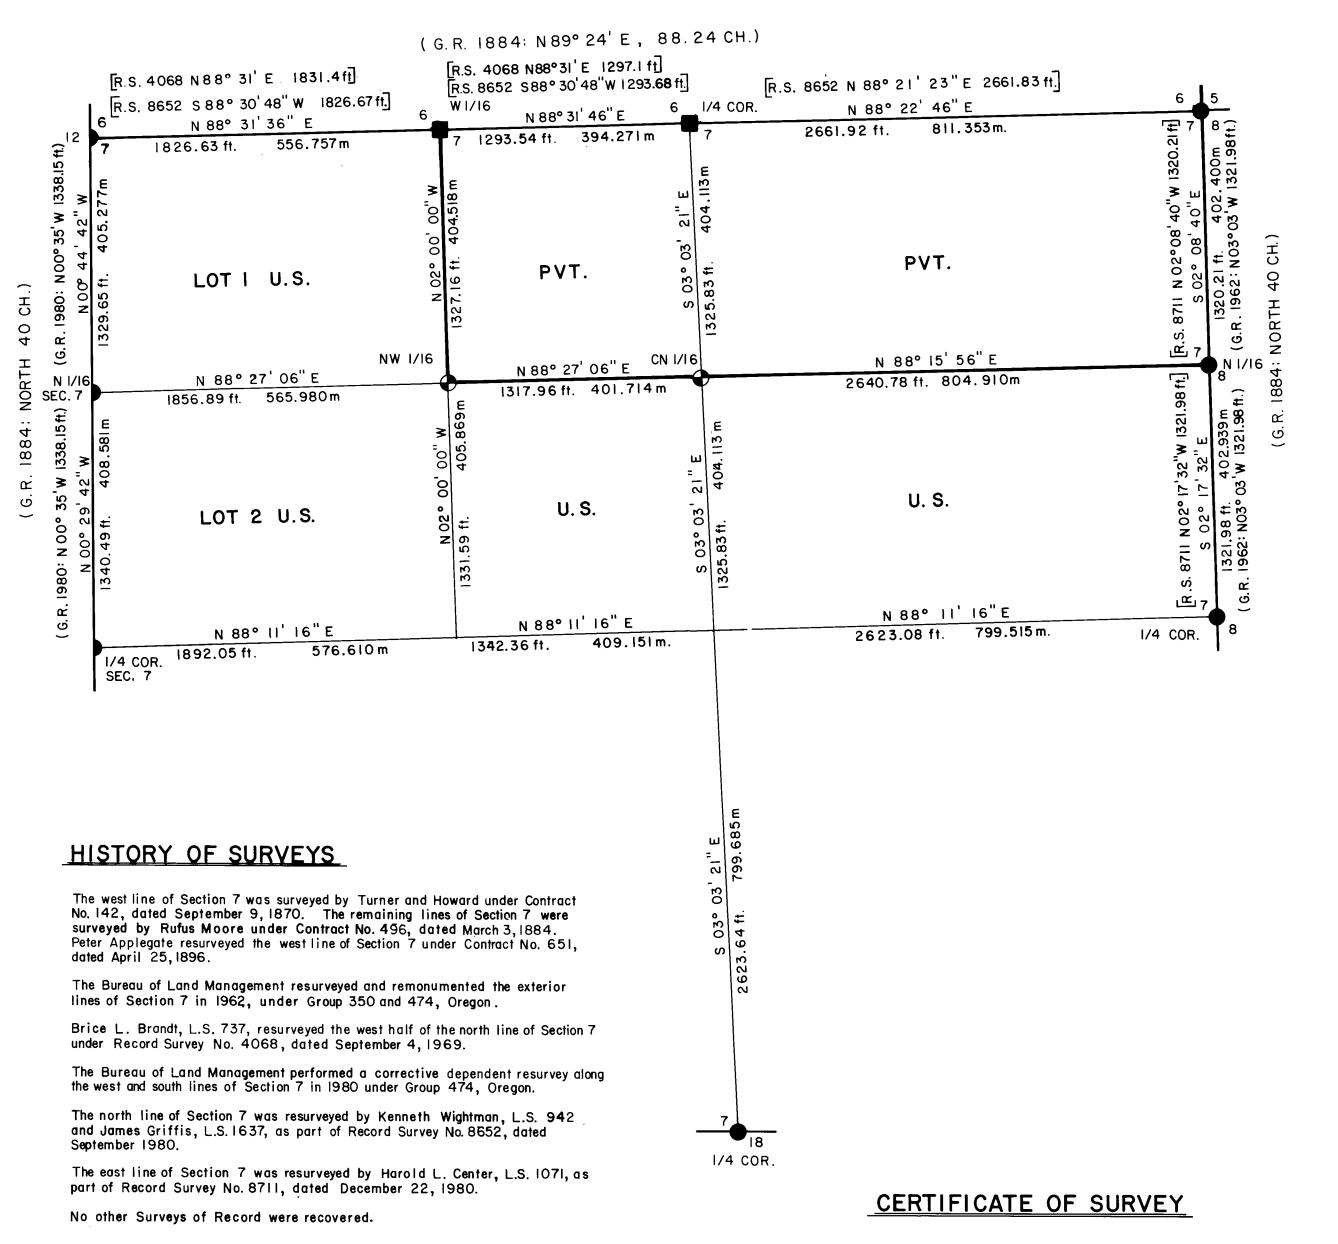
BASIS BEARING: SOLAR OBSERVATION

SECTION SUBDIVISION
