**AMENDED
MAP OF SURVEY
FOR
ROGUE RIVER NATIONAL FOREST
P.O. BOX 520
MEDFORD, OREGON
and
MEDFORD WATER COMMISSION
MARCH 14, 1984**

**DEPENDENT RESURVEY
AND
SECTION SUBDIVISION
SECTION 35, T. 35 S., R. 3 E., W.M.
JACKSON COUNTY, OREGON**

SURVEY NARRATIVE TO COMPLY WITH
PARAGRAPH 209.250 OREGON REVISED STATUTES

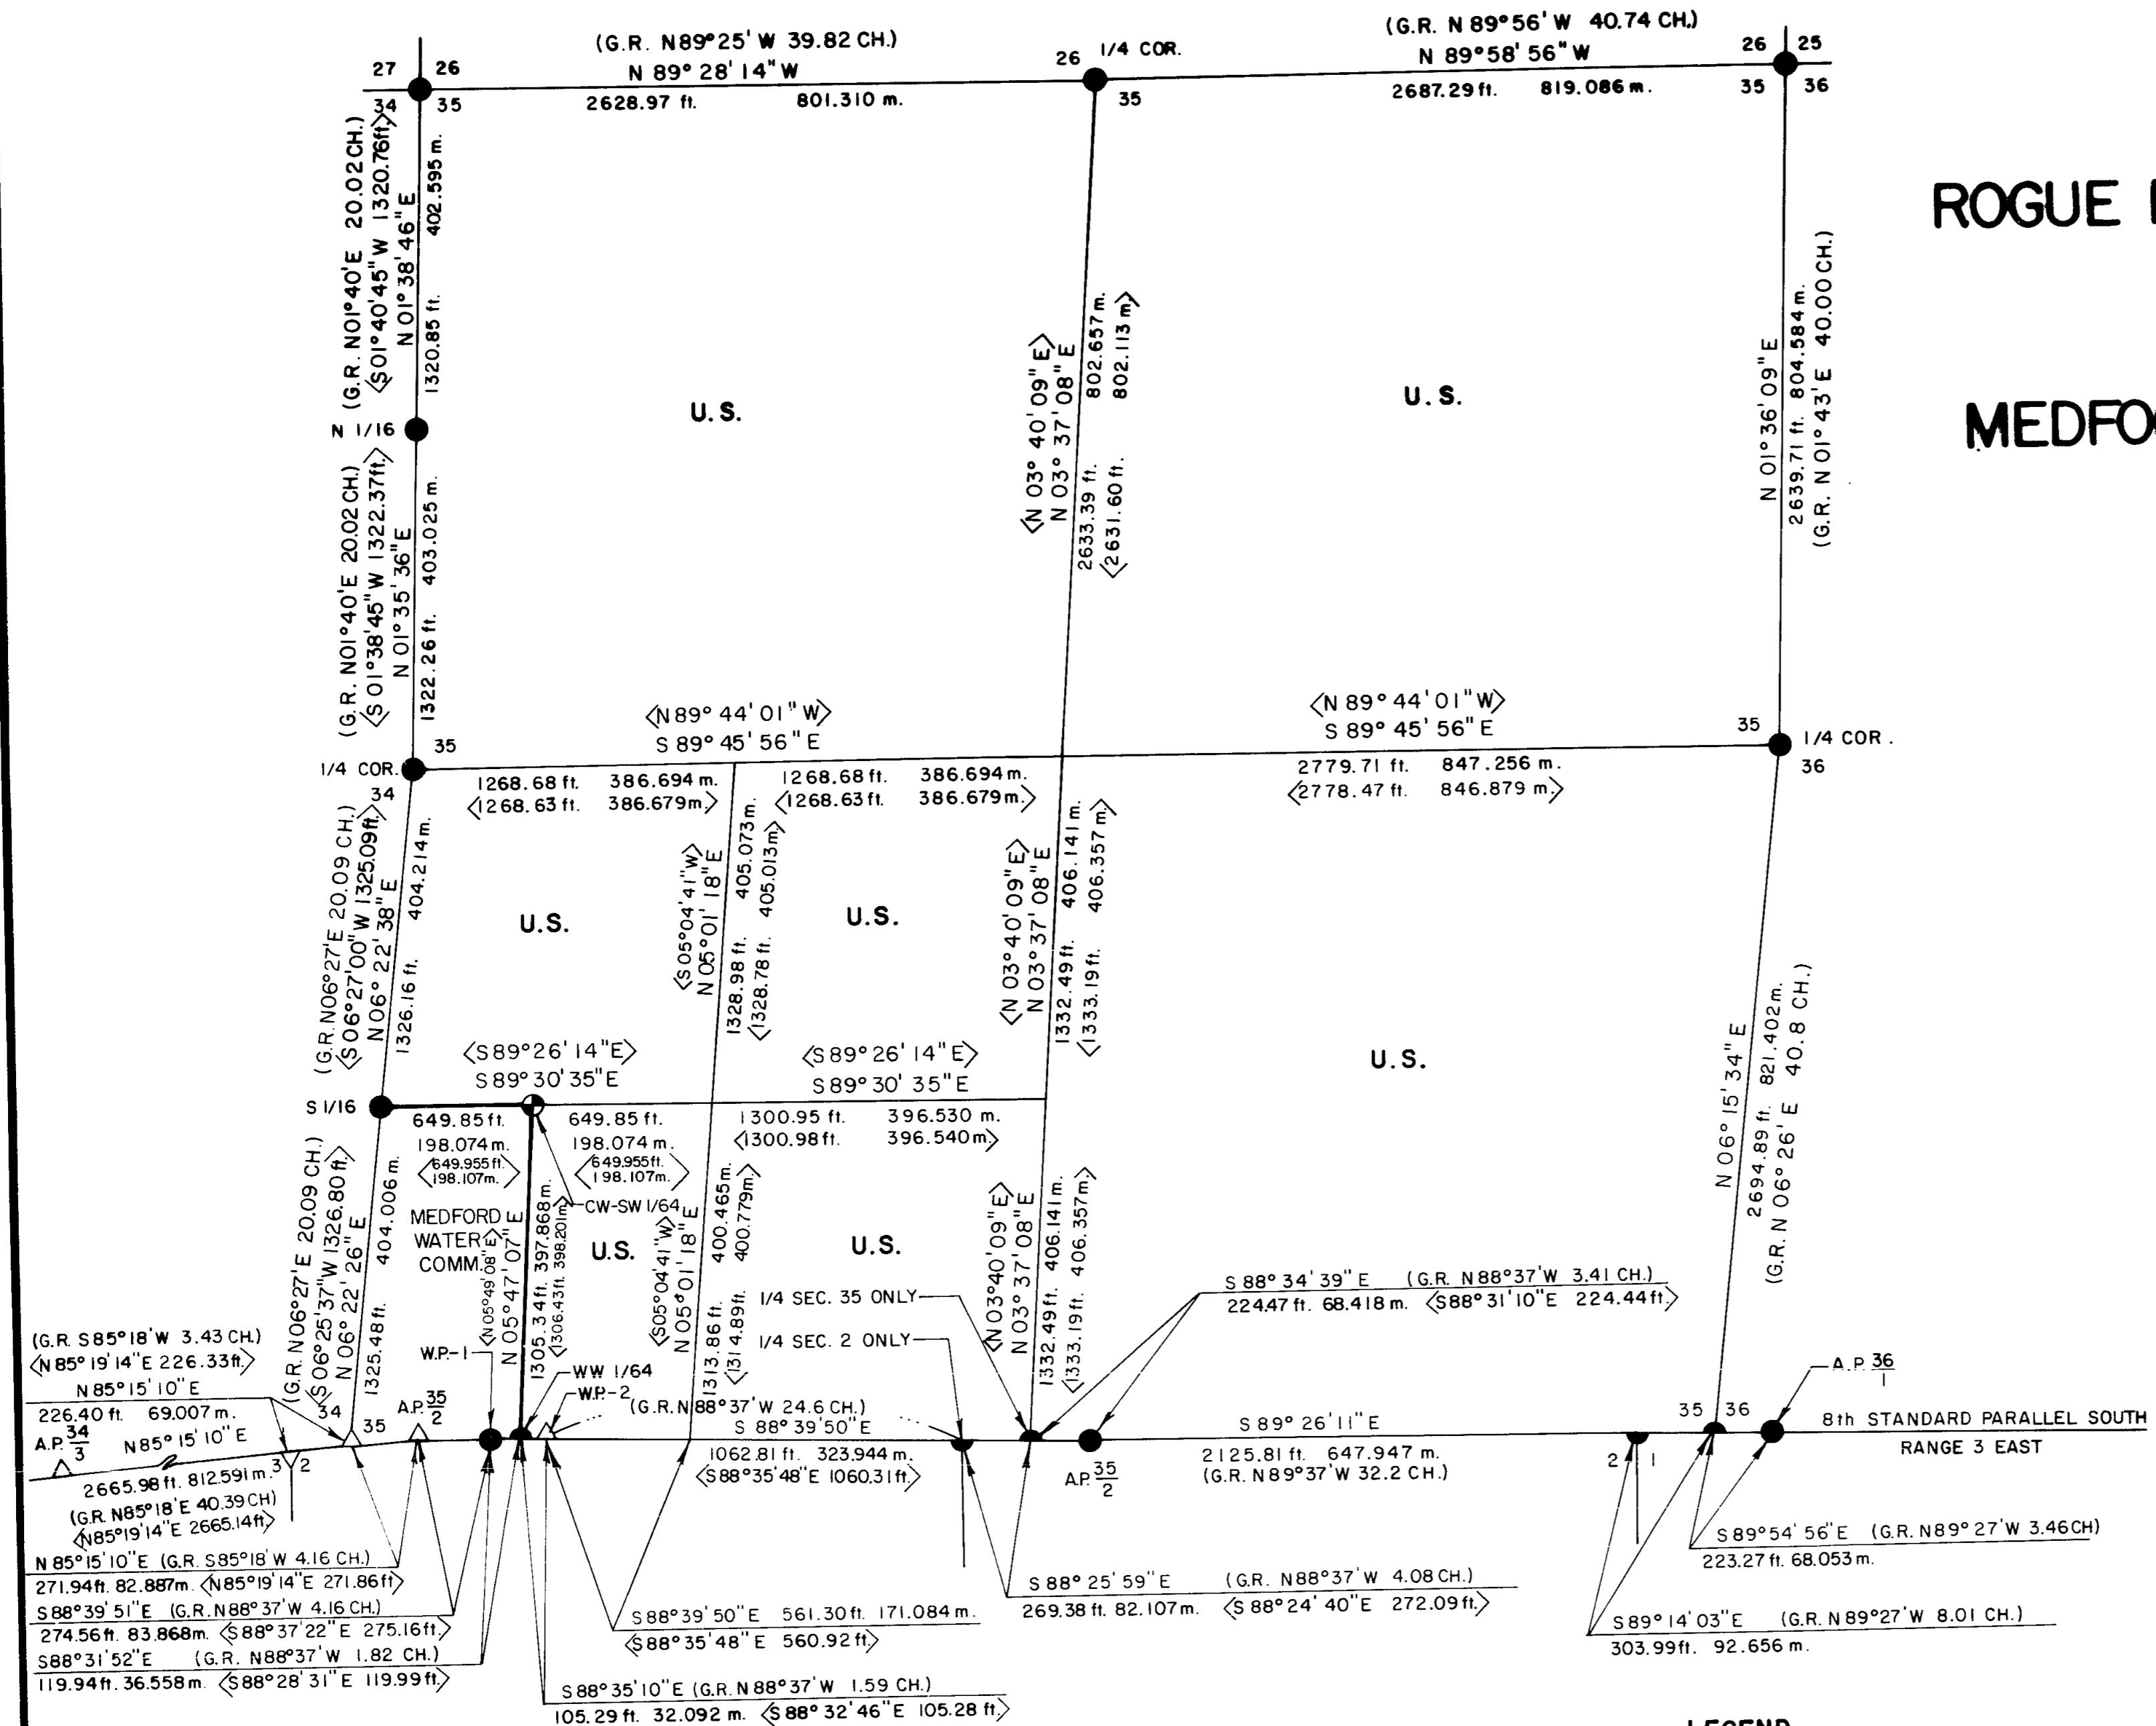
- LEGEND**
- FOUND STANDARD BLM OR COUNTY SURVEYOR BRASS CAP MONUMENT, UNLESS OTHERWISE NOTED.
 - ⊙ RESET PREVIOUSLY ESTABLISHED 2-1/2" DIA. X 30" LG. IRON POST WITH 2-1/2" DIA. BRASS CAP, UNLESS OTHERWISE NOTED.
 - △ COMPUTED POINT ONLY; NO MON.; SITUATED BELOW HIGH WATER.
 - PROPERTY LINES MARKED AND POSTED THIS SURVEY.
 - SECTION LINES CALCULATED FROM TRAVERSE SURVEY.
 - ◇ DENOTES R.S. 8306 RECORD.

PROCEDURE: I performed a closed traverse which began with my
traverse control for Section 34. I then ran coun-
terclockwise around the perimeter of Section 35
closing my survey to previously established control
at the northwest corner of Section 35. I then ran
from my control along the interior lines of Section
35, also closing this survey to my traverse
control. From this data corner points were
established and property lines posted as shown on
the attached map of survey.
